ASBESTOS REGISTER

REGISTER NO.: AS2250-51

FOR THE PROPERTY AT: Old Police Station Complex
Johns Street,
Wallaroo, SA

DATE INSPECTED: 09/05/2013

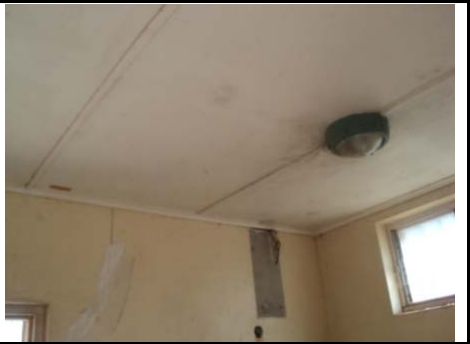
LOCATION - DESCRIPTION	EXTENT	ASBESTOS ASSESSMENT	CONDITION	SAMPLE NO VISUAL TEST	SIGNAGE STATUS
1. Internal, old jail cells, bathroom ceiling linings – fibre cement sheet.	Approx 9m ² Limited access	Presume asbestos content	Good Sealed Non friable	Visual	Visible
SURVEY FINDINGS and HAZARD MANAGEMENT RECOMMENDATIONS					
Low Risk P4 – Avoid physical and mechanical damage. When maintenance/upgrade is required, recommend removal and reinstate with non-asbestos product.
