ASBESTOS REGISTER

REGISTER NO.: AS2250-37

FOR THE PROPERTY AT: Wallaroo Recreation Grounds,
Amenities Blocks x 3
Cornish Street,
Wallaroo, SA

CLIENT: District Council of the Copper Coast

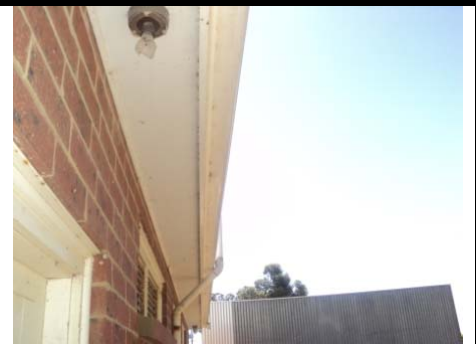
LOCATION – DESCRIPTION <u>RED BRICK TOILET BLOCK - EXTERNAL</u>	EXTENT	ASBESTOS ASSESSMENT	CONDITION	SAMPLE NO VISUAL TEST	SIGNAGE STATUS
A. East and west elevations, eaves and verandah, lining – fibre cement sheet.	Approx 20m ² Limited access	Chrysotile asbestos detected	Good Sealed Non friable	14RTA050810	Visible
SURVEY FINDINGS and HAZARD MANAGEMENT RECOMMENDATIONS					
<p>Low Risk P4 – Avoid physical and mechanical damage. When maintenance/upgrade is required, recommend removal and reinstate with non-asbestos product.</p>

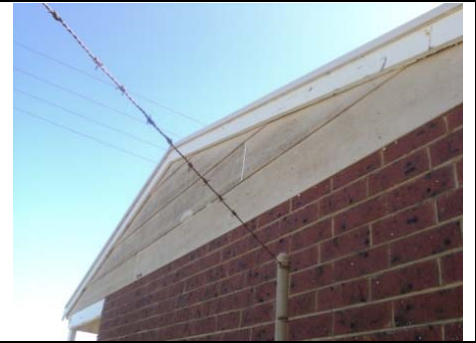
LOCATION – DESCRIPTION <u>RED BRICK TOILET BLOCK - EXTERNAL</u>	EXTENT	ASBESTOS ASSESSMENT	CONDITION	SAMPLE NO VISUAL TEST	SIGNAGE STATUS
B. North and south elevations, gable end infills, lining – fibre cement sheet.	Approx 10m ² Limited access	Chrysotile asbestos detected	Moderate Sealed Non friable	15RTA050810	Visible
SURVEY FINDINGS and HAZARD MANAGEMENT RECOMMENDATIONS					
<p>Low Risk P4 – Avoid physical and mechanical damage. When maintenance/upgrade is required, recommend removal and reinstate with non-asbestos product.</p> <p>August 2010 Item made safe in accordance with “Approved Code of Practice”</p> <p>April 2012 note: hole visible in gable end planking. Recommend make safe in accordance with “Asbestos Approved Code of Practice”.</p> <p>July 2012 note: Item made safe with the approved codes of practice.</p>
