ASBESTOS REGISTER

REGISTER NO.: AS2250-35

FOR THE PROPERTY AT: Old Kadina Racecourse, Grandstand
& Sheds
New Road
Wallaroo, SA

DATE INSPECTED: 09/05/2013

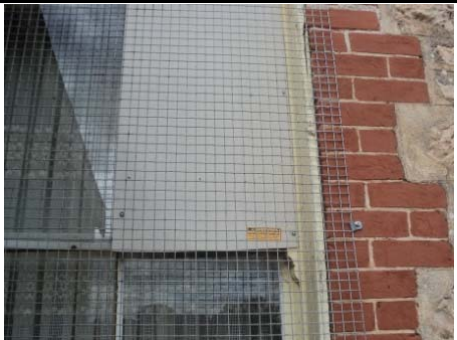
A. West elevation, window infills, lining – fibre cement sheet.	Approx 3m ² Limited access	Presume asbestos content	Good Unsealed Non friable	Visual	Visible	
<i>SURVEY FINDINGS and HAZARD MANAGEMENT RECOMMENDATIONS</i>						
<p>Low Risk P4 – Avoid physical and mechanical damage. When maintenance/upgrade is required, recommend removal and reinstate with non-asbestos product. Fibre cement sheet used to block windows after vandalism.</p> <p>It is possible that more modern installations of cement sheeting (due to building upgrades or repairs) may be non-asbestos; however this must be qualified individually by sample analysis.</p> <p>Recommend sample and laboratory analyse materials prior to being worked upon specific to the area concerned. Otherwise, treat all cement sheet products as asbestos containing.</p>

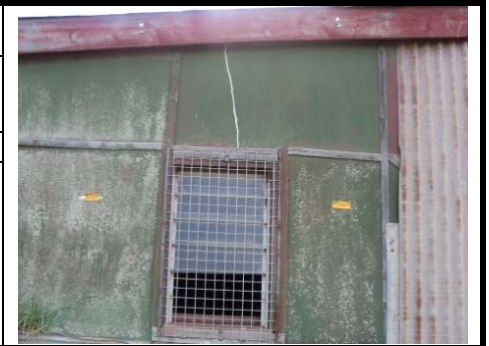
LOCATION – DESCRIPTION <u>METAL GRANDSTAND EXTERNAL</u>	EXTENT	ASBESTOS ASSESSMENT	CONDITION	SAMPLE NO VISUAL TEST	SIGNAGE STATUS
B. East elevation, 'lean to' section of building, wall, lining – fibre cement sheet.	Approx 12m ² Accessible	Presume asbestos content	Good Sealed Non friable	Visual	Visible
SURVEY FINDINGS and HAZARD MANAGEMENT RECOMMENDATIONS					
<p>Low Risk P4 – Avoid further physical and mechanical damage. When maintenance/upgrade is required, recommend removal and reinstate with non-asbestos product. Recommend sample (x1) to qualify material content, otherwise treat item as asbestos containing. August 2010 Item made safe in accordance with "Approved code of practice".</p>

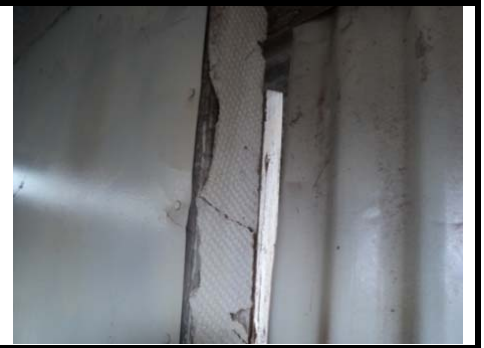
LOCATION – DESCRIPTION <u>TOILET BLOCK INTERNAL</u>	EXTENT	ASBESTOS ASSESSMENT	CONDITION	SAMPLE NO VISUAL TEST	SIGNAGE STATUS
5. Male and female toilets, walls, lining – fibre cement sheet.	Approx 3m ² Accessible	Presume asbestos content	Moderate Sealed Non friable	Visual	Visible
<i>SURVEY FINDINGS and HAZARD MANAGEMENT RECOMMENDATIONS</i>					
<p>Low Risk P4 – Avoid further physical and mechanical damage. When maintenance/upgrade is required, recommend removal and reinstate with non-asbestos product.</p> <p>August 2010 Item made safe in accordance with “Approved code of practice”.</p> <p>May 2013 note: Recommend planned removal in accordance with “Asbestos Approved Code of Practice”.</p>

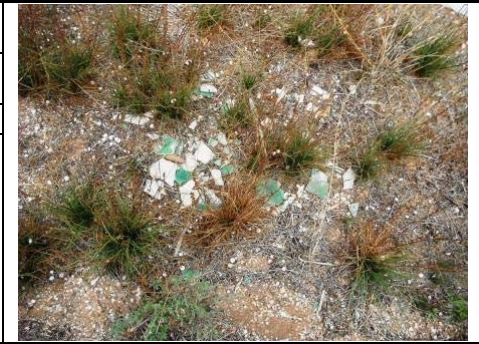
LOCATION – DESCRIPTION SOUTHERN AREA OF SITE	EXTENT	ASBESTOS ASSESSMENT	CONDITION	SAMPLE NO VISUAL TEST	SIGNAGE STATUS
D. Asbestos cement sheet debris on ground at the main entrance gate – fibre cement sheet.	-	Chrysotile & Amosite asbestos detected	-	01/LJ/260412	-
SURVEY FINDINGS and HAZARD MANAGEMENT RECOMMENDATIONS					
<p>Medium Risk P3 – Recommend planned removal in accordance with "Asbestos Approved Code of Practice".</p> <p>April 2012 note: debris visible at main gate.</p> <p>July 2012 note: debris collected with the approved codes of practice.</p>
