ASBESTOS REGISTER

REGISTER NO.: AS2250-54

FOR THE PROPERTY AT: Paskeville District Primary School
Maitland Road,
Paskeville, SA

DATE INSPECTED: 10/05/2013

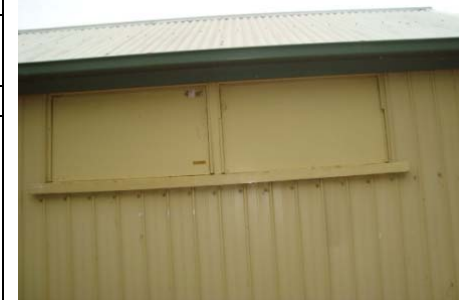
LOCATION – DESCRIPTION <u>SHED 3 – GARAGE/STORE</u>	EXTENT	ASBESTOS ASSESSMENT	CONDITION	SAMPLE NO VISUAL TEST	SIGNAGE STATUS
Item 1 – South side of shed - Infill panels - lining – fibre cement sheet.	Approx 1m ² Accessible	Presume asbestos content	Good Sealed Non friable	Visual	Visible
<i>SURVEY FINDINGS and HAZARD MANAGEMENT RECOMMENDATIONS</i>					
<p>Low Risk P4 – Avoid physical and mechanical damage. When maintenance/upgrade is required, recommend removal and reinstate with non-asbestos product.</p> <p>As item is the last remaining asbestos item in the building site register - Recommend removal and reinstate with non-asbestos product.</p> <p>This would negate the need for future update inspections of the buildings.</p>
