ASBESTOS REGISTER

REGISTER NO.: AS2250-11

FOR THE PROPERTY AT: Amenity Block
Victoria Square,
Kadina SA

DATE INSPECTED: 10/05/2013

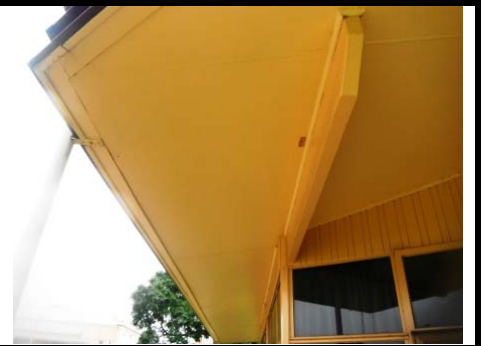
| LOCATION - DESCRIPTION | EXTENT | ASBESTOS ASSESSMENT | CONDITION | SAMPLE NO VISUAL TEST | SIGNAGE STATUS |
|---|---|---|---|---|---|
| <p>Low Risk P4 – Avoid physical and mechanical damage. When maintenance/upgrade is required, recommend removal and reinstate with non-asbestos product. Recommend sample (x1) to qualify material content, otherwise treat item as asbestos containing.</p> | | | | | |

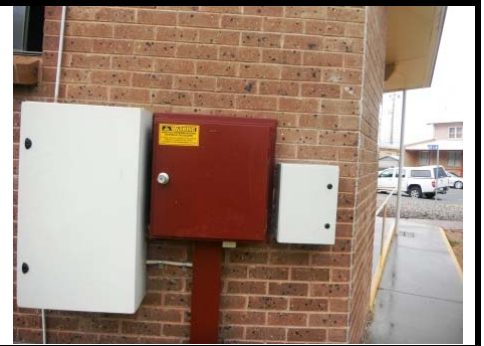
| LOCATION - DESCRIPTION | EXTENT | ASBESTOS ASSESSMENT | CONDITION | SAMPLE NO VISUAL TEST | SIGNAGE STATUS |
|--|---|---|---|---|---|
| B. External, west side, electrical cabinets (2 of) – possible asbestos containing materials within | Extent not able to be confirmed | Presume asbestos content | - | Not accessed | - |
| <p>Accessed 2008. No asbestos visible upon inspection. Refer also notes below.</p> | | | | | |
