ASBESTOS REGISTER

REGISTER NO.: AS2250-2

FOR THE PROPERTY AT: Recreation Centre
Doswell Terrace,
Kadina, SA

DATE INSPECTED: 10/05/2013

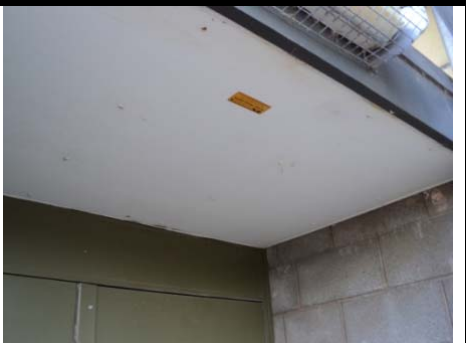
LOCATION - DESCRIPTION	EXTENT	ASBESTOS ASSESSMENT	CONDITION	SAMPLE NO VISUAL TEST	SIGNAGE STATUS
A. External, ground floor, main building, southern corridor entry, above doors, porch lining – fibre cement sheet.	Approx 3m ² Limited access	Presume asbestos content	Good Sealed Non friable	Visual	Visible
SURVEY FINDINGS and HAZARD MANAGEMENT RECOMMENDATIONS					
<p>Low Risk P4 – Avoid physical and mechanical damage. When maintenance/upgrade is required, recommend removal and reinstate with non-asbestos product. Recommend sample (x1) to qualify material content, otherwise treat item as asbestos containing.</p>

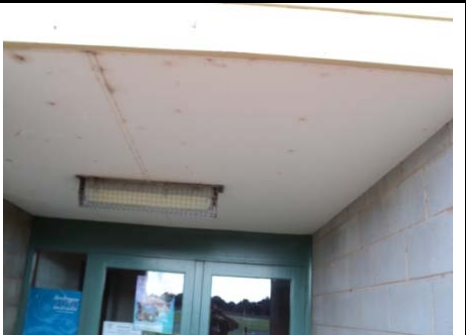
LOCATION - DESCRIPTION	EXTENT	ASBESTOS ASSESSMENT	CONDITION	SAMPLE NO VISUAL TEST	SIGNAGE STATUS
B. External, ground floor, main building, northern entry to lobby of sports hall, porch lining – fibre cement sheet.	Approx 7m ² Limited access	Chrysotile asbestos detected	Good Sealed Non friable	01RTA040810	Visible
SURVEY FINDINGS and HAZARD MANAGEMENT RECOMMENDATIONS					
<p>Low Risk P4 – Avoid physical and mechanical damage. When maintenance/upgrade is required, recommend removal and reinstate with non-asbestos product.</p> <p>August 2010 Item made safe in accordance with “Approved code of practice”.</p>

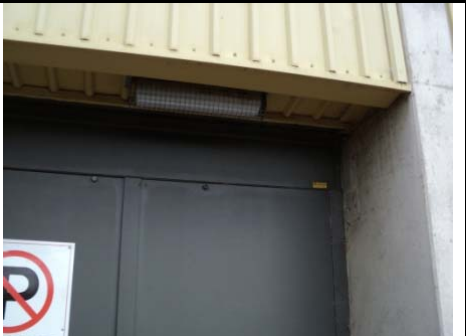
LOCATION - DESCRIPTION	EXTENT	ASBESTOS ASSESSMENT	CONDITION	SAMPLE NO VISUAL TEST	SIGNAGE STATUS
C. External, ground floor, main building, northern entry to sports hall, panel above door – fibre cement sheet.	Approx 1m ² Limited access	Presume asbestos content	Good Sealed Non friable	Visual	Visible
SURVEY FINDINGS and HAZARD MANAGEMENT RECOMMENDATIONS					
<p>Low Risk P4 – Avoid physical and mechanical damage. When maintenance/upgrade is required, recommend removal and reinstate with non-asbestos product. Recommend sample (x1) to qualify material content, otherwise treat item as asbestos containing.</p>

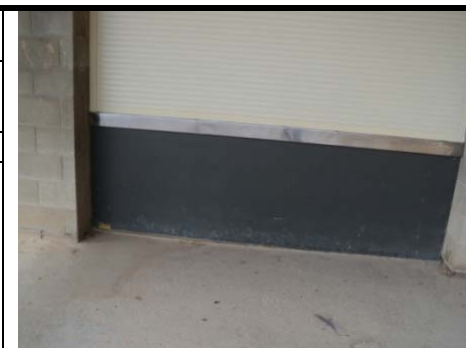
LOCATION - DESCRIPTION	EXTENT	ASBESTOS ASSESSMENT	CONDITION	SAMPLE NO VISUAL TEST	SIGNAGE STATUS
D. External, ground floor, main building, north side of main building, caterer's room, panel below door – fibre cement sheet.	Approx 1m ² Accessible	Presume asbestos content	Good Sealed Non friable	Visual	Visible
SURVEY FINDINGS and HAZARD MANAGEMENT RECOMMENDATIONS					
<p>Low Risk P4 – Avoid physical and mechanical damage. When maintenance/upgrade is required, recommend removal and reinstate with non-asbestos product. Recommend sample (x1) to qualify material content, otherwise treat item as asbestos containing.</p>

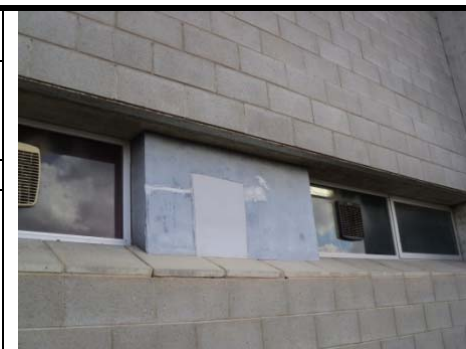
LOCATION - DESCRIPTION	EXTENT	ASBESTOS ASSESSMENT	CONDITION	SAMPLE NO VISUAL TEST	SIGNAGE STATUS
E. External, ground floor, main building, east wall, window/ flue infill panel – fibre cement sheet.	Approx 1.5m ² Limited access	Chrysotile asbestos detected	Good Sealed Non friable	02RTA040810	Visible
SURVEY FINDINGS and HAZARD MANAGEMENT RECOMMENDATIONS					
<p>Low Risk P4 – Avoid physical and mechanical damage. When maintenance/upgrade is required, recommend removal and reinstate with non-asbestos product.</p> <p>August 2010 Item made safe in accordance with "Approved code of practice".</p>

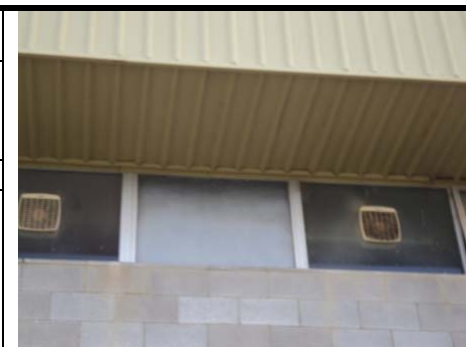
LOCATION - DESCRIPTION	EXTENT	ASBESTOS ASSESSMENT	CONDITION	SAMPLE NO VISUAL TEST	SIGNAGE STATUS
F. External, first floor, main building, east wall, window/ flue infill panel – fibre cement sheet.	Approx 1.5m ² Limited access	Presume asbestos content	Good Sealed Non friable	Visual	Not visible
SURVEY FINDINGS and HAZARD MANAGEMENT RECOMMENDATIONS					
<p>Low Risk P4 – Avoid physical and mechanical damage. When maintenance/upgrade is required, recommend removal and reinstate with non-asbestos product. Recommend sample (x1) to qualify material content, otherwise treat item as asbestos containing.</p>

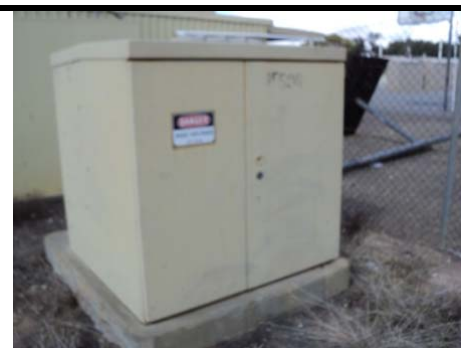
LOCATION - DESCRIPTION	EXTENT	ASBESTOS ASSESSMENT	CONDITION	SAMPLE NO VISUAL TEST	SIGNAGE STATUS
G. External, ground floor, ETSA. box to the north west of main building	Approx 1m ² Limited access	Presume asbestos content	Not assessed	Visual	Not visible
SURVEY FINDINGS and HAZARD MANAGEMENT RECOMMENDATIONS					
<p>Low Risk P4 – Avoid physical and mechanical damage. When maintenance/upgrade is required, recommend removal and reinstate with non-asbestos product.</p> <p>July 2007 Cabinet cleaned as per register recommendations during asbestos maintenance July 07.</p> <p>May 2013 No internal inspection.</p>

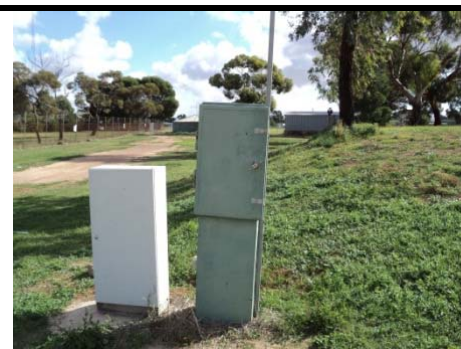
LOCATION - DESCRIPTION	EXTENT	ASBESTOS ASSESSMENT	CONDITION	SAMPLE NO VISUAL TEST	SIGNAGE STATUS
H. External, north and west of the main building, freestanding metal cabinet, electrical boards (2 of) – black resin board.	Approx 1m ² Limited access	Presume asbestos content	Not assessed	Visual	Not visible
SURVEY FINDINGS and HAZARD MANAGEMENT RECOMMENDATIONS					
<p>Low Risk P4 – Avoid physical and mechanical damage. When maintenance/upgrade is required, recommend removal and reinstate with non-asbestos product.</p> <p>May 2013 No access to cabinets. One cabinet appears new and may now not contain an asbestos board – recommend gain access to qualify at next inspection.</p>

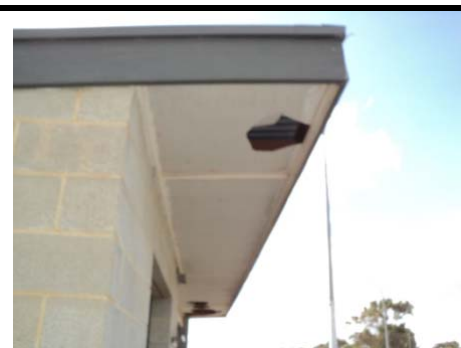
LOCATION - DESCRIPTION	EXTENT	ASBESTOS ASSESSMENT	CONDITION	SAMPLE NO VISUAL TEST	SIGNAGE STATUS
I. External, netball shelter to the east of main building, eaves lining – fibre cement sheet.	Approx 12m ² Accessible	Presume asbestos content	-	Visual	-
SURVEY FINDINGS and HAZARD MANAGEMENT RECOMMENDATIONS					
<p>No Inspection - Item has been removed prior to audit. No record of removal available. Recommend gather any asbestos removal or maintenance information and include/document this into the work/access section of the register to gain compliance. Information to include air monitoring results and where applicable statutory government approvals.</p>

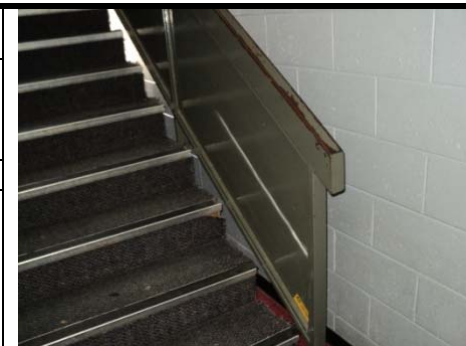
LOCATION - DESCRIPTION	EXTENT	ASBESTOS ASSESSMENT	CONDITION	SAMPLE NO VISUAL TEST	SIGNAGE STATUS
1. Internal, ground & first floors, main building, front entry, stairwell, balustrade lining – fibre cement sheet.	Approx 35m ² Accessible	Presume asbestos content	Good Sealed Non friable	Visual	Visible
SURVEY FINDINGS and HAZARD MANAGEMENT RECOMMENDATIONS					
<p>Low Risk P4 – Avoid physical and mechanical damage. When maintenance/upgrade is required, recommend removal and reinstate with non-asbestos product. Recommend sample (x1) to qualify material content, otherwise treat item as asbestos containing.</p> <p>August 2010 Item made safe in accordance with “Approved code of practice” 04/08/2010</p>

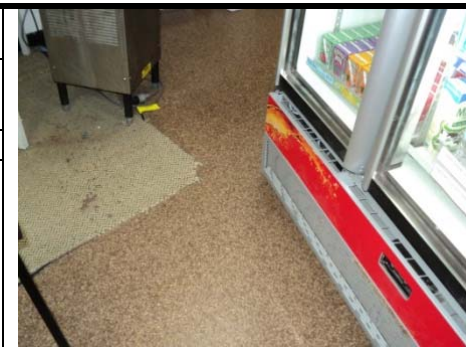
LOCATION - DESCRIPTION	EXTENT	ASBESTOS ASSESSMENT	CONDITION	SAMPLE NO VISUAL TEST	SIGNAGE STATUS
2. Internal, ground floor, main building, kiosk, floor covering – brown patterned sheet vinyl (lino) backing.	-	Chrysotile asbestos detected	-	Sample no. 01RTA221008	-
SURVEY FINDINGS and HAZARD MANAGEMENT RECOMMENDATIONS					
<p>September 2012 – Item has been removed and disposed after hours on Saturday 15/9/12 whilst site vacant, in accordance with Safework SA approval number A108824 with ‘all clear’ air-monitoring results provided to site representative Lisa Raymond upon handover of area back for safe re-occupation.</p> <p>April 2012 - High Risk P2 – Recommend immediate seal/make safe to damaged areas as interim hazard management and planned removal in accordance with “Asbestos Approved Code of Practice”.</p>

Item 2. Internal, ground floor, main building, kiosk, floor covering – brown patterned sheet vinyl. Recommend planned removal using the approved codes of practice.

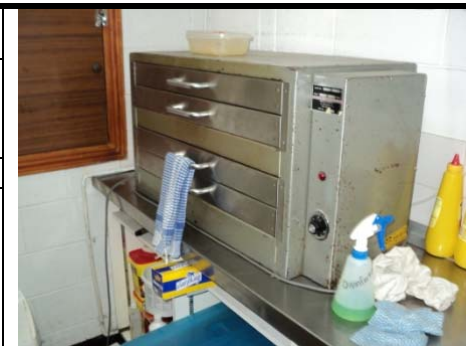
LOCATION - DESCRIPTION	EXTENT	ASBESTOS ASSESSMENT	CONDITION	SAMPLE NO VISUAL TEST	SIGNAGE STATUS
3. Internal, ground floor, main building, kiosk, ‘electra bake’ pie warmer, electrical component box – possible insulating heat shield and wire sheathing.	Not quantified Limited access	Presume asbestos content	Not assessed Unsealed Friable	Not accessed	Visible
SURVEY FINDINGS and HAZARD MANAGEMENT RECOMMENDATIONS					
<p>Low Risk P4 –Avoid physical and mechanical damage. When maintenance/upgrade is required, recommend removal and reinstate with non-asbestos product. Pie warmer not dismantled for inspection. Assume asbestos within the unit unless confirmed otherwise. Access with caution.</p>

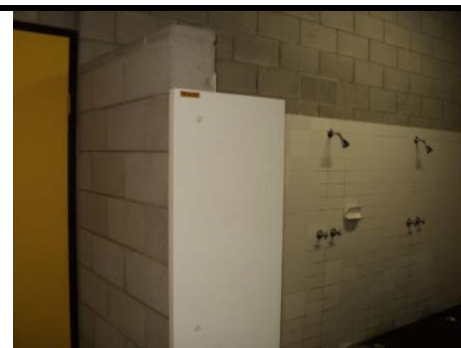
LOCATION - DESCRIPTION	EXTENT	ASBESTOS ASSESSMENT	CONDITION	SAMPLE NO VISUAL TEST	SIGNAGE STATUS
4. Internal, ground floor, main building, football club showers, shower partitions – fibre cement thick sheet	Approx 2.5m ² Accessible	Presume asbestos content	Good Sealed Non friable	Visual	Visible
SURVEY FINDINGS and HAZARD MANAGEMENT RECOMMENDATIONS					
<p>Low Risk P4 – Avoid physical and mechanical damage. When maintenance/upgrade is required, recommend removal and reinstate with non-asbestos product. Recommend sample (x1) to qualify material content, otherwise treat item as asbestos containing.</p>

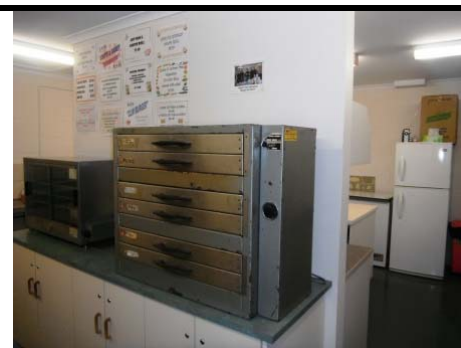
LOCATION - DESCRIPTION	EXTENT	ASBESTOS ASSESSMENT	CONDITION	SAMPLE NO VISUAL TEST	SIGNAGE STATUS
5. Internal, ground floor, main building, caterers room, 'electra bake' pie warmer, electrical component box – possible insulating heat shield and wire sheathing.	Not quantified Limited access	Presume asbestos content	Not assessed Unsealed Friable	Not accessed	Visible
SURVEY FINDINGS and HAZARD MANAGEMENT RECOMMENDATIONS					
<p>Low Risk P4 – Avoid physical and mechanical damage. When maintenance/upgrade is required, recommend removal and reinstate with non-asbestos product. Pie warmer not dismantled for inspection. Assume asbestos within the unit unless confirmed otherwise. Access with caution.</p>

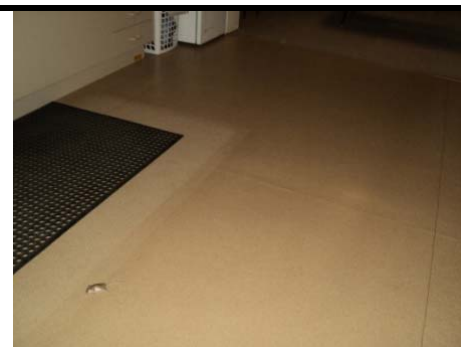
LOCATION - DESCRIPTION	EXTENT	ASBESTOS ASSESSMENT	CONDITION	SAMPLE NO VISUAL TEST	SIGNAGE STATUS
6. Internal, ground floor, main building, youth hall area, kitchen, floor covering – yellow patterned sheet vinyl (lino) backing.	Approx 18m ² Accessible	Presume asbestos content	Good Sealed Friable	Visual	Visible
SURVEY FINDINGS and HAZARD MANAGEMENT RECOMMENDATIONS					
<p>Low Risk P4 – Avoid physical and mechanical damage. When maintenance/upgrade is required, recommend removal and reinstate with non-asbestos product. Backing layer trapped under vinyl. Item regarded safe whilst vinyl remains in good condition to protect from and prevent disturbance of asbestos backing layer.</p> <p>Note - as required by the OHS&W regulations, removal of this type of material is required to be performed by a licensed removalist.</p>

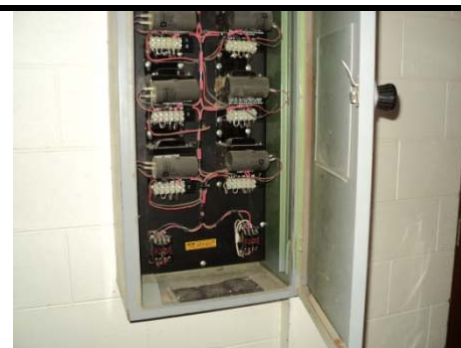
LOCATION - DESCRIPTION	EXTENT	ASBESTOS ASSESSMENT	CONDITION	SAMPLE NO VISUAL TEST	SIGNAGE STATUS
7. Internal, ground floor, main building, youth hall area, kitchen, within wall mounted metal cabinet, electrical board – black resin board.	Approx 0.5m ² Accessible	Chrysotile asbestos (typical)	Good Unsealed Non friable	Visual	Visible
SURVEY FINDINGS and HAZARD MANAGEMENT RECOMMENDATIONS					
<p>Low Risk P4 – Avoid physical and mechanical damage. When maintenance/upgrade is required, recommend removal and reinstate with non-asbestos product.</p>

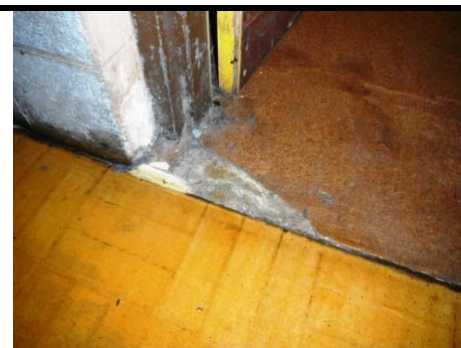
- **Item '8' – Internal, ground floor, main building, youth hall area, lobby and toilets, floor covering – orange patterned sheet vinyl (lino) backing. (Damaged and in need of repair).**
- **Item '14' – Internal, main building, first floor, kitchen, floor covering – vinyl tiles (white colour). Lifting and in need of repair.**

LOCATION - DESCRIPTION	EXTENT	ASBESTOS ASSESSMENT	CONDITION	SAMPLE NO VISUAL TEST	SIGNAGE STATUS
8. Internal, ground floor, main building, youth hall area, lobby and toilets, floor covering – orange patterned sheet vinyl (lino) backing.	Approx 450m ² Accessible	Chrysotile asbestos detected	Moderate Unsealed Friable	Sample no. 2 (Feb / 07)	Visible
SURVEY FINDINGS and HAZARD MANAGEMENT RECOMMENDATIONS					
<p>Medium Risk P3 – Avoid physical and mechanical damage. When maintenance/upgrade is required, recommend removal and reinstate with non-asbestos product.</p> <p>April 2011/12 - Recommend immediate make safe any holes / tears in accordance with “Approved Code of Practice”. Recommend planned removal in accordance with “Approved Code of Practice”.</p> <p>May 2013 note: Recommend immediate make safe any holes / tears in accordance with “Approved Code of Practice”. Recommend planned removal in accordance with “Approved Code of Practice”.</p>

Item 8 Internal, ground floor, main building, youth hall area, lobby and toilets, floor covering – orange patterned sheet vinyl (lino) backing. Recommend make safe

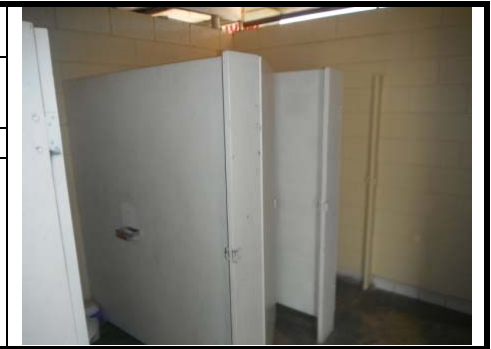
LOCATION - DESCRIPTION	EXTENT	ASBESTOS ASSESSMENT	CONDITION	SAMPLE NO VISUAL TEST	SIGNAGE STATUS
10. Internal, toilet block at western boundary opposite football oval, female toilets, toilet partitions – fibre cement thick sheet	Approx 8m ² Accessible	Chrysotile asbestos detected	Good Sealed Non friable	Sample no. 1 (August 2007)	Not visible
SURVEY FINDINGS and HAZARD MANAGEMENT RECOMMENDATIONS					
<p>Low Risk P4 – Avoid physical and mechanical damage. When maintenance/upgrade is required, recommend removal and reinstate with non-asbestos product.</p> <p>April 2011/2012 No access to this room / item. Treat as asbestos containing until qualified by inspection. Access with caution.</p>

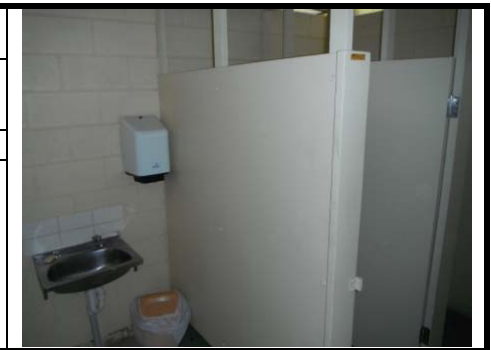
LOCATION - DESCRIPTION	EXTENT	ASBESTOS ASSESSMENT	CONDITION	SAMPLE NO VISUAL TEST	SIGNAGE STATUS
11. Internal, toilet block at western boundary opposite football oval, male toilets, toilet partitions – fibre cement thick sheet	Approx 5m ² Accessible	Presume asbestos content	Good Sealed Non friable	Sample 1 of 1 July 2007	Not visible
SURVEY FINDINGS and HAZARD MANAGEMENT RECOMMENDATIONS					
<p>Low Risk P4 – Avoid physical and mechanical damage. When maintenance/upgrade is required, recommend removal and reinstate with non-asbestos product. Monitor condition. Recommend install (x1) specific warning sign.</p> <p>July 2007 Split / cracked partitions have had pre-cautionary make safe performed by sealing with mastic during asbestos maintenance work.</p> <p>May 2010 Recommend planned replacement of one male toilet partition in accordance with “Approved Code of Practice”.</p> <p>April 2011/2012 No access to this room / item. Treat as asbestos containing until qualified by inspection. Access with caution.</p>

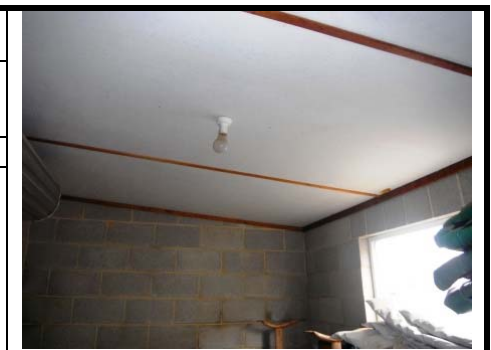
LOCATION - DESCRIPTION	EXTENT	ASBESTOS ASSESSMENT	CONDITION	SAMPLE NO VISUAL TEST	SIGNAGE STATUS
12. Internal, netball shelter to the east of main building, ceiling lining – fibre cement sheet.	Approx 6m ² Limited access	Presume asbestos content	Good Unsealed Non friable	Visual	Visible
SURVEY FINDINGS and HAZARD MANAGEMENT RECOMMENDATIONS					
<p>Low Risk P4 – Avoid physical and mechanical damage. When maintenance/upgrade is required, recommend removal and reinstate with non-asbestos product.</p> <p>April 2011 No access to this room / item. Treat as asbestos containing until qualified by inspection. Access with caution.</p> <p>May 2013 note: No access to this room at time of inspection.</p>

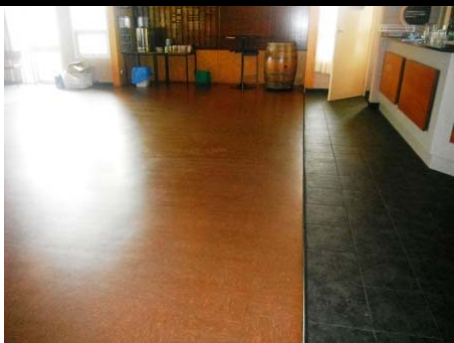
LOCATION - DESCRIPTION	EXTENT	ASBESTOS ASSESSMENT	CONDITION	SAMPLE NO VISUAL TEST	SIGNAGE STATUS
13. Internal, main building, first floor, bar area, dance floor, floor covering – vinyl tiles (brown colour).	Approx 50m ² Accessible	Presume asbestos content	Good Unsealed Non friable	Visual	Visible
SURVEY FINDINGS and HAZARD MANAGEMENT RECOMMENDATIONS					
<p>Low Risk P4 – Avoid physical and mechanical damage. When maintenance/upgrade is required, recommend removal and reinstate with non-asbestos product.</p>

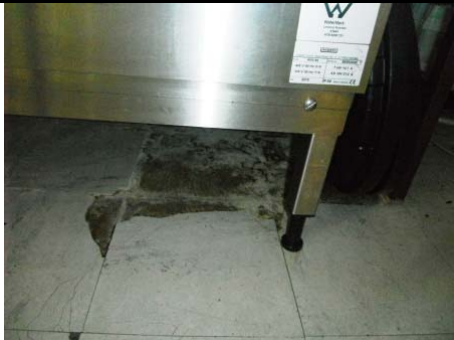
LOCATION - DESCRIPTION	EXTENT	ASBESTOS ASSESSMENT	CONDITION	SAMPLE NO VISUAL TEST	SIGNAGE STATUS
14. Internal, main building, first floor, kitchen, floor covering – vinyl tiles (white colour).	Approx 50m ² Accessible	Chrysotile asbestos detected	Moderate Unsealed Non friable	O2/LJ/260412	Visible
SURVEY FINDINGS and HAZARD MANAGEMENT RECOMMENDATIONS					
<p>Low Risk P4 – Avoid physical and mechanical damage. When maintenance/upgrade is required, recommend removal and reinstate with non-asbestos product. Monitor condition.</p> <p>April 2011 On inspection a 25cm area of damage was seen under the wash machine and griddle.</p> <p>April 2012 tiles lifting in various areas x3. Recommend make safe in accordance with “Asbestos Approved Code of Practice”.</p> <p>May 2013 tiles lifting in various areas x3. Recommend make safe in accordance with “Asbestos Approved Code of Practice”.</p>

Item 14. Internal, main building, first floor, kitchen, floor covering – vinyl tiles (white colour). Tiles lifting in various areas. Recommend make safe (remove) loose tiles.

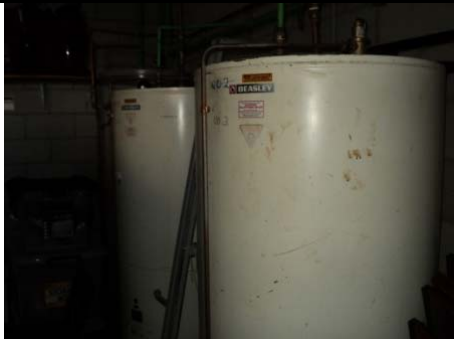
LOCATION - DESCRIPTION	EXTENT	ASBESTOS ASSESSMENT	CONDITION	SAMPLE NO VISUAL TEST	SIGNAGE STATUS
15. Internal, main building, first floor, plant room, 'Beasley' hot water service's (3 of), electrical component box – possible insulating heat shield and wire sheathing.	Extent not able to be confirmed	Presume asbestos content	Inaccessible Unsealed Friable	Not accessed	Visible
SURVEY FINDINGS and HAZARD MANAGEMENT RECOMMENDATIONS					
<p>Low Risk P4 – Avoid physical and mechanical damage. When maintenance/upgrade is required, recommend removal and reinstate with non-asbestos product. One hws has been replaced with new Rheem.</p> <p>Hot water service's not dismantled for inspection. Assume asbestos within the unit unless confirmed otherwise. Access with caution.</p>
