ASBESTOS REGISTER

REGISTER NO.: AS2250-17

FOR THE PROPERTY AT: Refuse Depot
Wallaroo Road,
Moonta SA

DATE INSPECTED: 09/05/2013

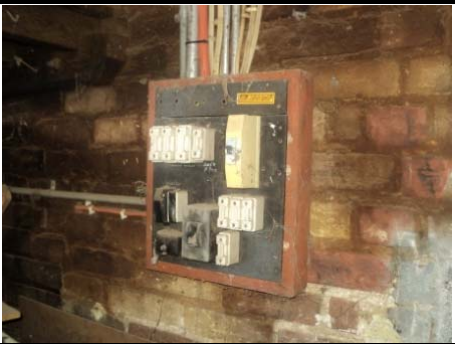
LOCATION – DESCRIPTION <u>BUILDING - INTERNAL</u>	EXTENT	ASBESTOS ASSESSMENT	CONDITION	SAMPLE NO VISUAL TEST	SIGNAGE STATUS
1. Internal, old workshop, bus lock up area, wall mounted electrical board – black resin board.	Approx 0.3m ² Accessible	Chrysotile asbestos (typical)	Good Unsealed Non friable	Visual	Visible
SURVEY FINDINGS and HAZARD MANAGEMENT RECOMMENDATIONS					
Low Risk P4 – Avoid physical and mechanical damage. When maintenance/upgrade is required, recommend removal and reinstate with non-asbestos product.

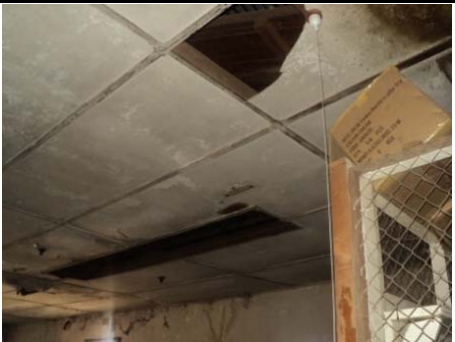
LOCATION – DESCRIPTION <u>BUILDING - INTERNAL</u>	EXTENT	ASBESTOS ASSESSMENT	CONDITION	SAMPLE NO VISUAL TEST	SIGNAGE STATUS
2. Internal, old workshop, ceiling throughout, linings – fibre cement sheet.	Approx 25m ² Limited access	Chrysotile & Crocidolite asbestos detected	Poor Unsealed Non friable	03RTA040810	Visible
SURVEY FINDINGS and HAZARD MANAGEMENT RECOMMENDATIONS					
Medium Risk P3 – Avoid physical and mechanical damage. When maintenance/upgrade is required, recommend removal and reinstate with non-asbestos product.					
August 2010 Item made safe in accordance with “Approved code of practice”.
