ASBESTOS REGISTER

REGISTER NO.: AS2250-1
FOR THE PROPERTY AT: Aerodrome
HD Wallaroo, SA
CLIENT: District Council of the Copper Coast
REGISTER CONTROLLER: Mr Andy West
CONSULTANT: Lee Jenkins
DATE INSPECTED: 09/05/2013

ADDRESS: Aerodrome, HD Wallaroo

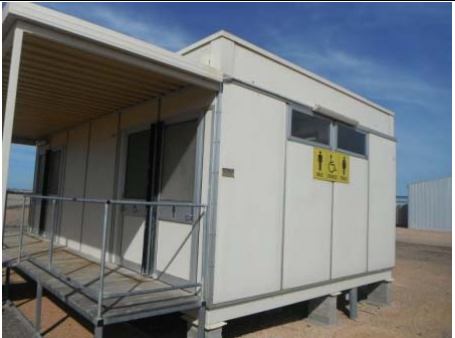
LOCATION – DESCRIPTION <u>TRANSPORTABLE TOILET BUILDING (RELOCATED OCTOBER 2007) – EXTERNAL</u>	EXTENT	ASBESTOS ASSESSMENT	CONDITION	SAMPLE NO VISUAL TEST	SIGNAGE STATUS
A. All elevations, wall cladding – fibre cement sheet.	Approx 75m ² Accessible	Chrysotile asbestos detected	Good Sealed Non friable	Sample no. 1 (March 2007)	Visible
<i>SURVEY FINDINGS and HAZARD MANAGEMENT RECOMMENDATIONS</i>					
Low Risk P4 – Avoid physical and mechanical damage. When maintenance/upgrade is required, recommend removal and reinstate with non-asbestos product.

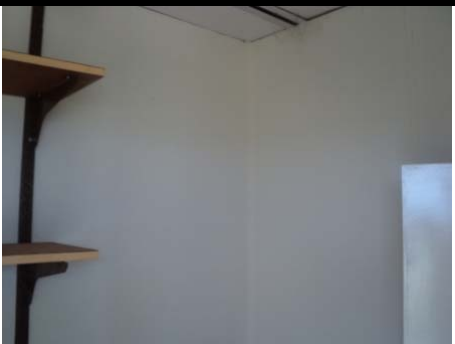
1. All rooms (male, female, disabled, cleaners store) wall linings – fibre cement sheet.	Approx 120m ² Accessible	Chrysotile asbestos detected	Good Sealed Non friable	Samples 2 & 3 (March 2007)	Visible

<i>SURVEY FINDINGS and HAZARD MANAGEMENT RECOMMENDATIONS</i>						
Low Risk P4 – Avoid physical and mechanical damage. When maintenance/upgrade is required, recommend removal and reinstate with non-asbestos product.						
LOCATION – DESCRIPTION <u>TRANSPORTABLE TOILET BUILDING – (RELOCATED OCTOBER 2007) - INTERNAL</u>	EXTENT	ASBESTOS ASSESSMENT	CONDITION	SAMPLE NO VISUAL TEST	SIGNAGE STATUS
