ASBESTOS REGISTER

REGISTER NO.: AS2250-49

FOR THE PROPERTY AT: Council Office and Public Library
Johns Terrace,
Wallaroo, SA

DATE INSPECTED: 09/05/2013

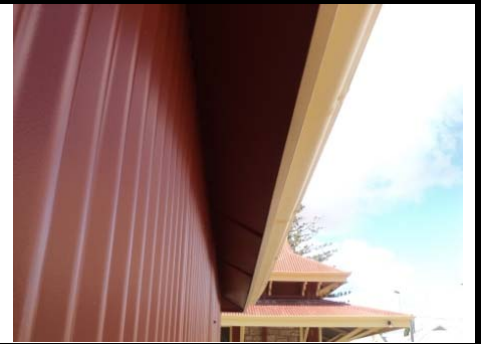
LOCATION – DESCRIPTION <u>BUILDING – EXTERNAL</u>	EXTENT	ASBESTOS ASSESSMENT	CONDITION	SAMPLE NO VISUAL TEST	SIGNAGE STATUS
A. External, lions shed to the north of the main building, perimeter of shed, eaves linings – fibre cement sheet.	Approx 10m ² Limited access	Presume asbestos content	Good Sealed Non friable	Visual	Visible
SURVEY FINDINGS and HAZARD MANAGEMENT RECOMMENDATIONS					
<p>Low Risk P4 – Avoid physical and mechanical damage. When maintenance/upgrade is required, recommend removal and reinstate with non-asbestos product. Recommend sample (x1) to qualify material content, otherwise treat item as asbestos containing.</p>

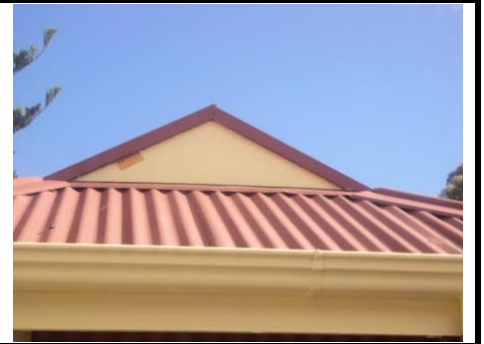
LOCATION – DESCRIPTION <u>BUILDING – EXTERNAL</u>	EXTENT	ASBESTOS ASSESSMENT	CONDITION	SAMPLE NO VISUAL TEST	SIGNAGE STATUS
B. External, lions shed to the north of the main building, atop roof, gable linings – fibre cement sheet.	Approx 1m ² Limited access	Presume asbestos content	Good Sealed Non friable	Visual	Visible
SURVEY FINDINGS and HAZARD MANAGEMENT RECOMMENDATIONS					
<p>Low Risk P4 – Avoid physical and mechanical damage. When maintenance/upgrade is required, recommend removal and reinstate with non-asbestos product. Recommend sample (x1) to qualify material content, otherwise treat item as asbestos containing.</p>

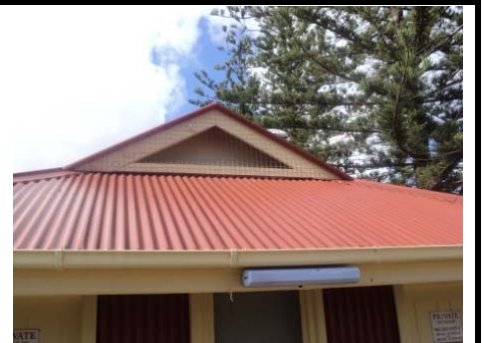
LOCATION – DESCRIPTION <u>BUILDING – EXTERNAL</u>	EXTENT	ASBESTOS ASSESSMENT	CONDITION	SAMPLE NO VISUAL TEST	SIGNAGE STATUS
C. External, toilet block to the south of the main building, atop roof, gable linings – fibre cement sheet.	Approx 3m ² Limited access	Presume asbestos content	Good Sealed Non friable	Visual	Visible
SURVEY FINDINGS and HAZARD MANAGEMENT RECOMMENDATIONS					
<p>Low Risk P4 – Avoid physical and mechanical damage. When maintenance/upgrade is required, recommend removal and reinstate with non-asbestos product. Recommend sample (x1) to qualify material content, otherwise treat item as asbestos containing.</p>
