ASBESTOS REGISTER

REGISTER NO.: AS2250-53

FOR THE PROPERTY AT: Old Court House (Band Building)
32 Lydia Terrace,
Wallaroo, SA

DATE INSPECTED: 09/05/2013

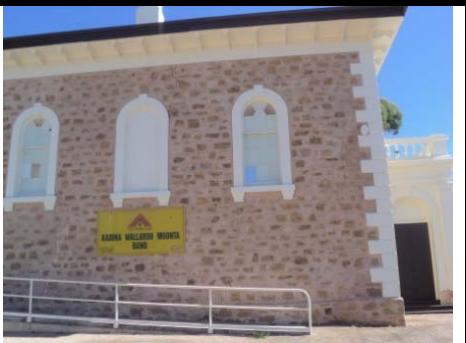
LOCATION – DESCRIPTION <u>BUILDING – EXTERNAL</u>	EXTENT	ASBESTOS ASSESSMENT	CONDITION	SAMPLE NO VISUAL TEST	SIGNAGE STATUS
No asbestos visible.	-	-	-	-	-
<i>SURVEY FINDINGS and HAZARD MANAGEMENT RECOMMENDATIONS</i>					
No asbestos visible upon inspection. Refer also notes below.

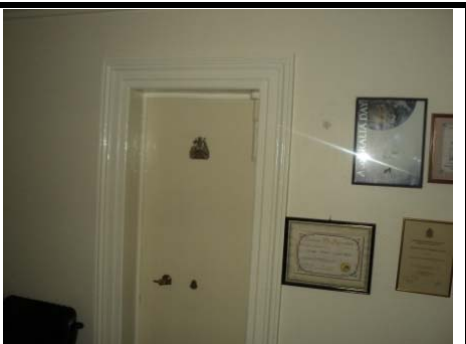
LOCATION - DESCRIPTION	EXTENT	ASBESTOS ASSESSMENT	CONDITION	SAMPLE NO VISUAL TEST	SIGNAGE STATUS
2. Internal, strong room, fire door, internal core – compressed fibre insulation.	Not quantified Inaccessible	Presume asbestos content	Not assessed Sealed Friable	Not accessed	Visible
<i>SURVEY FINDINGS and HAZARD MANAGEMENT RECOMMENDATIONS</i>					
<p>Low Risk P4 – Avoid physical and mechanical damage. When maintenance/upgrade is required, recommend removal and reinstate with non-asbestos product.</p> <p>Treat all fire doors as having an asbestos internal core unless confirmed otherwise by sample analysis.</p>

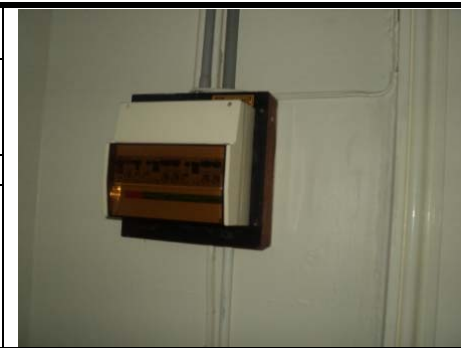
LOCATION - DESCRIPTION	EXTENT	ASBESTOS ASSESSMENT	CONDITION	SAMPLE NO VISUAL TEST	SIGNAGE STATUS
4. Internal, committee office, east wall, wall mounted electrical board – black resin board.	Approx 300x300mm Accessible	Chrysotile asbestos detected	Good Unsealed Non friable	Sample no. 02/SH/200410	Specific caution sign visible on item.
SURVEY FINDINGS and HAZARD MANAGEMENT RECOMMENDATIONS					
Low Risk P4 – Avoid physical and mechanical damage. When maintenance/upgrade is required, recommend removal and reinstate with non-asbestos product.

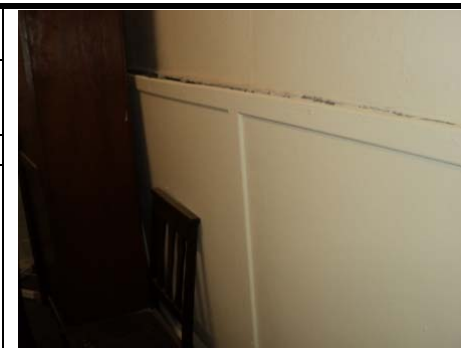
- Item '5' – Internal, committee office, northwest corner and west internal lower wall, wall linings – fibre cement sheet.
- Item '8' – Internal, east annexe, wall linings – fibre cement sheet.

LOCATION - DESCRIPTION	EXTENT	ASBESTOS ASSESSMENT	CONDITION	SAMPLE NO VISUAL TEST	SIGNAGE STATUS
5. Internal, committee office, north west corner and west internal lower wall, wall linings – fibre cement sheet.	Approx 30m ² Accessible	Chrysotile, & Crocidolite asbestos detected	Moderate Sealed Non friable	Sample no. 03/SH/200410	Visible
SURVEY FINDINGS and HAZARD MANAGEMENT RECOMMENDATIONS					
Medium Risk P3 – Avoid physical and mechanical damage. When maintenance/upgrade is required, recommend removal and reinstate with non-asbestos product.					
April 2011 Walls are unstable and bulging out making repairs difficult. Recommend removal in accordance with “Approved Code of Practice”.

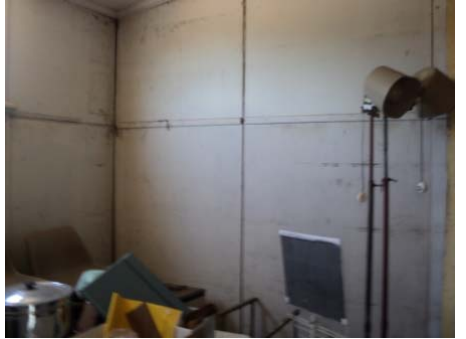
8. Internal, east annexe, wall linings – fibre cement sheet.	Approx 40m ² Accessible	Chrysotile asbestos detected	Moderate Sealed Non friable	Sample no. 04/SH/200410	Visible	
SURVEY FINDINGS and HAZARD MANAGEMENT RECOMMENDATIONS Low Risk P4 – Avoid physical and mechanical damage. When maintenance/upgrade is required, recommend removal and reinstate with non-asbestos product. April 2010 Cracks visible and batons missing. Recommend make safe in accordance with "Approved Code of Practice". July 2012 Note: Item made safe with the approved codes of practice.
