ASBESTOS REGISTER

REGISTER NO.: AS2250-42

FOR THE PROPERTY AT: North Beach Caravan Park
1 Pamir Court Wallaroo SA

DATE INSPECTED: 09/05/2013

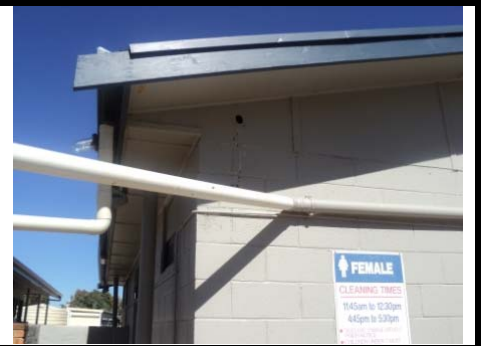
LOCATION - DESCRIPTION	EXTENT	ASBESTOS ASSESSMENT	CONDITION	SAMPLE NO VISUAL TEST	SIGNAGE STATUS
G. External, toilet block B, eaves and gable linings – fibre cement sheet.	Approx 24m ² Limited access	Presume asbestos content	-	Visual	-
SURVEY FINDINGS and HAZARD MANAGEMENT RECOMMENDATIONS					
No Inspection - Item has been removed prior to audit. No record of removal available. Recommend gather any asbestos removal or maintenance information and include/document this into the work/access section of the register to gain compliance. Information to include air monitoring results and where applicable statutory government approvals.

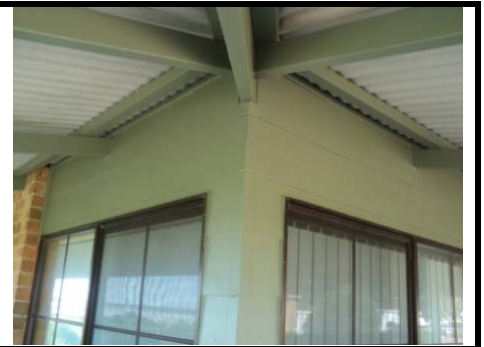
LOCATION - DESCRIPTION	EXTENT	ASBESTOS ASSESSMENT	CONDITION	SAMPLE NO VISUAL TEST	SIGNAGE STATUS
H. External, units 9 to 16, corner, wall planking – fibre cement planks	Approx 3m ² each unit Accessible	Presume asbestos content	Good Sealed Non friable	Visual	Not visible
SURVEY FINDINGS and HAZARD MANAGEMENT RECOMMENDATIONS					
Low Risk P4 – Avoid physical and mechanical damage. When maintenance/upgrade is required, recommend removal and reinstate with non-asbestos product. Recommend sample (x1) to qualify material content, otherwise treat item as asbestos containing. Recommend install (x1) specific warning sign.

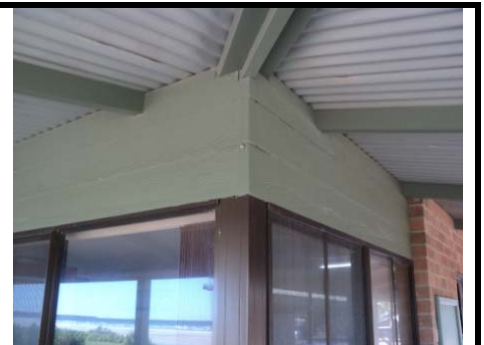
LOCATION - DESCRIPTION	EXTENT	ASBESTOS ASSESSMENT	CONDITION	SAMPLE NO VISUAL TEST	SIGNAGE STATUS
I. External, units 1 to 8, corner, wall planking / infills adjacent corner windows – fibre cement planks	Approx 3m ² each unit Accessible	Presume asbestos content	Good Sealed Non friable	Visual	Not visible
SURVEY FINDINGS and HAZARD MANAGEMENT RECOMMENDATIONS					
Low Risk P4 – Avoid physical and mechanical damage. When maintenance/upgrade is required, recommend removal and reinstate with non-asbestos product. Recommend sample (x1) to qualify material content, otherwise treat item as asbestos containing. Recommend install (x1) specific warning sign.

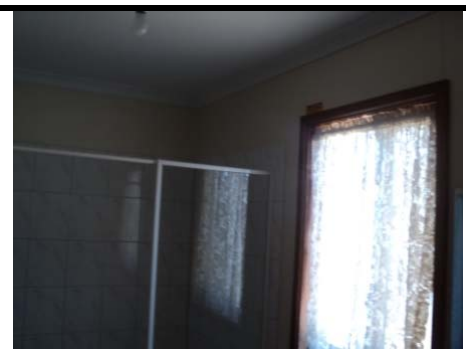
LOCATION - DESCRIPTION	EXTENT	ASBESTOS ASSESSMENT	CONDITION	SAMPLE NO VISUAL TEST	SIGNAGE STATUS
1. Internal, residence, ensuite & bathroom wall linings – fibre cement sheet	Approx 40m ² Accessible	Presume asbestos content	Good Sealed Non friable	Visual	Visible
SURVEY FINDINGS and HAZARD MANAGEMENT RECOMMENDATIONS					
<p>Low Risk P4 – It is possible that more modern installations of cement sheeting (due to building upgrades or repairs) may be non-asbestos; however this must be qualified individually by sample analysis. Recommend sample and laboratory analyse materials prior to being worked upon specific to the area concerned. Otherwise, treat all cement sheet products as asbestos containing.</p>

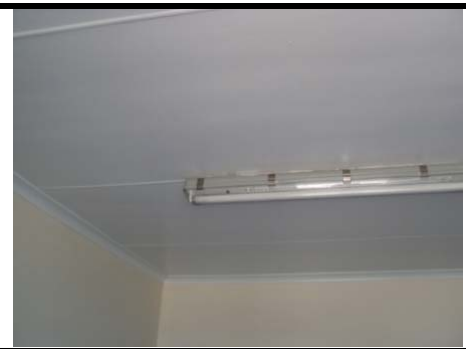
LOCATION - DESCRIPTION	EXTENT	ASBESTOS ASSESSMENT	CONDITION	SAMPLE NO VISUAL TEST	SIGNAGE STATUS
2. Internal, toilet blocks A, ceiling linings throughout – fibre cement sheet.	Approx 85m ² Accessible	Presume asbestos content	Good Sealed Non friable	Visual	Visible
SURVEY FINDINGS and HAZARD MANAGEMENT RECOMMENDATIONS					
<p>Low Risk P4 – Avoid physical and mechanical damage. When maintenance/upgrade is required, recommend removal and reinstate with non-asbestos product. Recommend sample (x1) to qualify material content, otherwise treat item as asbestos containing.</p>

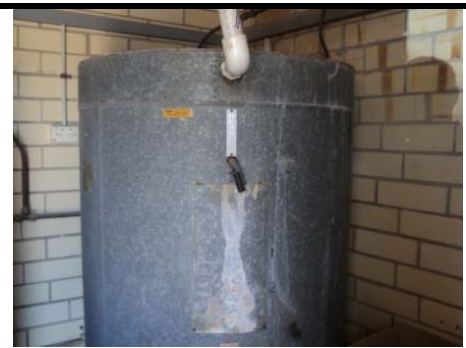
LOCATION - DESCRIPTION	EXTENT	ASBESTOS ASSESSMENT	CONDITION	SAMPLE NO VISUAL TEST	SIGNAGE STATUS
3. Internal, toilet block A, hot water service room, 'Beasley' hot water service, electrical component box – possible insulating heat shield and wire sheathing.	Not quantified Limited access	Presume asbestos content	Not assessed Unsealed Friable	Not accessed	Visible
SURVEY FINDINGS and HAZARD MANAGEMENT RECOMMENDATIONS					
<p>Low Risk P4 – Avoid physical and mechanical damage. When maintenance/upgrade is required, recommend removal and reinstate with non-asbestos product. Recommend sample (x1) to qualify material content, otherwise treat item as asbestos containing. Hot water service not dismantled for inspection. Presume asbestos within the unit unless confirmed otherwise. Access with caution.</p>

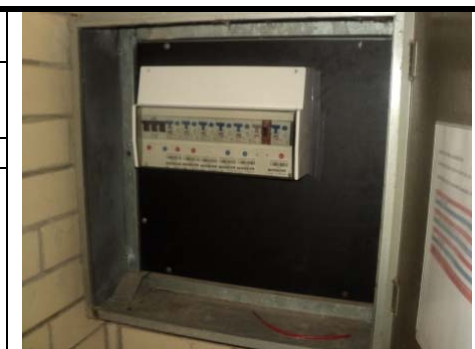
LOCATION - DESCRIPTION	EXTENT	ASBESTOS ASSESSMENT	CONDITION	SAMPLE NO VISUAL TEST	SIGNAGE STATUS
4. Internal, toilet block A, within wall mounted metal cabinet electrical board – black resin board.	Approx 0.7m ² Accessible	Chrysotile asbestos (typical)	Good Sealed Non friable	Visual	Not visible

Low Risk P4 – Avoid physical and mechanical damage. When maintenance/upgrade is required, recommend removal and reinstate with non-asbestos product.
Recommend install (x1) specific warning sign.
August 2010 Item made safe in accordance with “Approved Code of Practice”.

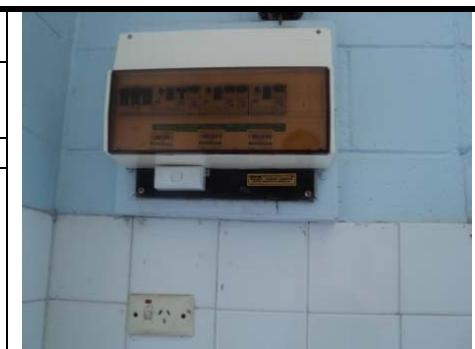
LOCATION - DESCRIPTION	EXTENT	ASBESTOS ASSESSMENT	CONDITION	SAMPLE NO VISUAL TEST	SIGNAGE STATUS
5. Internal, toilet block B, store / laundry area, wall mounted electrical board – black resin board.	Approx 300x300mm Accessible	Chrysotile asbestos (typical)	-	Visual	-

No Inspection - Item has been removed prior to audit. No record of removal available. Recommend gather any asbestos removal or maintenance information and include/document this into the work/access section of the register to gain compliance. Information to include air monitoring results and where applicable statutory government approvals.

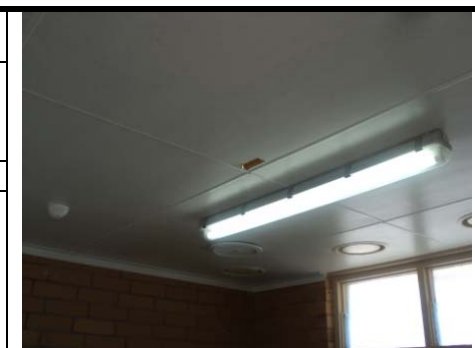
LOCATION - DESCRIPTION	EXTENT	ASBESTOS ASSESSMENT	CONDITION	SAMPLE NO VISUAL TEST	SIGNAGE STATUS
6. Internal, toilet block C, ceiling linings throughout – fibre cement sheet.	Approx 85m ² Limited access	Presume asbestos content	Good Sealed Non friable	Visual	Visible

Low Risk P4 – Avoid physical and mechanical damage. When maintenance/upgrade is required, recommend removal and reinstate with non-asbestos product.
Recommend sample (x1) to qualify material content, otherwise treat item as asbestos containing.
August 2010 Item made safe in accordance with “Approved Code of Practice”.

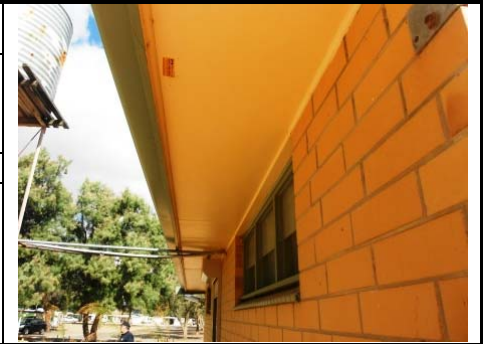
LOCATION - DESCRIPTION	EXTENT	ASBESTOS ASSESSMENT	CONDITION	SAMPLE NO VISUAL TEST	SIGNAGE STATUS
6a. External, toilet block C, eaves, linings – fibre cement sheet.	Approx 85m ² Limited access	Presume asbestos content	Good Sealed Non friable	Visual	Visible
SURVEY FINDINGS and HAZARD MANAGEMENT RECOMMENDATIONS					
<p>Low Risk P4 – Avoid physical and mechanical damage. When maintenance/upgrade is required, recommend removal and reinstate with non-asbestos product. Recommend sample (x1) to qualify material content, otherwise treat item as asbestos containing.</p>

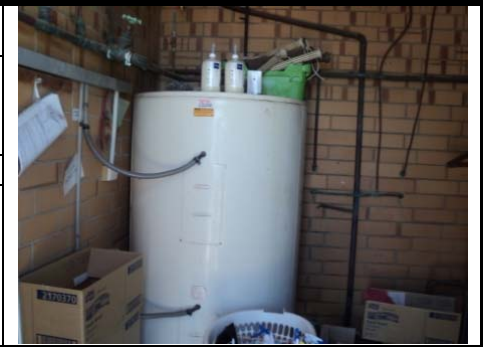
LOCATION - DESCRIPTION	EXTENT	ASBESTOS ASSESSMENT	CONDITION	SAMPLE NO VISUAL TEST	SIGNAGE STATUS
7. Internal, toilet block C, hot water service room, 'Beasley' hot water service, electrical component box – possible insulating heat shield and wire sheathing.	Not quantified Limited access	Presume asbestos content	Inaccessible Unsealed Friable	Not accessed	Visible
SURVEY FINDINGS and HAZARD MANAGEMENT RECOMMENDATIONS					
<p>Low Risk P4 – Avoid physical and mechanical damage. When maintenance/upgrade is required, recommend removal and reinstate with non-asbestos product. Recommend sample (x1) to qualify material content, otherwise treat item as asbestos containing. Hot water service not dismantled for inspection. Presume asbestos within the unit unless confirmed otherwise. Access with caution.</p>

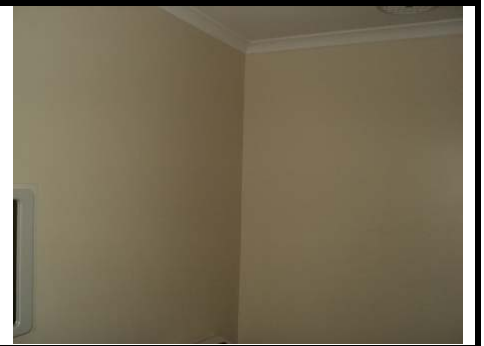
LOCATION - DESCRIPTION	EXTENT	ASBESTOS ASSESSMENT	CONDITION	SAMPLE NO VISUAL TEST	SIGNAGE STATUS
9. Internal, units 9 to 16, bathroom walls – fibre cement sheet	Approx 20m ² visible per unit Accessible	Presume asbestos content	Good Sealed Non friable	Visual	Not visible
SURVEY FINDINGS and HAZARD MANAGEMENT RECOMMENDATIONS					
<p>Low Risk P4 – Avoid physical and mechanical damage. When maintenance/upgrade is required, recommend removal and reinstate with non-asbestos product. Recommend sample (x1) to qualify material content, otherwise treat item as asbestos containing. Unable to affix specific warning sign to item, covered by General sign.</p>

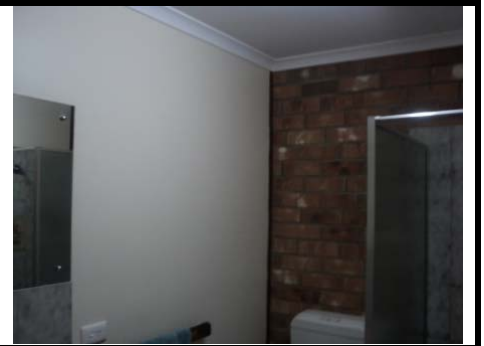
LOCATION - DESCRIPTION	EXTENT	ASBESTOS ASSESSMENT	CONDITION	SAMPLE NO VISUAL TEST	SIGNAGE STATUS
10. Internal, units 1 to 8, bathroom walls – fibre cement sheet.	Approx 20m ² visible per unit Accessible	Presume asbestos content	Good Sealed Non friable	Visual	Not visible
SURVEY FINDINGS and HAZARD MANAGEMENT RECOMMENDATIONS					
<p>Low Risk P4 – Avoid physical and mechanical damage. When maintenance/upgrade is required, recommend removal and reinstate with non-asbestos product. Recommend sample (x1) to qualify material content, otherwise treat item as asbestos containing. Unable to affix specific warning sign to item, covered by General sign.</p>
