ASBESTOS REGISTER

REGISTER NO.: AS2250-23

FOR THE PROPERTY AT: Amenities / Shelters
Queen Square,
Moonta SA

DATE INSPECTED: 09/05/2013

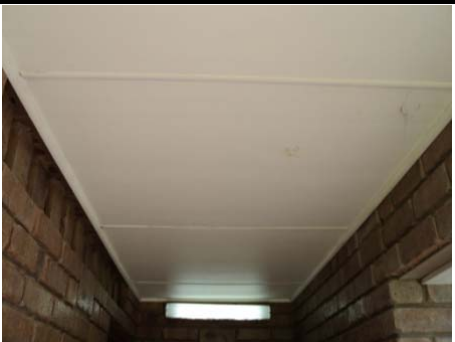
LOCATION – DESCRIPTION <u>AMENITIES BLOCK – EXTERNAL</u>	EXTENT	ASBESTOS ASSESSMENT	CONDITION	SAMPLE NO VISUAL TEST	SIGNAGE STATUS
B. Entrances to male and female toilets, ceiling linings – fibre cement sheet.	Approx 3m ² visible per entrance Limited access	Presume asbestos content	Good Sealed Non friable	Visual	Visible
<i>SURVEY FINDINGS and HAZARD MANAGEMENT RECOMMENDATIONS</i>					
Low Risk P4 – Avoid physical and mechanical damage. When maintenance/upgrade is required, recommend removal and reinstate with non-asbestos product. Recommend sample (x1) to qualify material content, otherwise treat item as asbestos containing.

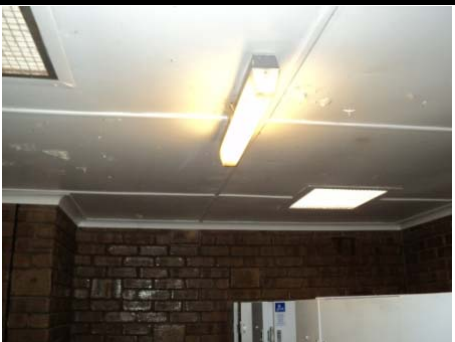
LOCATION – DESCRIPTION <u>AMENITIES BLOCK – INTERNAL</u>	EXTENT	ASBESTOS ASSESSMENT	CONDITION	SAMPLE NO VISUAL TEST	SIGNAGE STATUS
1. Male and female toilets, ceilings, lining – fibre cement sheet.	Approx 20m ² per toilet ceiling Limited access	Presume asbestos content	Good Sealed Non friable	Visual	Visible
<i>SURVEY FINDINGS and HAZARD MANAGEMENT RECOMMENDATIONS</i>					
Low Risk P4 – Avoid physical and mechanical damage. When maintenance/upgrade is required, recommend removal and reinstate with non-asbestos product. Recommend sample (x1) to qualify material content, otherwise treat item as asbestos containing. August 2010 Item made safe in accordance with "Approved code of practice".

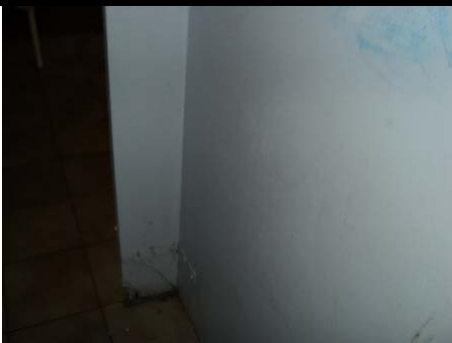
LOCATION – DESCRIPTION <u>AMENITIES BLOCK – INTERNAL</u>	EXTENT	ASBESTOS ASSESSMENT	CONDITION	SAMPLE NO VISUAL TEST	SIGNAGE STATUS
2. Male and female toilets, cubicle partitions, lining – fibre cement thick sheet.	Approx 10m ² (average per toilet) Accessible	No asbestos detected (Organic fibre)	-	04/LJ/270712	-
<i>SURVEY FINDINGS and HAZARD MANAGEMENT RECOMMENDATIONS</i>					
No asbestos detected upon laboratory analysis of sample.

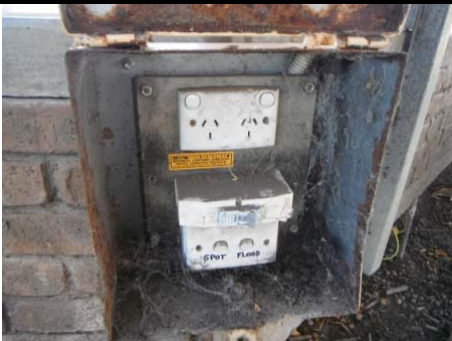
LOCATION – DESCRIPTION <u>ROTUNDA EXTERNAL</u>	EXTENT	ASBESTOS ASSESSMENT	CONDITION	SAMPLE NO VISUAL TEST	SIGNAGE STATUS
C. Western elevation, electrical cabinet, electrical board – black resin board.	Approx 150 x 150mm Limited access	Chrysotile asbestos (typical)	Good Unsealed Non friable	Visual	Visible
<i>SURVEY FINDINGS and HAZARD MANAGEMENT RECOMMENDATIONS</i>					
<p>Low Risk P4 – Avoid physical and mechanical damage. When maintenance/upgrade is required, recommend removal and reinstate with non-asbestos product.</p> <p>Larger electrical cabinet (B&R), no asbestos visible, small cabinet has resin back panel.</p> <p>October 2008 - Dust residue and debris in base of electrical cabinet cleaned up with approved asbestos vacuum system in accordance with "Approved Code of Practice".</p> <p>2011 no access as keys not available.</p>

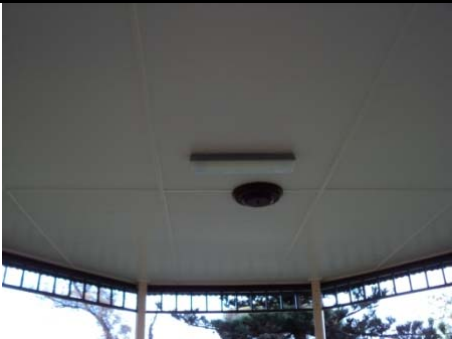
LOCATION – DESCRIPTION <u>ROTUNDA INTERNAL</u>	EXTENT	ASBESTOS ASSESSMENT	CONDITION	SAMPLE NO VISUAL TEST	SIGNAGE STATUS
3. Ceiling, lining – fibre cement sheet.	Approx 20m ² Limited access	Presume asbestos content	Good Sealed Non friable	Visual	Visible
<i>SURVEY FINDINGS and HAZARD MANAGEMENT RECOMMENDATIONS</i>					
<p>Low Risk P4 – Avoid physical and mechanical damage. When maintenance/upgrade is required, recommend removal and reinstate with non-asbestos product.</p> <p>The ceiling has had replacement panels installed due to vandalism, installation dates were not known. Treat item as asbestos containing unless qualified otherwise by specific sample analysis.</p> <p>Recommend sample (x2) to qualify material content, otherwise treat item as asbestos containing.</p>
