ASBESTOS REGISTER

REGISTER NO.: AS2250-9

FOR THE PROPERTY AT: Council Offices
Taylor Street,
Kadina SA

DATE INSPECTED: 10/05/2013

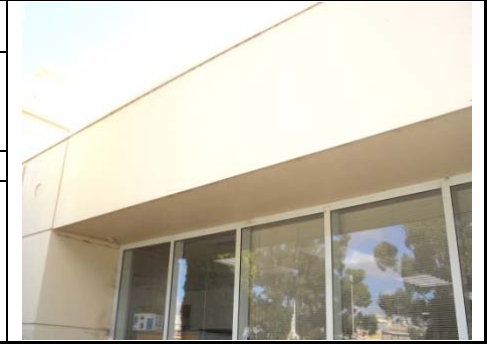
LOCATION - DESCRIPTION	EXTENT	ASBESTOS ASSESSMENT	CONDITION	SAMPLE NO VISUAL TEST	SIGNAGE STATUS
A. External, southern side of offices, fascia & eaves lining – fibre cement thick sheet.	Approx 45m ² Limited access	Presume asbestos content	Good Sealed Non friable	Visual	Not visible
SURVEY FINDINGS and HAZARD MANAGEMENT RECOMMENDATIONS					
<p>Low Risk P4 – Avoid physical and mechanical damage. When maintenance/upgrade is required, recommend removal and reinstate with non-asbestos product. Recommend sample (x1) to qualify material content, otherwise treat item as asbestos containing. Recommend install (x4) specific warning sign.</p>

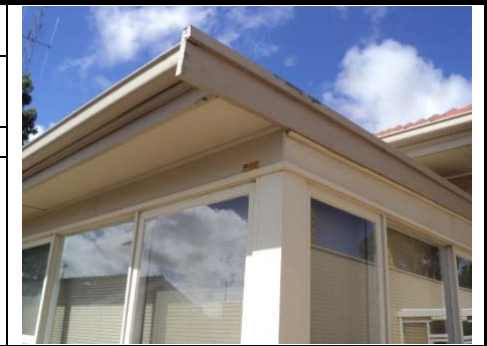
LOCATION - DESCRIPTION	EXTENT	ASBESTOS ASSESSMENT	CONDITION	SAMPLE NO VISUAL TEST	SIGNAGE STATUS
B. External, planning/ archive building, north side, store office, fascia infill lining – fibre cement sheet.	Approx 3m ²	Presume asbestos content	Not assessed	Visual	-
SURVEY FINDINGS and HAZARD MANAGEMENT RECOMMENDATIONS					
<p>No Inspection - Item has been removed prior to audit. No record of removal available. Recommend gather any asbestos removal or maintenance information and include/document this into the work/access section of the register to gain compliance. Information to include air monitoring results and where applicable statutory government approvals.</p>

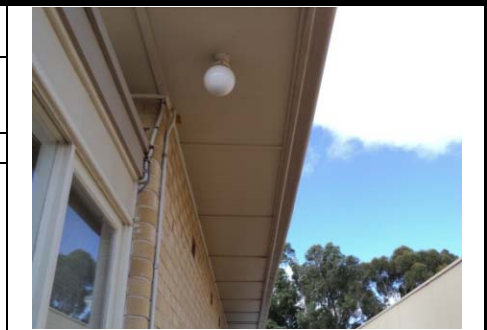
LOCATION - DESCRIPTION	EXTENT	ASBESTOS ASSESSMENT	CONDITION	SAMPLE NO VISUAL TEST	SIGNAGE STATUS
C. External, planning/ archive building, perimeter of building, eaves lining – fibre cement sheet.	Approx 60m ²	Presume asbestos cement	Not assessed	Visual	-
SURVEY FINDINGS and HAZARD MANAGEMENT RECOMMENDATIONS					
<p>No Inspection - Item has been removed prior to audit. No record of removal available. Recommend gather any asbestos removal or maintenance information and include/document this into the work/access section of the register to gain compliance. Information to include air monitoring results and where applicable statutory government approvals.</p>

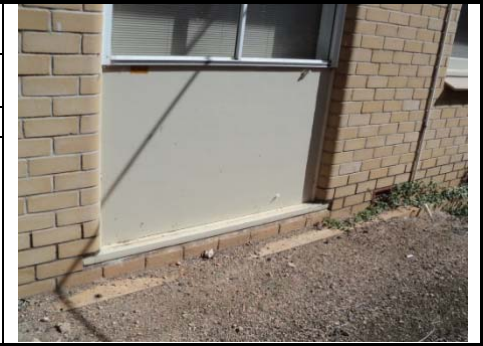
LOCATION - DESCRIPTION	EXTENT	ASBESTOS ASSESSMENT	CONDITION	SAMPLE NO VISUAL TEST	SIGNAGE STATUS
D. External, planning/ archive building, east wall, window infill – fibre cement sheet	Approx 2m ²	Presume asbestos content	Not assessed	Visual	-
SURVEY FINDINGS and HAZARD MANAGEMENT RECOMMENDATIONS					
No Inspection - Item has been removed prior to audit. No record of removal available. Recommend gather any asbestos removal or maintenance information and include/document this into the work/access section of the register to gain compliance. Information to include air monitoring results and where applicable statutory government approvals.

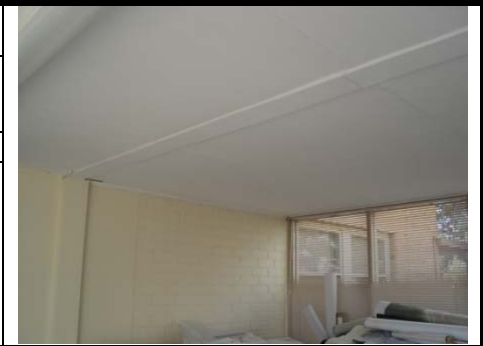
LOCATION - DESCRIPTION	EXTENT	ASBESTOS ASSESSMENT	CONDITION	SAMPLE NO VISUAL TEST	SIGNAGE STATUS
1. Internal, planning/ store building, link way, ceiling lining – fibre cement sheet	Approx 12m ²	Presume asbestos content	Not assessed	Visual	-
SURVEY FINDINGS and HAZARD MANAGEMENT RECOMMENDATIONS					
No Inspection - Item has been removed prior to audit. No record of removal available. Recommend gather any asbestos removal or maintenance information and include/document this into the work/access section of the register to gain compliance. Information to include air monitoring results and where applicable statutory government approvals.

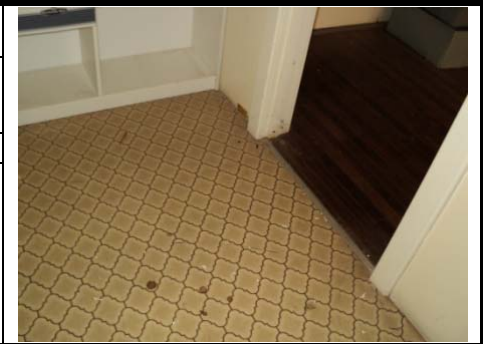
LOCATION - DESCRIPTION	EXTENT	ASBESTOS ASSESSMENT	CONDITION	SAMPLE NO VISUAL TEST	SIGNAGE STATUS
2. Internal, planning/ store building, store room/ toilet, beige patterned floor covering – sheet vinyl (lino) backing.	Approx 10m ²	Presume asbestos content	Not assessed	Visual	-
SURVEY FINDINGS and HAZARD MANAGEMENT RECOMMENDATIONS					
No Inspection - Item has been removed prior to audit. No record of removal available. Recommend gather any asbestos removal or maintenance information and include/document this into the work/access section of the register to gain compliance. Information to include air monitoring results and where applicable statutory government approvals.

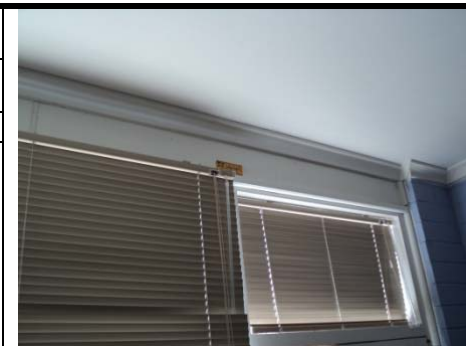
LOCATION - DESCRIPTION	EXTENT	ASBESTOS ASSESSMENT	CONDITION	SAMPLE NO VISUAL TEST	SIGNAGE STATUS
3. Internal, planning/ store building, store office, fascia infill lining – fibre cement sheet.	Approx 1m ²	Presume asbestos content	Not assessed	Visual	-
SURVEY FINDINGS and HAZARD MANAGEMENT RECOMMENDATIONS					
No Inspection - Item has been removed prior to audit. No record of removal available. Recommend gather any asbestos removal or maintenance information and include/document this into the work/access section of the register to gain compliance. Information to include air monitoring results and where applicable statutory government approvals.

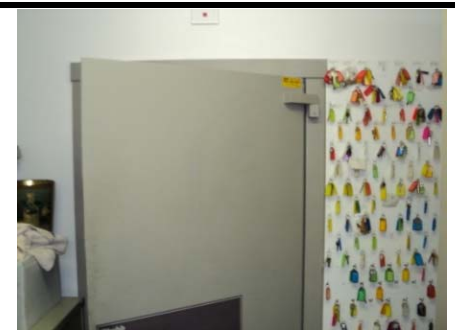
LOCATION - DESCRIPTION	EXTENT	ASBESTOS ASSESSMENT	CONDITION	SAMPLE NO VISUAL TEST	SIGNAGE STATUS
5. Internal, storage/ safe room, fire door, internal core – compressed fibre insulation.	Not quantified Inaccessible	Presume asbestos content	Not assessed Unsealed Friable	Not accessed	Visible
SURVEY FINDINGS and HAZARD MANAGEMENT RECOMMENDATIONS					
Low Risk P4 – Treat all fire doors as having an asbestos internal core unless confirmed otherwise by sample analysis. Avoid physical and mechanical damage. When maintenance/upgrade is required, recommend removal and reinstate with non-asbestos product.

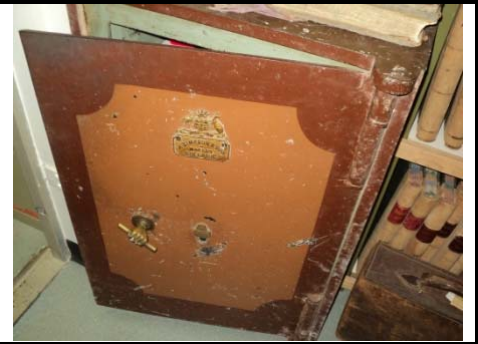
LOCATION - DESCRIPTION	EXTENT	ASBESTOS ASSESSMENT	CONDITION	SAMPLE NO VISUAL TEST	SIGNAGE STATUS
5a. Internal, storage/ safe room, safe (A Simpson and Son), internal core – possible compressed fibre insulation.	Not quantified Inaccessible	Presume asbestos content	Not assessed Unsealed Friable	Not accessed	Visible
SURVEY FINDINGS and HAZARD MANAGEMENT RECOMMENDATIONS					
<p>Low Risk P4 – Treat all fire doors as having an asbestos internal core unless confirmed otherwise by sample analysis. Avoid physical and mechanical damage. When maintenance/upgrade is required, recommend removal and reinstate with non-asbestos product.</p>

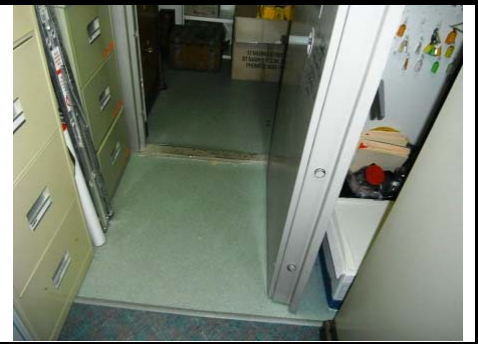
LOCATION - DESCRIPTION	EXTENT	ASBESTOS ASSESSMENT	CONDITION	SAMPLE NO VISUAL TEST	SIGNAGE STATUS
6. Internal, cleaners room/ hallway/ storage/ safe room, blue floor covering – sheet vinyl (lino) backing.	Approx 16m ² visible total	No asbestos detected	-	Sample no. 2 (March/ 2007) 03/LJ/260412	-
SURVEY FINDINGS and HAZARD MANAGEMENT RECOMMENDATIONS					
<p>No asbestos detected upon laboratory analysis of sample. Refer also notes below.</p>

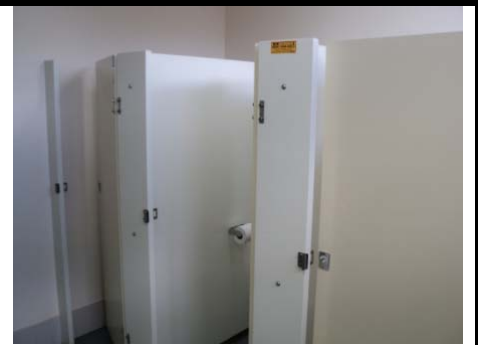
LOCATION - DESCRIPTION	EXTENT	ASBESTOS ASSESSMENT	CONDITION	SAMPLE NO VISUAL TEST	SIGNAGE STATUS
7. Internal, female toilets, toilet partitions lining – fibre cement thick sheet.	Approx 12m ² Accessible	Presume asbestos content	Good Sealed Non friable	Visual	Visible
SURVEY FINDINGS and HAZARD MANAGEMENT RECOMMENDATIONS					
<p>Low Risk P4 – Avoid physical and mechanical damage. When maintenance/upgrade is required, recommend removal and reinstate with non-asbestos product. Recommend sample (x1) to qualify material content, otherwise treat item as asbestos containing.</p>

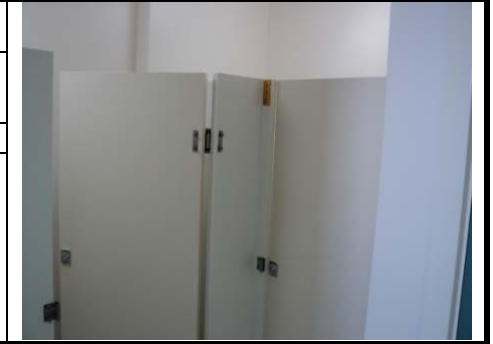
LOCATION - DESCRIPTION	EXTENT	ASBESTOS ASSESSMENT	CONDITION	SAMPLE NO VISUAL TEST	SIGNAGE STATUS
8. Internal, male toilets, toilet partitions lining – fibre cement thick sheet.	Approx 4m ² Accessible	Presume asbestos content	Good Sealed Non friable	Visual	Visible
<i>SURVEY FINDINGS and HAZARD MANAGEMENT RECOMMENDATIONS</i>					
<p>Low Risk P4 – Avoid physical and mechanical damage. When maintenance/upgrade is required, recommend removal and reinstate with non-asbestos product. Recommend sample (x1) to qualify material content, otherwise treat item as asbestos containing.</p>
