## ASBESTOS REGISTER

**REGISTER NO.:** AS2250-50

**FOR THE PROPERTY AT:** Town Hall  
Owen Street,  
Wallaroo, SA

**DATE INSPECTED:** 09/05/2013

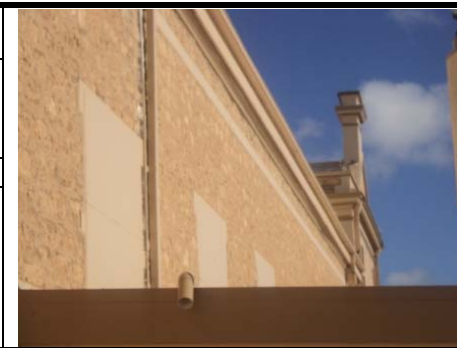
LOCATION - DESCRIPTION	EXTENT	ASBESTOS ASSESSMENT	CONDITION	SAMPLE NO VISUAL TEST	SIGNAGE STATUS
B. External, above annexe building, east wall, infill panels (3 of) – fibre cement sheet.	Approx 6m <sup>2</sup> x3 Limited access	Presume asbestos content	Good Sealed Non friable	Visual access only	Not visible
<b>SURVEY FINDINGS and HAZARD MANAGEMENT RECOMMENDATIONS</b>					
<b>Low Risk P4</b> – Avoid physical and mechanical damage. When maintenance/upgrade is required, recommend removal and reinstate with non-asbestos product. Unable to affix specific warning sign to item, covered by General sign.

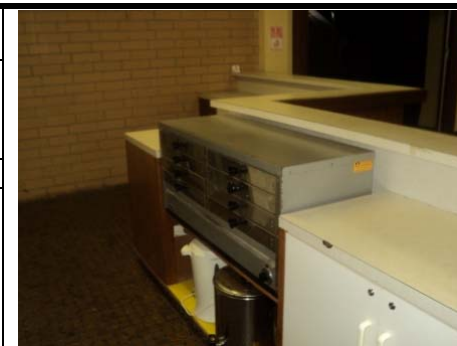
LOCATION - DESCRIPTION	EXTENT	ASBESTOS ASSESSMENT	CONDITION	SAMPLE NO VISUAL TEST	SIGNAGE STATUS
1. Internal, annexe building, ground floor, kitchen, 'Hecla' pie warmer, electrical component box – possible insulating heat shield and wire sheathing.	Not quantified Limited access	Presume asbestos content	Not assessed Unsealed Friable	Not accessed	Visible
<b>SURVEY FINDINGS and HAZARD MANAGEMENT RECOMMENDATIONS</b>					
<b>Low Risk P4</b> – Avoid physical and mechanical damage. When maintenance/upgrade is required, recommend removal and reinstate with non-asbestos product. Pie warmer not dismantled for inspection. Assume asbestos within the unit unless confirmed otherwise. Access with caution.

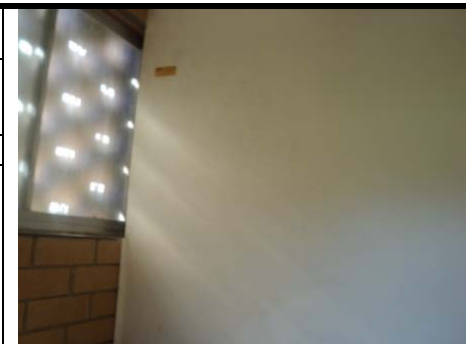
LOCATION - DESCRIPTION	EXTENT	ASBESTOS ASSESSMENT	CONDITION	SAMPLE NO VISUAL TEST	SIGNAGE STATUS
2. Internal, annexe building, ground floor, disabled toilet, wall linings – fibre cement sheet	Approx 30m <sup>2</sup> Accessible	Presume asbestos content	Good Sealed Non friable	Visual	Visible
<b>SURVEY FINDINGS and HAZARD MANAGEMENT RECOMMENDATIONS</b>					
<p><b>Low Risk P4</b> – Avoid physical and mechanical damage. When maintenance/upgrade is required, recommend removal and reinstate with non-asbestos product. Recommend sample (x1) to qualify material content, otherwise treat item as asbestos containing.</p> <p><b>August 2010</b> Item made safe in accordance with "Approved Code of Practice".</p>

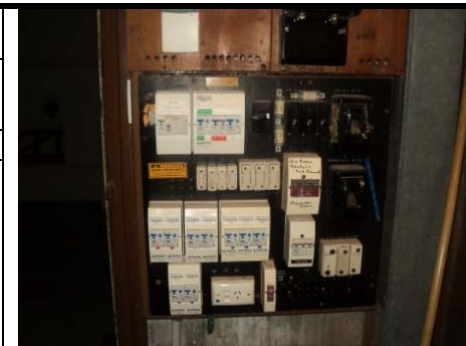
LOCATION - DESCRIPTION	EXTENT	ASBESTOS ASSESSMENT	CONDITION	SAMPLE NO VISUAL TEST	SIGNAGE STATUS
3. Internal, main building, ground floor, under stair store west of foyer, wall mounted electrical board – black resin board.	Approx 1m <sup>2</sup> Accessible	Chrysotile asbestos (typical)	Good Unsealed Non friable	Visual	Visible
<b>SURVEY FINDINGS and HAZARD MANAGEMENT RECOMMENDATIONS</b>					
<p><b>Low Risk P4</b> – Avoid physical and mechanical damage. When maintenance/upgrade is required, recommend removal and reinstate with non-asbestos product.</p>

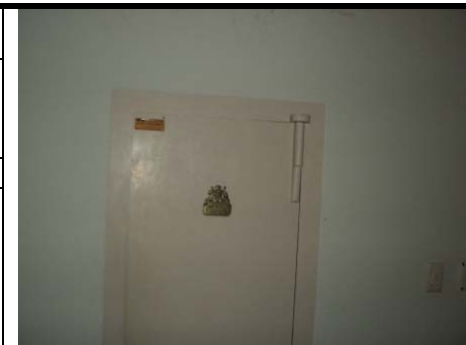
LOCATION - DESCRIPTION	EXTENT	ASBESTOS ASSESSMENT	CONDITION	SAMPLE NO VISUAL TEST	SIGNAGE STATUS
4. Internal, main building, ground floor, strong room/ safe store to the west of foyer, metal fire door, internal core – compressed fibre insulation.	Not quantified Limited access	Presume asbestos content	Not assessed Sealed Friable	Not accessed	Visible
<b>SURVEY FINDINGS and HAZARD MANAGEMENT RECOMMENDATIONS</b>					
<p><b>Low Risk P4</b> – Avoid physical and mechanical damage. When maintenance/upgrade is required, recommend removal and reinstate with non-asbestos product. Treat all fire doors as having an asbestos internal core unless confirmed otherwise by sample analysis.</p>

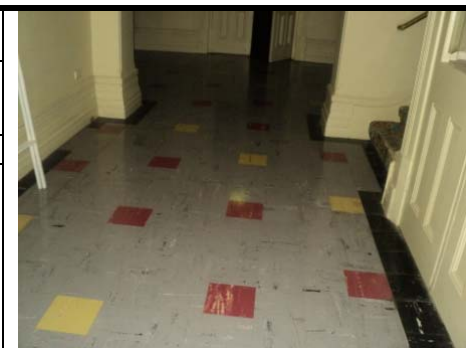
LOCATION - DESCRIPTION	EXTENT	ASBESTOS ASSESSMENT	CONDITION	SAMPLE NO VISUAL TEST	SIGNAGE STATUS
5. Internal, main building, ground floor, foyer, floor covering – vinyl tiles, colour grey, yellow, red and black mixed.	Approx 65m <sup>2</sup> Accessible	Presume asbestos content	Good Unsealed Non friable	Visual	Visible
<b>SURVEY FINDINGS and HAZARD MANAGEMENT RECOMMENDATIONS</b>					
<p><b>Low Risk P4</b> – Avoid physical and mechanical damage. When maintenance/upgrade is required, recommend removal and reinstate with non-asbestos product.</p> <p>Recommend sample (x4) to qualify material content, otherwise treat item as asbestos containing.</p>

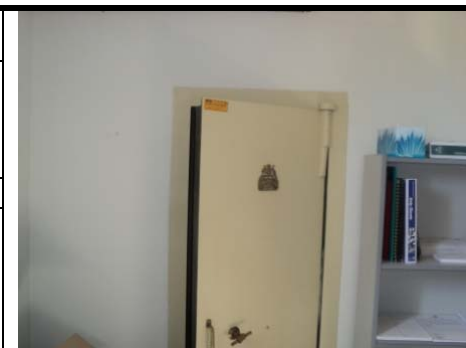
LOCATION - DESCRIPTION	EXTENT	ASBESTOS ASSESSMENT	CONDITION	SAMPLE NO VISUAL TEST	SIGNAGE STATUS
6. Internal, main building, ground floor, strong room/ safe store to the east of foyer, metal fire door, internal core – compressed fibre insulation.	Not quantified Limited access	Presume asbestos content	Not assessed Sealed Friable	Not accessed	Visible
<b>SURVEY FINDINGS and HAZARD MANAGEMENT RECOMMENDATIONS</b>					
<p><b>Low Risk P4</b> – Avoid physical and mechanical damage. When maintenance/upgrade is required, recommend removal and reinstate with non-asbestos product. Treat all fire doors as having an asbestos internal core unless confirmed otherwise by sample analysis.</p>

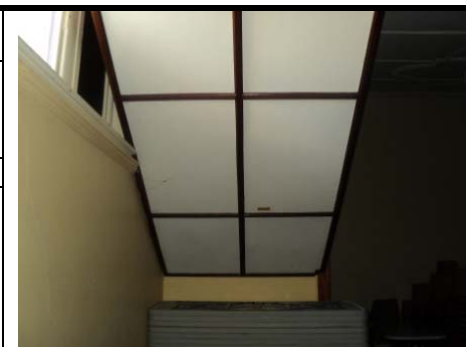
LOCATION - DESCRIPTION	EXTENT	ASBESTOS ASSESSMENT	CONDITION	SAMPLE NO VISUAL TEST	SIGNAGE STATUS
7. Internal, main building, ground floor, panels beneath stairs – fibre cement sheet.	Approx 25m <sup>2</sup> Limited access	Presume asbestos content	Good Sealed Non friable	Visual	Visible
<b>SURVEY FINDINGS and HAZARD MANAGEMENT RECOMMENDATIONS</b>					
<p><b>Low Risk P4</b> – Avoid physical and mechanical damage. When maintenance/upgrade is required, recommend removal and reinstate with non-asbestos product.</p> <p>Recommend sample (x1) to qualify material content, otherwise treat item as asbestos containing.</p>

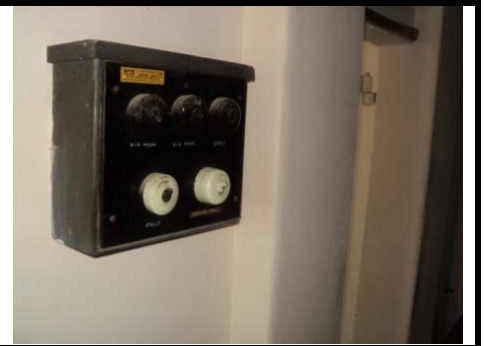
LOCATION - DESCRIPTION	EXTENT	ASBESTOS ASSESSMENT	CONDITION	SAMPLE NO VISUAL TEST	SIGNAGE STATUS
8. Internal, main building, first floor, projector room, wall mounted electrical board – black resin board.	Approx 300x300mm Accessible	Chrysotile asbestos (typical)	Good Unsealed Non friable	Visual	Visible
<b>SURVEY FINDINGS and HAZARD MANAGEMENT RECOMMENDATIONS</b>					
<b>Low Risk P4</b> – Avoid physical and mechanical damage. When maintenance/upgrade is required, recommend removal and reinstate with non-asbestos product.

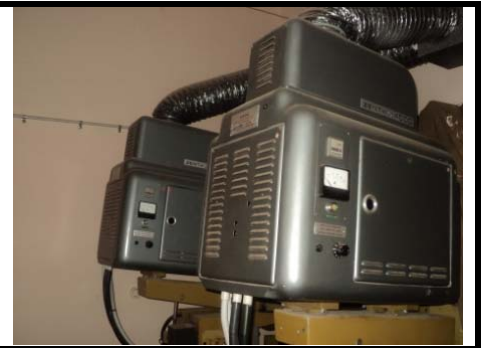
LOCATION - DESCRIPTION	EXTENT	ASBESTOS ASSESSMENT	CONDITION	SAMPLE NO VISUAL TEST	SIGNAGE STATUS
9. Internal, main building, first floor, projector room, (2 of) 'Zenith 4000' projector units, possible electrical component box – possible insulating heat shield and wire sheathing.	Not quantified Limited access	Presume asbestos content	Not assessed Unsealed Friable	Not accessed	Visible
<b>SURVEY FINDINGS and HAZARD MANAGEMENT RECOMMENDATIONS</b>					
<b>Low Risk P4</b> – Avoid physical and mechanical damage. When maintenance/upgrade is required, recommend removal and reinstate with non-asbestos product. Projector units not dismantled for inspection. Assume asbestos within the unit unless confirmed otherwise. Access with caution. Recommend install (x2) specific warning sign.

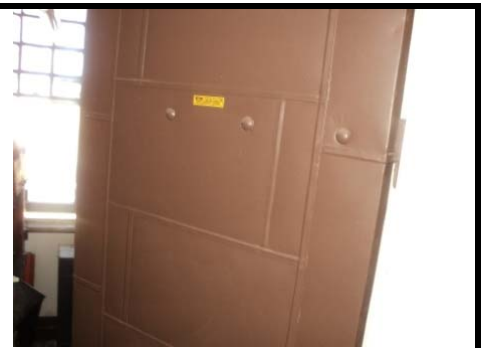
LOCATION - DESCRIPTION	EXTENT	ASBESTOS ASSESSMENT	CONDITION	SAMPLE NO VISUAL TEST	SIGNAGE STATUS
10. Internal, main building, first floor, projector room, north side metal fire door, internal core – compressed fibre insulation.	Not quantified Limited access	Presume asbestos content	Not assessed Sealed Friable	Not accessed	Visible
<b>SURVEY FINDINGS and HAZARD MANAGEMENT RECOMMENDATIONS</b>					
<b>Low Risk P4</b> – Treat all fire doors as having an asbestos internal core unless confirmed otherwise by sample analysis. Avoid physical and mechanical damage. When maintenance/upgrade is required, recommend removal and reinstate with non-asbestos product.

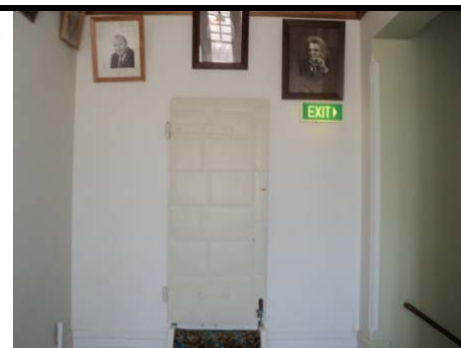
LOCATION - DESCRIPTION	EXTENT	ASBESTOS ASSESSMENT	CONDITION	SAMPLE NO VISUAL TEST	SIGNAGE STATUS
11. Internal, main building, first floor, projector room, west side metal fire door, internal core – compressed fibre insulation.	Not quantified Limited access	Presume asbestos content	Not assessed Sealed Friable	Not accessed	Visible
<b>SURVEY FINDINGS and HAZARD MANAGEMENT RECOMMENDATIONS</b>					
<p><b>Low Risk P4</b> – Treat all fire doors as having an asbestos internal core unless confirmed otherwise by sample analysis. Avoid physical and mechanical damage. When maintenance/upgrade is required, recommend removal and reinstate with non-asbestos product.</p>

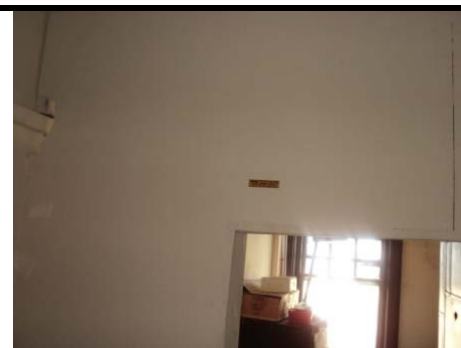
LOCATION - DESCRIPTION	EXTENT	ASBESTOS ASSESSMENT	CONDITION	SAMPLE NO VISUAL TEST	SIGNAGE STATUS
12. Internal, main building, first floor, room adjacent to projector room, wall linings – fibre cement sheet	Approx 8m <sup>2</sup> Accessible	Presume asbestos content	Good Sealed Non friable	Visual	Visible
<b>SURVEY FINDINGS and HAZARD MANAGEMENT RECOMMENDATIONS</b>					
<p><b>Low Risk P4</b> – Avoid physical and mechanical damage. When maintenance/upgrade is required, recommend removal and reinstate with non-asbestos product. Recommend sample (x1) to qualify material content, otherwise treat item as asbestos containing.</p>

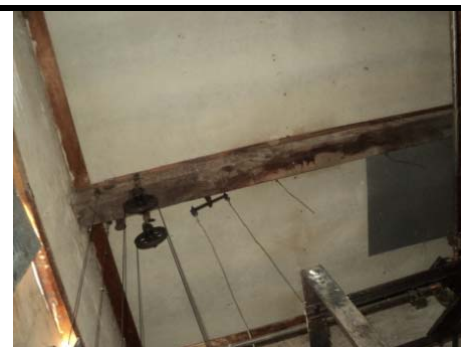
LOCATION - DESCRIPTION	EXTENT	ASBESTOS ASSESSMENT	CONDITION	SAMPLE NO VISUAL TEST	SIGNAGE STATUS
13. Internal, main building, clock tower, upper floor of tower, ceiling lining – fibre cement sheet.	Approx 16m <sup>2</sup> Limited access	Presume asbestos content	Good Unsealed Non friable	Visual	Not visible
<b>SURVEY FINDINGS and HAZARD MANAGEMENT RECOMMENDATIONS</b>					
<p><b>Low Risk P4</b> – Avoid physical and mechanical damage. When maintenance/upgrade is required, recommend removal and reinstate with non-asbestos product. Unable to fix signs due to height. Covered by general awareness signs Recommend sample (x1) to qualify material content, otherwise treat item as asbestos containing. It was noted that previous damage had been repaired with a sheet metal patch.</p>
