ASBESTOS REGISTER

REGISTER NO.: AS2250-18

FOR THE PROPERTY AT: Works Depot
Blanche Terrace and Pryors Lane,
Moonta SA

DATE INSPECTED: 09/05/2013

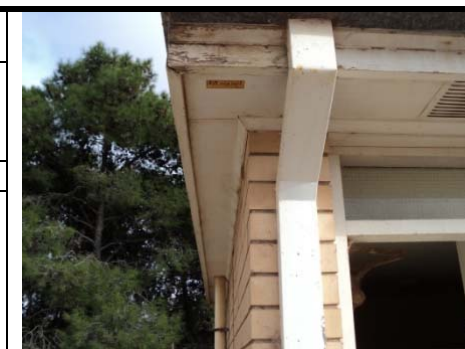
LOCATION - DESCRIPTION	EXTENT	ASBESTOS ASSESSMENT	CONDITION	SAMPLE NO VISUAL TEST	SIGNAGE STATUS
A. External, toilet block, perimeter of block, eaves lining – fibre cement sheet.	Approx 12m ² visible Limited access	Presume asbestos content	Good Sealed Non friable	Visual	Visible
SURVEY FINDINGS and HAZARD MANAGEMENT RECOMMENDATIONS					
<p>Low Risk P4 – Avoid physical and mechanical damage. When maintenance/upgrade is required, recommend removal and reinstate with non-asbestos product.</p> <p>Recommend sample (x1) to qualify material content, otherwise treat item as asbestos containing.</p>

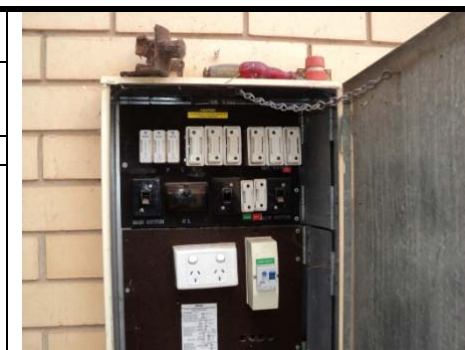
LOCATION - DESCRIPTION	EXTENT	ASBESTOS ASSESSMENT	CONDITION	SAMPLE NO VISUAL TEST	SIGNAGE STATUS
B. External, toilet block, south elevation, within wall mounted metal cabinet electrical board – black resin board.	Approx 0.4m ² Accessible	Chrysotile asbestos (typical)	Good Unsealed Non friable	Visual	Visible
SURVEY FINDINGS and HAZARD MANAGEMENT RECOMMENDATIONS					
<p>Low Risk P4 – Avoid physical and mechanical damage. When maintenance/upgrade is required, recommend removal and reinstate with non-asbestos product.</p> <p>August 2010 Dust residue and debris visible in base of electrical cabinet cleaned up with approved asbestos vacuum system in accordance with "Approved Code of Practice".</p>

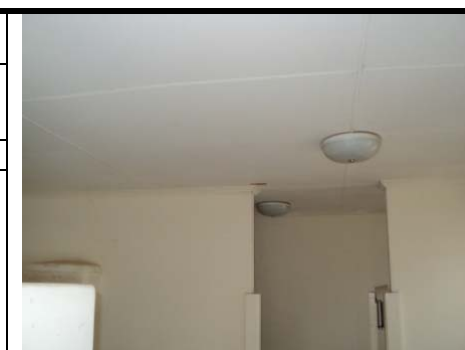
LOCATION - DESCRIPTION	EXTENT	ASBESTOS ASSESSMENT	CONDITION	SAMPLE NO VISUAL TEST	SIGNAGE STATUS
1. Internal, toilet block, ceiling lining throughout – fibre cement sheet	Approx 25m ² Accessible	Presume asbestos content	Good Sealed Non friable	Visual	Visible
SURVEY FINDINGS and HAZARD MANAGEMENT RECOMMENDATIONS					
<p>Low Risk P4 – Avoid physical and mechanical damage. When maintenance/upgrade is required, recommend removal and reinstate with non-asbestos product.</p> <p>Recommend sample (x1) to qualify material content, otherwise treat item as asbestos containing.</p>

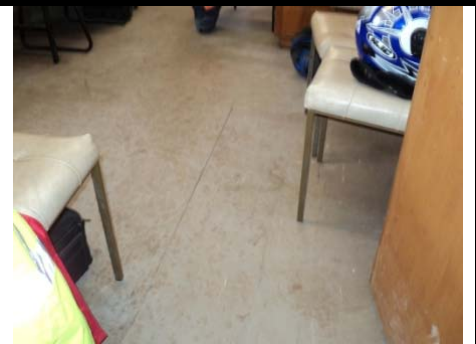
LOCATION - DESCRIPTION	EXTENT	ASBESTOS ASSESSMENT	CONDITION	SAMPLE NO VISUAL TEST	SIGNAGE STATUS
2. Internal, main building, lunch room, floor covering – brown sheet vinyl (lino).	-	No asbestos detected	-	03/LJ/270712	-
SURVEY FINDINGS and HAZARD MANAGEMENT RECOMMENDATIONS					
No asbestos detected upon laboratory analysis of sample.

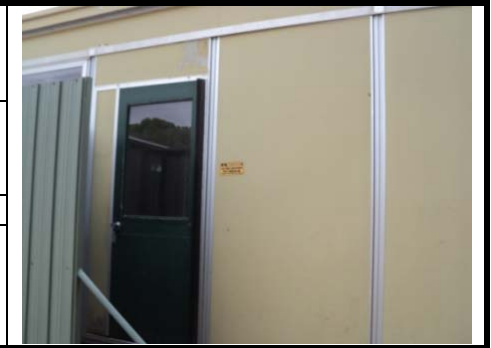
LOCATION - DESCRIPTION	EXTENT	ASBESTOS ASSESSMENT	CONDITION	SAMPLE NO VISUAL TEST	SIGNAGE STATUS
TRANSPORTABLE (RELOCATED OCTOBER 2007) BUILDING - EXTERNAL					
A. External elevations, façade comprising of solid fibre cement sheets, windows and timber doors – cladding - fibre cement sheet (top fascia approx 400mm deep is metal).	Approx 100m ² Accessible	Chrysotile asbestos detected.	Good Sealed Non friable	Sample no. 3 (Mar / 1995)	Visible
SURVEY FINDINGS and HAZARD MANAGEMENT RECOMMENDATIONS					
<p>Low Risk P4 – Avoid physical and mechanical damage. When maintenance/upgrade is planned, recommend removal and reinstate with non-asbestos product.</p> <p>October 2008 - Made safe / sealed damaged & holed areas, in accordance with “Approved Code of Practice”.</p>

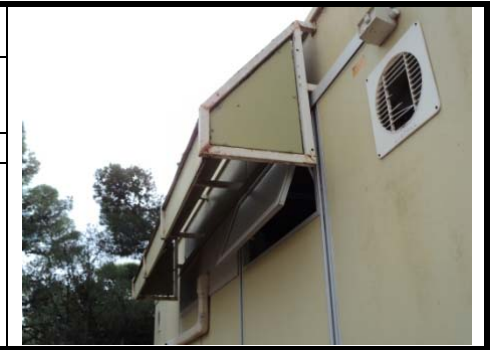
LOCATION - DESCRIPTION	EXTENT	ASBESTOS ASSESSMENT	CONDITION	SAMPLE NO VISUAL TEST	SIGNAGE STATUS
B. Windows, left and right elevations, sunhoods, lining – fibre cement sheet.	Approx 11m ² Accessible	Chrysotile asbestos detected.	Good Sealed Non friable	Sample no. 2 (Mar / 1995)	Visible
SURVEY FINDINGS and HAZARD MANAGEMENT RECOMMENDATIONS					
<p>Low Risk P4 – Avoid physical and mechanical damage. When maintenance/upgrade is planned, recommend removal and reinstate with non-asbestos product.</p>

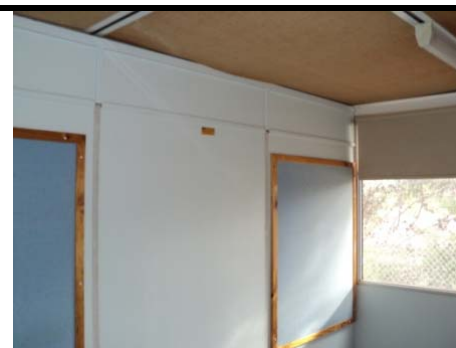
LOCATION - DESCRIPTION	EXTENT	ASBESTOS ASSESSMENT	CONDITION	SAMPLE NO VISUAL TEST	SIGNAGE STATUS
TRANSPORTABLE (RELOCATED OCTOBER 2007) BUILDING - INTERNAL					
1, Reception, 3 no office / room areas, all internal partitions and linings to external walls lining – fibre cement sheet.	Approx 180m ² Accessible	Chrysotile asbestos detected	Good Sealed Non friable	Sample no. 4 (Mar / 1995)	Visible
SURVEY FINDINGS and HAZARD MANAGEMENT RECOMMENDATIONS					
<p>Low Risk P4 – Avoid physical and mechanical damage. When maintenance/upgrade is planned, recommend removal and reinstate with non-asbestos product.</p> <p>October 2008 - Made safe / sealed damaged & holed areas, in accordance with “Approved Code of Practice”.</p>

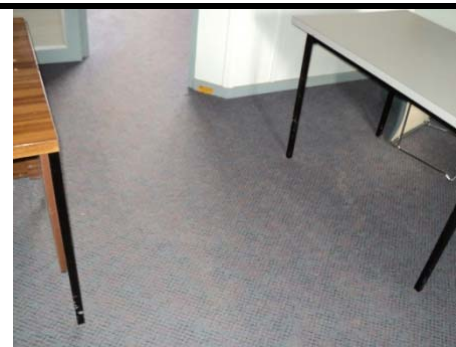
LOCATION - DESCRIPTION	EXTENT	ASBESTOS ASSESSMENT	CONDITION	SAMPLE NO VISUAL TEST	SIGNAGE STATUS
2, Flooring, Flooring comprises of carpet throughout with asbestos cement sheet bonded onto timber boarding core with hardboard sheet bonded to underside forming a veneer type construction lining – fibre cement sheet.	Approx 100m ² Inaccessible	Chrysotile asbestos detected	Not assessed Unsealed Non friable	Sample no. 2 (Oct / 07) Sample no. 3 (Oct / 07)	Visible
SURVEY FINDINGS and HAZARD MANAGEMENT RECOMMENDATIONS					
<p>Low Risk P4 – Avoid physical and mechanical damage. When maintenance/upgrade is planned, recommend removal and reinstate with non-asbestos product.</p>

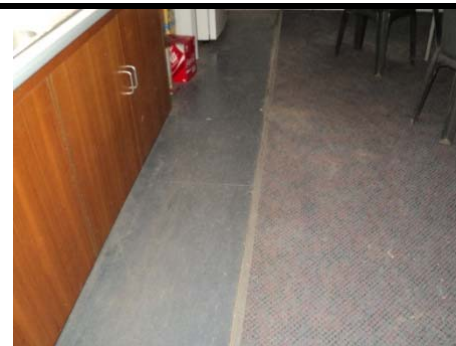
LOCATION - DESCRIPTION	EXTENT	ASBESTOS ASSESSMENT	CONDITION	SAMPLE NO VISUAL TEST	SIGNAGE STATUS
3, Flooring, Flooring comprises of sheet vinyl in the vicinity of the sink area with asbestos cement sheet bonded onto timber boarding core with hardboard sheet bonded to underside forming a veneer type construction lining – fibre cement sheet.	Approx 6m ² Inaccessible	Chrysotile asbestos detected	Not assessed Unsealed Non friable	Sample no. 1 (Oct / 07)	Visible
SURVEY FINDINGS and HAZARD MANAGEMENT RECOMMENDATIONS					
<p>Low Risk P4 – Avoid physical and mechanical damage. When maintenance/upgrade is planned, recommend removal and reinstate with non-asbestos product.</p>
