ASBESTOS REGISTER

REGISTER NO.: AS2250-28

FOR THE PROPERTY AT: Vietnam Veterans Building
(Montera Reserve)
Military Road,
Moonta SA

DATE INSPECTED: 10/05/2013

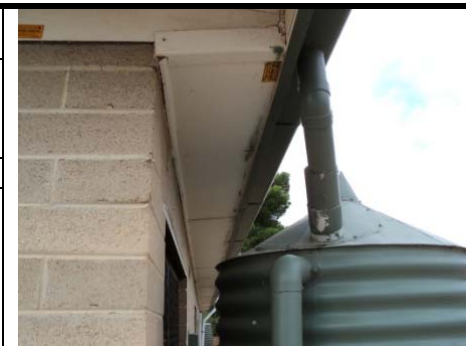
LOCATION - DESCRIPTION	EXTENT	ASBESTOS ASSESSMENT	CONDITION	SAMPLE NO VISUAL TEST	SIGNAGE STATUS
A. External, perimeter of building, eaves lining – fibre cement sheet.	Approx 20m x 0.4m Limited access	Presume asbestos content	Good Sealed Non friable	Visual	Visible
SURVEY FINDINGS and HAZARD MANAGEMENT RECOMMENDATIONS					
<p>Low Risk P4 – Avoid physical and mechanical damage. When maintenance/upgrade is required, recommend removal and reinstate with non-asbestos product.</p> <p>Recommend sample (x1) to qualify material content, otherwise treat item as asbestos containing.</p>

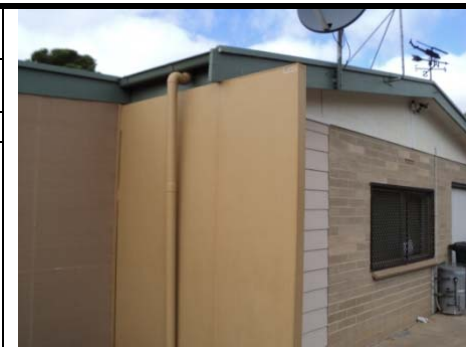
LOCATION - DESCRIPTION	EXTENT	ASBESTOS ASSESSMENT	CONDITION	SAMPLE NO VISUAL TEST	SIGNAGE STATUS
B. External, north west corner of building, wind break wall – fibre cement planks.	Approx 5m ² Accessible	-	-	Visual	-
SURVEY FINDINGS and HAZARD MANAGEMENT RECOMMENDATIONS					
<p>No asbestos visible upon inspection.</p> <p>April 2012 note: Informed by Keith Wilkinson that the wind break was installed in 2006 with non asbestos materials.</p>

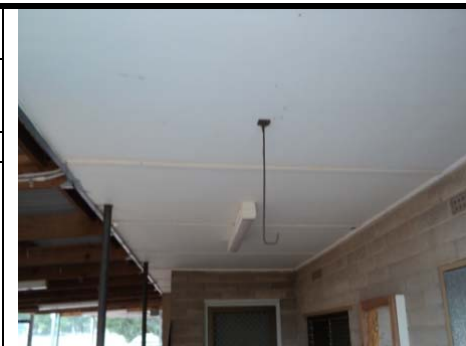
LOCATION - DESCRIPTION	EXTENT	ASBESTOS ASSESSMENT	CONDITION	SAMPLE NO VISUAL TEST	SIGNAGE STATUS
C. External, north west corner of building, verandah ceiling lining - fibre cement sheet	Approx 6m ² Limited access	Presume asbestos content	Good Sealed Non friable	Visual	Visible
SURVEY FINDINGS and HAZARD MANAGEMENT RECOMMENDATIONS					
<p>Low Risk P4 – Avoid physical and mechanical damage. When maintenance/upgrade is required, recommend removal and reinstate with non-asbestos product.</p> <p>Recommend sample (x1) to qualify material content, otherwise treat item as asbestos containing.</p>

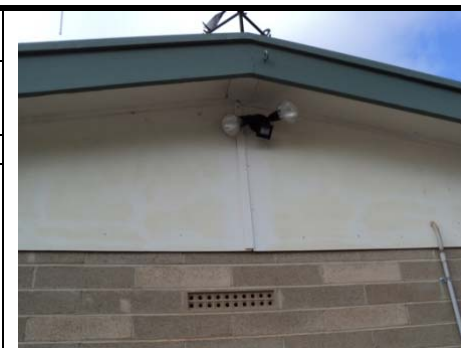
LOCATION - DESCRIPTION	EXTENT	ASBESTOS ASSESSMENT	CONDITION	SAMPLE NO VISUAL TEST	SIGNAGE STATUS
D. External, west end of building at high level, gable lining – fibre cement sheet	Approx 6m ² Limited access	Presume asbestos content	Good Sealed Non friable	Visual	Visible
SURVEY FINDINGS and HAZARD MANAGEMENT RECOMMENDATIONS					
<p>Low Risk P4 – Avoid physical and mechanical damage. When maintenance/upgrade is required, recommend removal and reinstate with non-asbestos product. Recommend sample (x1) to qualify material content, otherwise treat item as asbestos containing.</p>

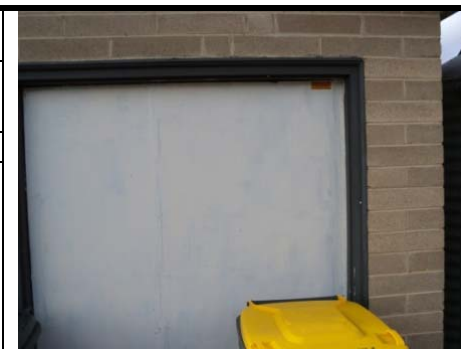
LOCATION - DESCRIPTION	EXTENT	ASBESTOS ASSESSMENT	CONDITION	SAMPLE NO VISUAL TEST	SIGNAGE STATUS
E. External, west end of building, door infill linings – fibre cement sheet	Approx 4m ² Accessible	Presume asbestos content	Good Sealed Non friable	Visual	Visible
SURVEY FINDINGS and HAZARD MANAGEMENT RECOMMENDATIONS					
<p>Low Risk P4 – Avoid physical and mechanical damage. When maintenance/upgrade is required, recommend removal and reinstate with non-asbestos product. Recommend sample (x1) to qualify material content, otherwise treat item as asbestos containing.</p>

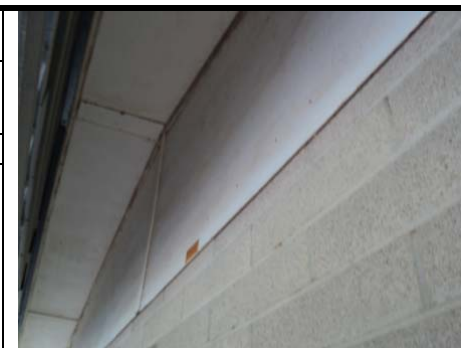
LOCATION - DESCRIPTION	EXTENT	ASBESTOS ASSESSMENT	CONDITION	SAMPLE NO VISUAL TEST	SIGNAGE STATUS
F. External, east end of building at high level, gable lining – fibre cement sheet	Approx 6m ² Limited access	Presume asbestos content	Good Sealed Non friable	Visual	Not visible
SURVEY FINDINGS and HAZARD MANAGEMENT RECOMMENDATIONS					
<p>Low Risk P4 – Avoid physical and mechanical damage. When maintenance/upgrade is required, recommend removal and reinstate with non-asbestos product. Recommend sample (x1) to qualify material content, otherwise treat item as asbestos containing.</p>

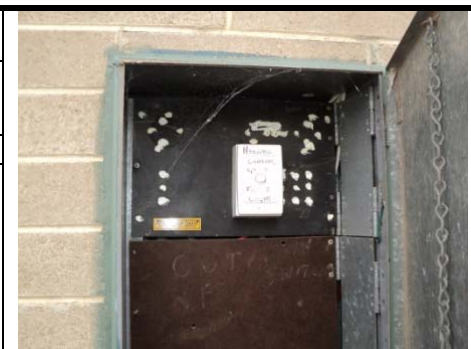
LOCATION - DESCRIPTION	EXTENT	ASBESTOS ASSESSMENT	CONDITION	SAMPLE NO VISUAL TEST	SIGNAGE STATUS
G. External, south wall of building within wall mounted metal cabinet, electrical board – black resin board	Approx 0.3m ² Accessible	Chrysotile asbestos (typical)	Good Sealed Non friable	Visual	Visible
SURVEY FINDINGS and HAZARD MANAGEMENT RECOMMENDATIONS					
<p>Low Risk P4 – Avoid physical and mechanical damage. When maintenance/upgrade is required, recommend removal and reinstate with non-asbestos product.</p> <p>October 2008 - Dust residue and debris in base of electrical cabinet cleaned up with approved asbestos vacuum system in accordance with "Approved Code of Practice".</p>

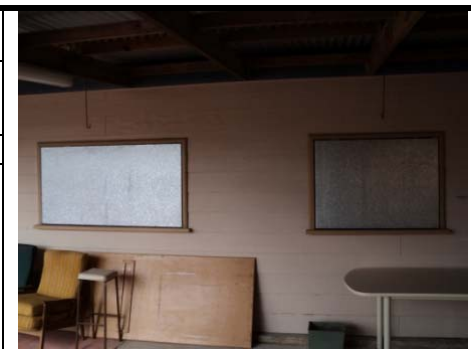
LOCATION - DESCRIPTION	EXTENT	ASBESTOS ASSESSMENT	CONDITION	SAMPLE NO VISUAL TEST	SIGNAGE STATUS
H. External, north wall of building, wall linings – fibre cement planks	Approx 16m ² Accessible	-	-	Visual	-
SURVEY FINDINGS and HAZARD MANAGEMENT RECOMMENDATIONS					
<p>No asbestos visible upon inspection.</p> <p>April 2012 note: Informed by Keith Wilkinson that this part of the building was installed in 2006 with non asbestos materials.</p>

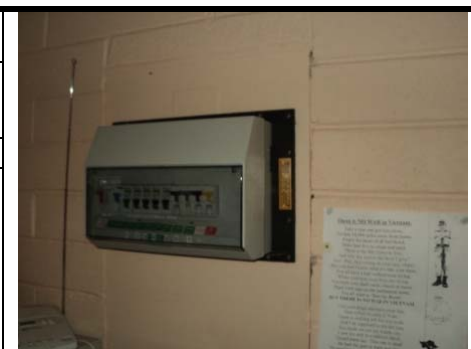
LOCATION - DESCRIPTION	EXTENT	ASBESTOS ASSESSMENT	CONDITION	SAMPLE NO VISUAL TEST	SIGNAGE STATUS
1. Internal, office, west wall, wall mounted electrical board – black resin board.	Approx 300x300mm Accessible	Chrysotile asbestos (typical)	Good Sealed Non friable	Visual	Visible
SURVEY FINDINGS and HAZARD MANAGEMENT RECOMMENDATIONS					
<p>Low Risk P4 – Avoid physical and mechanical damage. When maintenance/upgrade is required, recommend removal and reinstate with non-asbestos product.</p> <p>Recommend sample (x1) to qualify material content, otherwise treat item as asbestos containing.</p> <p>May 2013 note: no access to this item at time of inspection. Contact unavailable.</p>

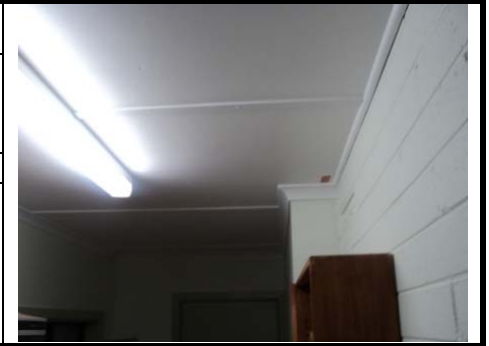
LOCATION - DESCRIPTION	EXTENT	ASBESTOS ASSESSMENT	CONDITION	SAMPLE NO VISUAL TEST	SIGNAGE STATUS
2. Internal, north east rear enclosed verandah ceiling lining - fibre cement sheet.	Approx 12m ² visible Limited access	Presume asbestos content	Good Sealed Non friable	Visual	Visible
<i>SURVEY FINDINGS and HAZARD MANAGEMENT RECOMMENDATIONS</i>					
<p>Low Risk P4 – Avoid physical and mechanical damage. When maintenance/upgrade is required, recommend removal and reinstate with non-asbestos product. Recommend sample (x1) to qualify material content, otherwise treat item as asbestos containing. May 2013 note: no access to this item at time of inspection. Contact unavailable.</p>
