ASBESTOS REGISTER

REGISTER NO.: AS2250-14

FOR THE PROPERTY AT: Council Works Depot
South Terrace,
Kadina SA

DATE INSPECTED: 10/05/2013

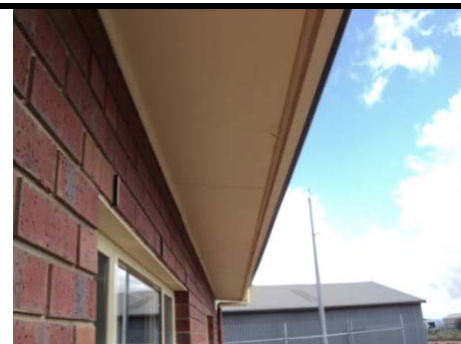
LOCATION - DESCRIPTION	EXTENT	ASBESTOS ASSESSMENT	CONDITION	SAMPLE NO VISUAL TEST	SIGNAGE STATUS
A. External, lunchroom building, perimeter of building, eave & porch lining – fibre cement sheet	Approx 60m ² Limited access	Chrysotile asbestos detected	Good Sealed Non friable	Visual - Similar to original sample no.1 (Feb / 07)	Visible
SURVEY FINDINGS and HAZARD MANAGEMENT RECOMMENDATIONS					
<p>Low Risk P4 – Avoid physical and mechanical damage. When maintenance/upgrade is required, recommend removal and reinstate with non-asbestos product.</p>

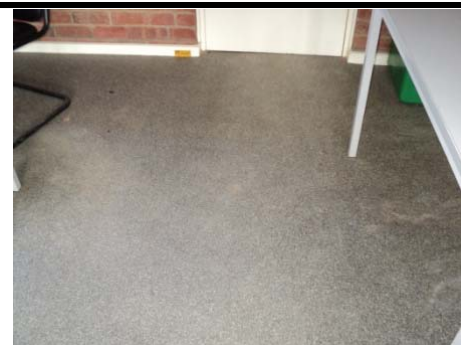
LOCATION - DESCRIPTION	EXTENT	ASBESTOS ASSESSMENT	CONDITION	SAMPLE NO VISUAL TEST	SIGNAGE STATUS
1. Internal, reception / lunchroom building, kitchen, floor covering – sheet vinyl (lino) backing.	Approx 100m ² Accessible	Presume asbestos content	Good Sealed Friable	Not accessed	Visible
SURVEY FINDINGS and HAZARD MANAGEMENT RECOMMENDATIONS					
<p>Low Risk P4 – Backing layer trapped under vinyl. Item regarded safe whilst vinyl remains in good condition to protect from and prevent disturbance of asbestos backing layer.</p> <p>Avoid physical and mechanical damage. When maintenance/upgrade is required, recommend removal and reinstate with non-asbestos product.</p> <p>Note - as required by the OHS&W regulations, removal of this type of material is required to be performed by a licensed removalist.</p>

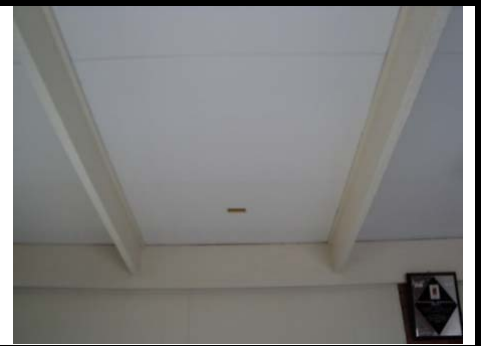
LOCATION - DESCRIPTION	EXTENT	ASBESTOS ASSESSMENT	CONDITION	SAMPLE NO VISUAL TEST	SIGNAGE STATUS
2. Internal, reception / lunchroom building, centre section of building, raked ceiling throughout – fibre cement sheet.	Approx 200m ² Limited access	Presume asbestos content	Good Sealed Non friable	Visual	Visible
SURVEY FINDINGS and HAZARD MANAGEMENT RECOMMENDATIONS					
<p>Low Risk P4 – Avoid physical and mechanical damage. When maintenance/upgrade is required, recommend removal and reinstate with non-asbestos product. Recommend sample (x3) to qualify material content, otherwise treat item as asbestos containing.</p>

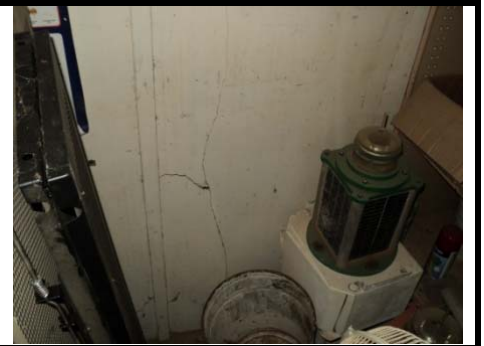
2011 Audit; This audit was based upon conducting a re-inspection of the items listed within the 2010, located in the office reception. Item 3 damaged. Recommend make safe.

LOCATION - DESCRIPTION	EXTENT	ASBESTOS ASSESSMENT	CONDITION	SAMPLE NO VISUAL TEST	SIGNAGE STATUS
3. Internal, work shed, wall lining – fibre cement sheet.	Approx 40m ² Accessible	Chrysotile asbestos detected	Moderate Sealed Non friable	01/LJ/270712	Visible
SURVEY FINDINGS and HAZARD MANAGEMENT RECOMMENDATIONS					
<p>Low Risk P4 – Avoid physical and mechanical damage. When maintenance/upgrade is required, recommend removal and reinstate with non-asbestos product. April 2011 Panels damaged. Recommend make safe in accordance with “Asbestos Approved Code of Practice”. July 2012 Note: Item made safe with the approved codes of practice.</p>

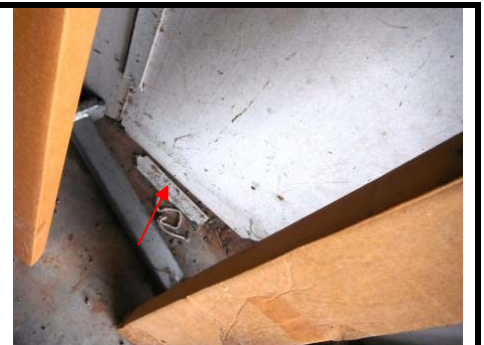
LOCATION - DESCRIPTION	EXTENT	ASBESTOS ASSESSMENT	CONDITION	SAMPLE NO VISUAL TEST	SIGNAGE STATUS
3a. Internal, work shed, debris on floor	-	Chrysotile asbestos detected	-	01/LJ/270712	-
SURVEY FINDINGS and HAZARD MANAGEMENT RECOMMENDATIONS					
<p>Medium Risk P3 – April 2012 Note: debris visible on floor. Recommend removal in accordance with “Asbestos Approved Code of Practice”. July 2012 Note: Item collected with the approved codes of practice.</p>

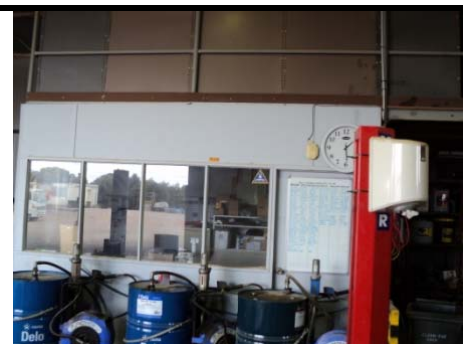
LOCATION - DESCRIPTION	EXTENT	ASBESTOS ASSESSMENT	CONDITION	SAMPLE NO VISUAL TEST	SIGNAGE STATUS
5. Internal, vehicle storage shed, office, outer wall linings – fibre cement sheet.	Approx 25m ² Accessible	Presume asbestos content	Good Sealed Non friable	Visual	Visible
SURVEY FINDINGS and HAZARD MANAGEMENT RECOMMENDATIONS					
Low Risk P4 – Avoid physical and mechanical damage. When maintenance/upgrade is required, recommend removal and reinstate with non-asbestos product. Recommend sample (x1) to qualify material content, otherwise treat item as asbestos containing.

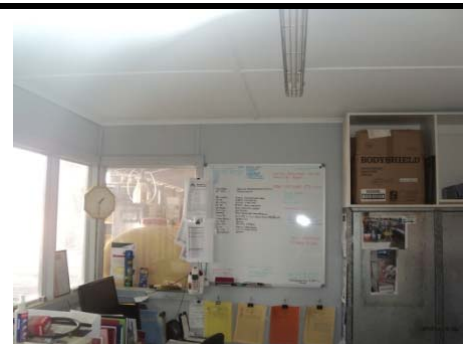
LOCATION - DESCRIPTION	EXTENT	ASBESTOS ASSESSMENT	CONDITION	SAMPLE NO VISUAL TEST	SIGNAGE STATUS
6. Internal, vehicle storage shed, office, (internal wall & ceiling) linings – fibre cement sheet.	Approx 40m ² Accessible	Presume asbestos content	Good Sealed Non friable	Visual	Visible
SURVEY FINDINGS and HAZARD MANAGEMENT RECOMMENDATIONS					
Low Risk P4 – Avoid physical and mechanical damage. When maintenance/upgrade is required, recommend removal and reinstate with non-asbestos product. Recommend sample (x1) to qualify material content, otherwise treat item as asbestos containing.

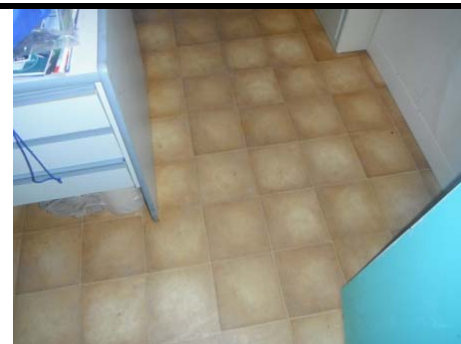
LOCATION - DESCRIPTION	EXTENT	ASBESTOS ASSESSMENT	CONDITION	SAMPLE NO VISUAL TEST	SIGNAGE STATUS
7. Internal, vehicle storage shed, office, floor covering – yellow sheet vinyl (lino) backing.	Approx 10m ² Accessible	Presume asbestos content	Good Sealed Friable	Not accessed	Visible
SURVEY FINDINGS and HAZARD MANAGEMENT RECOMMENDATIONS					
<p>Low Risk P4 – Backing layer trapped under vinyl. Item regarded safe whilst vinyl remains in good condition to protect from and prevent disturbance of asbestos backing layer.</p> <p>Avoid physical and mechanical damage. When maintenance/upgrade is required, recommend removal and reinstate with non-asbestos product.</p> <p>Note - as required by the OHS&W regulations, removal of this type of material is required to be performed by a licensed removalist.</p>

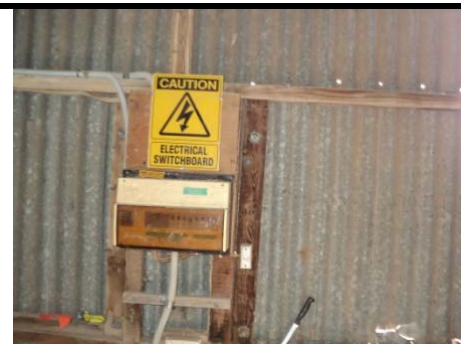
LOCATION - DESCRIPTION	EXTENT	ASBESTOS ASSESSMENT	CONDITION	SAMPLE NO VISUAL TEST	SIGNAGE STATUS
8. Internal, sign storage/ pesticide shed, adjacent entrance, electrical board – black resin board.	Approx 0.4m ² Accessible	Chrysotile asbestos (typical)	Good Unsealed Non friable	Visual	Visible
SURVEY FINDINGS and HAZARD MANAGEMENT RECOMMENDATIONS					
<p>Low Risk P4 – Avoid physical and mechanical damage. When maintenance/upgrade is required, recommend removal and reinstate with non-asbestos product.</p>

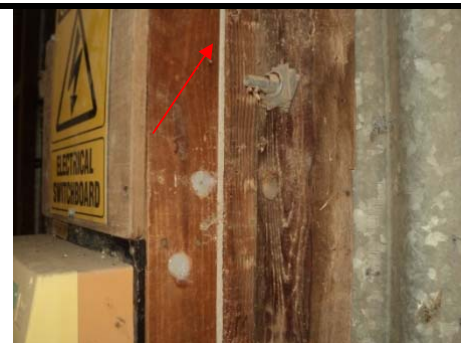
LOCATION - DESCRIPTION	EXTENT	ASBESTOS ASSESSMENT	CONDITION	SAMPLE NO VISUAL TEST	SIGNAGE STATUS
9. Internal, sign storage/ pesticide shed, adjacent entrance, backing plate – fibre cement sheet	Approx 0.6m ² Limited access	Presume asbestos content	Moderate Sealed Non friable	Visual	Visible
SURVEY FINDINGS and HAZARD MANAGEMENT RECOMMENDATIONS					
<p>Low Risk P4 – Avoid physical and mechanical damage. When maintenance/upgrade is required, recommend removal and reinstate with non-asbestos product. Board cracked. Monitor condition. Recommend sample (x1) to qualify material content, otherwise treat item as asbestos containing.</p>

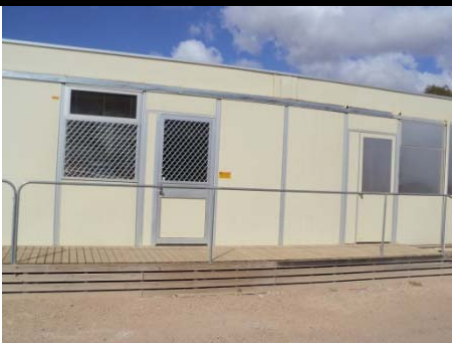
LOCATION - DESCRIPTION	EXTENT	ASBESTOS ASSESSMENT	CONDITION	SAMPLE NO VISUAL TEST	SIGNAGE STATUS
TRANSPORTABLE BUILDING (RELOCATED OCTOBER 2007) - EXTERNAL					
A, - Front elevation, façade comprising of solid fibre cement sheets, windows and timber doors, lining – fibre cement sheet, top fascia approx 400mm deep is metal	Approx 48m ² Accessible	Chrysotile asbestos detected	Good Sealed Non friable	Sample no. 3 (Oct / 07)	Visible
SURVEY FINDINGS and HAZARD MANAGEMENT RECOMMENDATIONS					
Low Risk P4 –Avoid physical and mechanical damage. When maintenance/upgrade is required, recommend removal and reinstate with non-asbestos product.

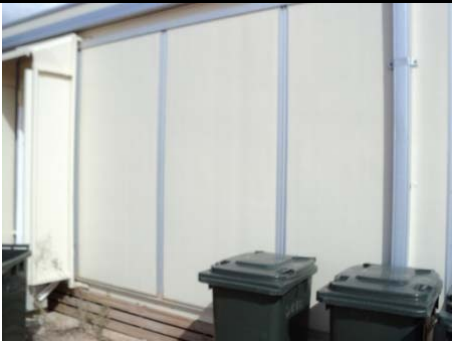
LOCATION - DESCRIPTION	EXTENT	ASBESTOS ASSESSMENT	CONDITION	SAMPLE NO VISUAL TEST	SIGNAGE STATUS
B, - Left elevation, façade comprising of solid fibre cement sheets, lining – fibre cement sheet, top fascia approx 400mm deep is metal	Approx 21m ² Accessible	Chrysotile asbestos detected	Good Sealed Non friable	Visual - Similar to sample no.3 (Oct / 07)	Visible
SURVEY FINDINGS and HAZARD MANAGEMENT RECOMMENDATIONS					
Low Risk P4 –Avoid physical and mechanical damage. When maintenance/upgrade is required, recommend removal and reinstate with non-asbestos product.

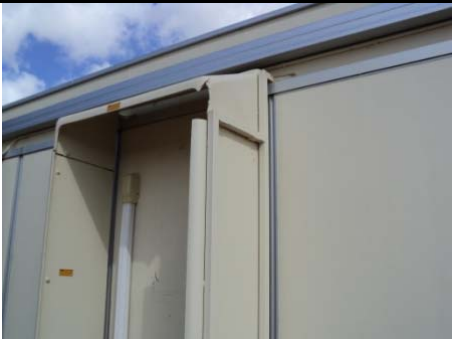
LOCATION - DESCRIPTION	EXTENT	ASBESTOS ASSESSMENT	CONDITION	SAMPLE NO VISUAL TEST	SIGNAGE STATUS
C, - Left elevation, sun cowl surrounding air-con unit, fixed to panels on metal framing lining – fibre cement sheet.	Approx 3m ² Accessible	Chrysotile asbestos detected	Good Sealed Non friable	Visual - Similar to sample no.3 (Oct / 07)	Visible
SURVEY FINDINGS and HAZARD MANAGEMENT RECOMMENDATIONS					
Low Risk P4 –Avoid physical and mechanical damage. When maintenance/upgrade is required, recommend removal and reinstate with non-asbestos product.

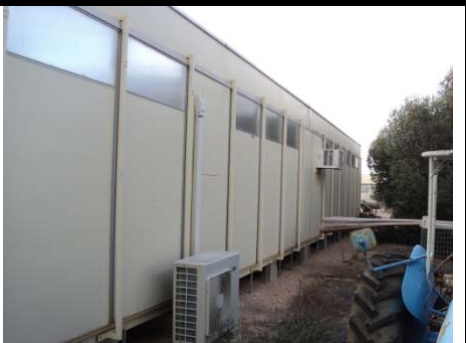
LOCATION - DESCRIPTION	EXTENT	ASBESTOS ASSESSMENT	CONDITION	SAMPLE NO VISUAL TEST	SIGNAGE STATUS
D, - Rear elevation, façade comprising of solid fibre cement sheets, with high level windows, lining – fibre cement sheet, top fascia approx 400mm deep is metal	Approx 48m ² Accessible	Chrysotile asbestos detected	Good Sealed Non friable	Visual - Similar to sample no.3 (Oct / 07)	Visible
SURVEY FINDINGS and HAZARD MANAGEMENT RECOMMENDATIONS					
Low Risk P4 –Avoid physical and mechanical damage. When maintenance/upgrade is required, recommend removal and reinstate with non-asbestos product.

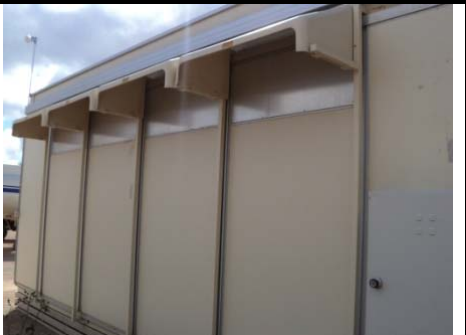
LOCATION - DESCRIPTION	EXTENT	ASBESTOS ASSESSMENT	CONDITION	SAMPLE NO VISUAL TEST	SIGNAGE STATUS
E, - Right elevation, façade comprising of solid fibre cement sheets, with high level glazing and sun shade canopy, lining – fibre cement sheet. top fascia approx 400mm deep is metal	Approx 26m ² Accessible	Chrysotile asbestos detected	Good Sealed Non friable	Visual - Similar to sample no.3 (Oct / 07)	Visible
SURVEY FINDINGS and HAZARD MANAGEMENT RECOMMENDATIONS					
Low Risk P4 –Avoid physical and mechanical damage. When maintenance/upgrade is required, recommend removal and reinstate with non-asbestos product. Item made safe in accordance with "Approved code of practice" 04/08/2010

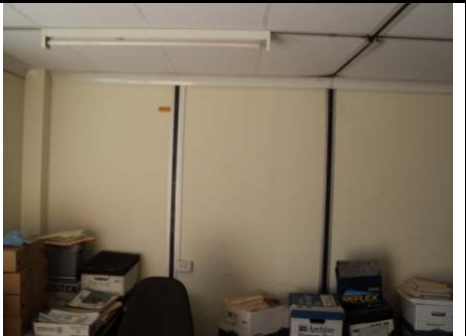
LOCATION – DESCRIPTION <u>TRANSPORTABLE BUILDING (RELOCATED OCTOBER 2007) – INTERNAL</u>	EXTENT	ASBESTOS ASSESSMENT	CONDITION	SAMPLE NO VISUAL TEST	SIGNAGE STATUS
1, - Left hand office, solid walls at gable and partition wall with glazed front and rear walls, door opening to front with asbestos cement transom panel, internal pass door at dividing partition, lining – fibre cement sheet.	Approx 60m ² Accessible	Chrysotile asbestos detected	Good Sealed Non friable	Sample no. 1 (Oct / 07) Sample no 8 (March 1995)	Visible
SURVEY FINDINGS and HAZARD MANAGEMENT RECOMMENDATIONS					
Low Risk P4 –Avoid physical and mechanical damage. When maintenance/upgrade is required, recommend removal and reinstate with non-asbestos product.

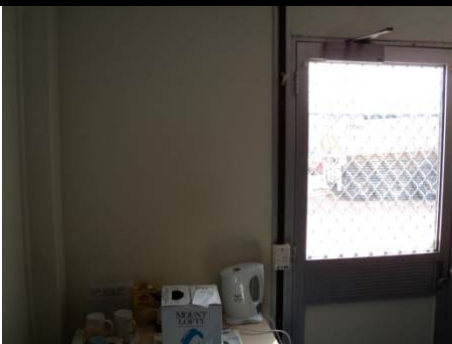
LOCATION - DESCRIPTION	EXTENT	ASBESTOS ASSESSMENT	CONDITION	SAMPLE NO VISUAL TEST	SIGNAGE STATUS
2, Central office, solid internal partition walls (wall to right hand office is plasterboard), part glazed wall front and back, door opening to front with asbestos cement transom panel, internal pass doors at dividing partitions, lining – fibre cement sheet.	Approx 40m ² Accessible	Chrysotile asbestos detected	Good Sealed Non friable	Visual - Similar to sample no.1 (Oct / 07)	Visible
SURVEY FINDINGS and HAZARD MANAGEMENT RECOMMENDATIONS					
Low Risk P4 –Avoid physical and mechanical damage. When maintenance/upgrade is required, recommend removal and reinstate with non-asbestos product.

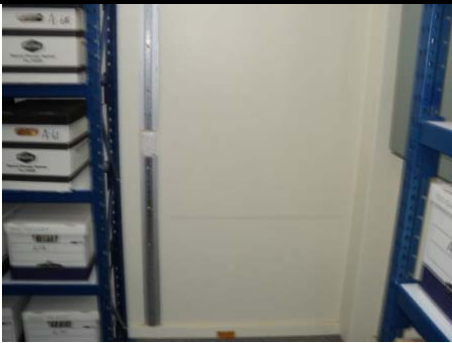
LOCATION - DESCRIPTION	EXTENT	ASBESTOS ASSESSMENT	CONDITION	SAMPLE NO VISUAL TEST	SIGNAGE STATUS
3, Right hand office, part glazed front gable and rear walls, door opening to front with asbestos cement transom panel, internal pass door at dividing partition, lining – fibre cement sheet	Approx 80m ² Accessible	Chrysotile asbestos detected	Good Sealed Non friable	Visual - Similar to sample no.3 (Oct / 07) Sample no 8 (March 1995)	Visible

SURVEY FINDINGS and HAZARD MANAGEMENT RECOMMENDATIONS					
Low Risk P4 –Avoid physical and mechanical damage. When maintenance/upgrade is required, recommend removal and reinstate with non-asbestos product.

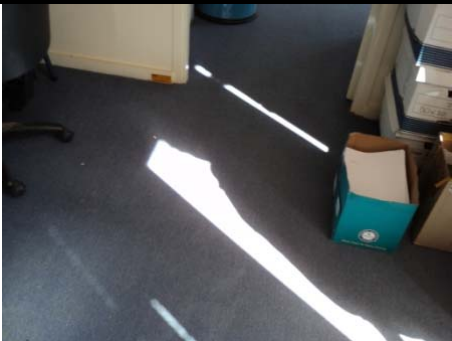
LOCATION - DESCRIPTION	EXTENT	ASBESTOS ASSESSMENT	CONDITION	SAMPLE NO VISUAL TEST	SIGNAGE STATUS
4, Flooring, Flooring comprises of carpet throughout with asbestos cement sheet bonded onto timber boarding core with asbestos sheet bonded to underside forming a veneer type construction. This floor is directly accessible from exterior underside of the portable structure and visible under carpets – veneered type fibre cement sheet.	Approx 112m ² Limited access	Chrysotile asbestos detected	Not assessed Unsealed Non friable	Sample no. 2 (Oct / 07)	Visible
SURVEY FINDINGS and HAZARD MANAGEMENT RECOMMENDATIONS					
Low Risk P4 –Avoid physical and mechanical damage. When maintenance/upgrade is required, recommend removal and reinstate with non-asbestos product. New carpet has been installed. Access underneath with caution. Avoid physical and mechanical damage. When maintenance/upgrade is required, recommend removal and reinstate with non-asbestos product.
