## ASBESTOS REGISTER

**REGISTER NO.:** AS2250-7

**FOR THE PROPERTY AT:** Ascot Theatre / Gallery Building  
Graves Street,  
Kadina SA

**DATE INSPECTED:** 10/05/2013

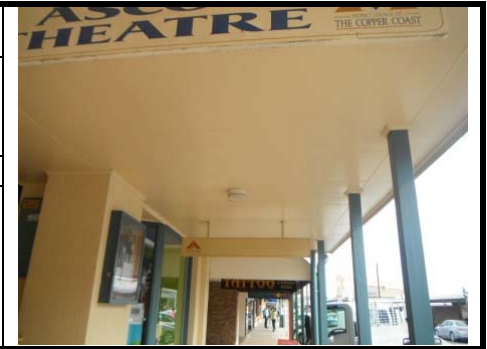
LOCATION - DESCRIPTION	EXTENT	ASBESTOS ASSESSMENT	CONDITION	SAMPLE NO VISUAL TEST	SIGNAGE STATUS
A. External, front of building, verandah eaves and fascia linings– fibre cement sheet.	Approx 100m <sup>2</sup> Limited access	Presume asbestos content	Good Sealed Non friable	Visual	Visible
<b>SURVEY FINDINGS and HAZARD MANAGEMENT RECOMMENDATIONS</b>					
<p><b>Low Risk P4</b> – Avoid physical and mechanical damage. When maintenance/upgrade is required, recommend removal and reinstate with non-asbestos product.</p> <p>Recommend sample (x1) to qualify material content, otherwise treat item as asbestos containing.</p> <p>April 2011 Holes visible. Recommend make safe in accordance with "Asbestos Approved Code of Practice".</p> <p>July 2012 note: item made safe with the approved codes of practice.</p>

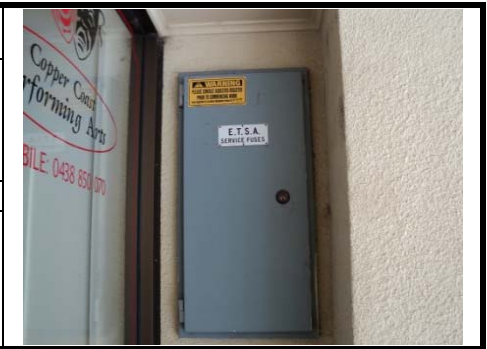
LOCATION - DESCRIPTION	EXTENT	ASBESTOS ASSESSMENT	CONDITION	SAMPLE NO VISUAL TEST	SIGNAGE STATUS
B. External, front of building, ETSA fuse box – possible asbestos containing materials within	Extent not able to be confirmed Limited access	Chrysotile asbestos (typical)	Not assessed Unsealed Non friable	Not accessed	Visible
<b>SURVEY FINDINGS and HAZARD MANAGEMENT RECOMMENDATIONS</b>					
<p><b>Low Risk P4</b> – Avoid physical and mechanical damage. When maintenance/upgrade is required, recommend removal and reinstate with non-asbestos product.</p>

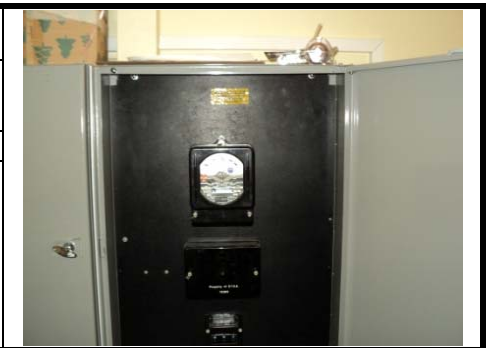
LOCATION - DESCRIPTION	EXTENT	ASBESTOS ASSESSMENT	CONDITION	SAMPLE NO VISUAL TEST	SIGNAGE STATUS
1. Internal, ground floor, north eastern most room, within metal cabinet electrical board – black resin board.	Approx 1m <sup>2</sup> Accessible	Presume asbestos content	Good Unsealed Non friable	Visual	Visible
<b>SURVEY FINDINGS and HAZARD MANAGEMENT RECOMMENDATIONS</b>					
<p><b>Low Risk P4</b> – Avoid physical and mechanical damage. When maintenance/upgrade is required, recommend removal and reinstate with non-asbestos product.</p>

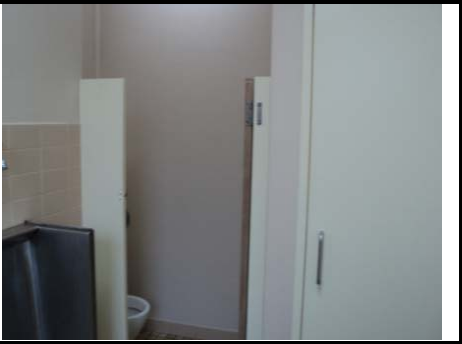
LOCATION - DESCRIPTION	EXTENT	ASBESTOS ASSESSMENT	CONDITION	SAMPLE NO VISUAL TEST	SIGNAGE STATUS	
2. Internal, ground floor, male toilets, toilet partitions lining – fibre cement thick sheet.	Approx 1m <sup>2</sup> Accessible	Presume asbestos content	Good Sealed Non friable	Visual	Visible

<b>SURVEY FINDINGS and HAZARD MANAGEMENT RECOMMENDATIONS</b>						
<p><b>Low Risk P4</b> – Avoid physical and mechanical damage. When maintenance/upgrade is required, recommend removal and reinstate with non-asbestos product. Recommend sample (x1) to qualify material content, otherwise treat item as asbestos containing.</p>

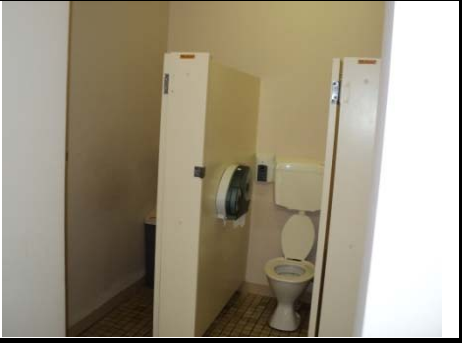
3. Internal, ground floor, female toilets, toilet partitions lining – fibre cement thick sheet.	Approx 6m <sup>2</sup> Accessible	Presume asbestos content	Good Sealed Non friable	Visual	Visible

<b>SURVEY FINDINGS and HAZARD MANAGEMENT RECOMMENDATIONS</b>						
<p><b>Low Risk P4</b> – Avoid physical and mechanical damage. When maintenance/upgrade is required, recommend removal and reinstate with non-asbestos product. Recommend sample (x1) to qualify material content, otherwise treat item as asbestos containing.</p>

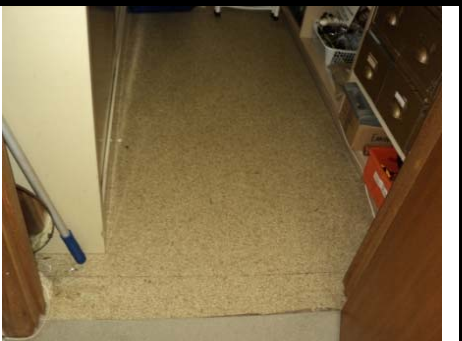
4. Internal, ground floor, art gallery office, floor covering – sheet vinyl (lino) backing.	Approx 6m <sup>2</sup> Limited access	Presume asbestos content	Good Unsealed Friable	Not accessed	Visible

<b>SURVEY FINDINGS and HAZARD MANAGEMENT RECOMMENDATIONS</b>						
<p><b>Medium Risk P3</b> – Backing layer trapped under vinyl. Item regarded safe whilst vinyl remains in good condition to protect from and prevent disturbance of asbestos backing layer.</p> <p>Avoid physical and mechanical damage. When maintenance/upgrade is required, recommend removal and reinstate with non-asbestos product.</p> <p>Note - as required by the OHS&amp;W regulations, removal of this type of material is required to be performed by a licensed removalist.</p>

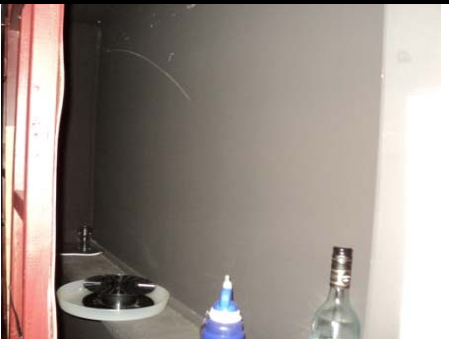
LOCATION - DESCRIPTION	EXTENT	ASBESTOS ASSESSMENT	CONDITION	SAMPLE NO VISUAL TEST	SIGNAGE STATUS
5. Internal, first floor, stage area, west wall, window infill lining – fibre cement sheet.	Approx 2m <sup>2</sup> Accessible	Presume asbestos content	Good Sealed Non friable	Visual	Visible
<b>SURVEY FINDINGS and HAZARD MANAGEMENT RECOMMENDATIONS</b>					
<p><b>Low Risk P4</b> – Avoid physical and mechanical damage. When maintenance/upgrade is required, recommend removal and reinstate with non-asbestos product.</p> <p>Recommend sample (x1) to qualify material content, otherwise treat item as asbestos containing.</p>

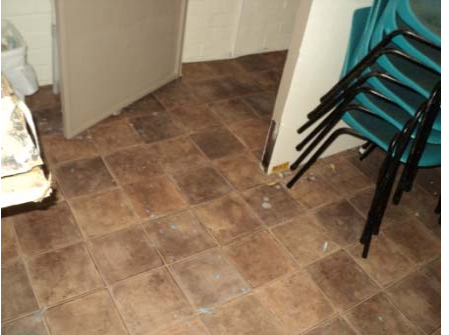
LOCATION - DESCRIPTION	EXTENT	ASBESTOS ASSESSMENT	CONDITION	SAMPLE NO VISUAL TEST	SIGNAGE STATUS
6. Internal, first floor, rear of building loading dock area, toilet floor – fibre cement thick sheet (below vinyl).	Approx 5m <sup>2</sup> Limited access	Presume asbestos content	Good Sealed Non friable	Visual	Visible
<b>SURVEY FINDINGS and HAZARD MANAGEMENT RECOMMENDATIONS</b>					
<p><b>Low Risk P4</b> – Avoid physical and mechanical damage. When maintenance/upgrade is required, recommend removal and reinstate with non-asbestos product.</p> <p>Recommend sample (x1) to qualify material content, otherwise treat item as asbestos containing.</p>

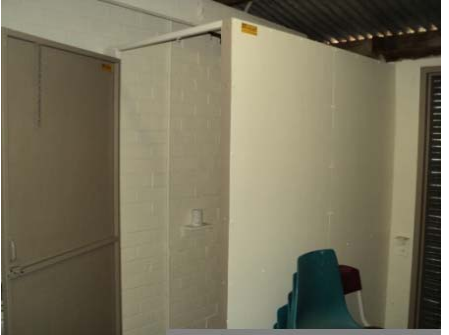
LOCATION - DESCRIPTION	EXTENT	ASBESTOS ASSESSMENT	CONDITION	SAMPLE NO VISUAL TEST	SIGNAGE STATUS
7. Internal, first floor, rear of building loading dock area, toilet walls and door – fibre cement sheet	Approx 6m <sup>2</sup> Accessible	Presume asbestos content	Good Sealed Non friable	Visual	Visible
<b>SURVEY FINDINGS and HAZARD MANAGEMENT RECOMMENDATIONS</b>					
<p><b>Low Risk P4</b> – Avoid physical and mechanical damage. When maintenance/upgrade is required, recommend removal and reinstate with non-asbestos product.</p> <p>Recommend sample (x1) to qualify material content, otherwise treat item as asbestos containing.</p>

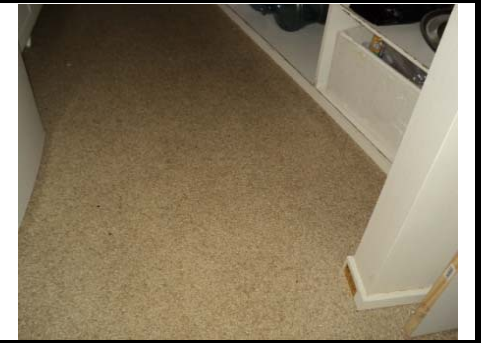
LOCATION - DESCRIPTION	EXTENT	ASBESTOS ASSESSMENT	CONDITION	SAMPLE NO VISUAL TEST	SIGNAGE STATUS
9. Internal, first floor, canteen, floor covering – sheet vinyl (lino) backing.	Approx 15m <sup>2</sup> Accessible	Chrysotile asbestos detected	Moderate Unsealed Friable	Sample 1 (Feb / 07)	Visible
<b>SURVEY FINDINGS and HAZARD MANAGEMENT RECOMMENDATIONS</b>					
<p><b>Medium Risk P3</b> – Avoid further physical and mechanical damage. When maintenance/upgrade is required, recommend removal and reinstate with non-asbestos product.</p> <p><b>April 2011 Recommend planned removal in accordance with “Approved Code of Practice”.</b></p> <p><b>May 2013:</b> No access to this room.</p>
