## ASBESTOS REGISTER

**REGISTER NO.:** AS2250-13

**FOR THE PROPERTY AT:** Yorke Peninsula Employment  
Hallett Street,  
Kadina SA

**DATE INSPECTED:** 10/05/2013

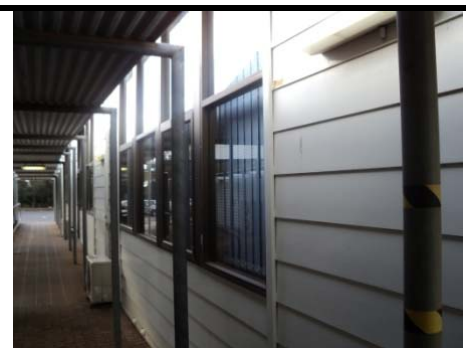
LOCATION - DESCRIPTION	EXTENT	ASBESTOS ASSESSMENT	CONDITION	SAMPLE NO VISUAL TEST	SIGNAGE STATUS
A. External, eastern admin building, west wall linings – fibre cement sheet.	Approx 75m <sup>2</sup> Accessible	Presume asbestos content	Good Sealed Non friable	Visual	Visible
<b>SURVEY FINDINGS and HAZARD MANAGEMENT RECOMMENDATIONS</b>					
<p><b>Low Risk P4</b> – Avoid physical and mechanical damage. When maintenance/upgrade is required, recommend removal and reinstate with non-asbestos product. Recommend sample (x2) to qualify material content, otherwise treat item as asbestos containing.</p>

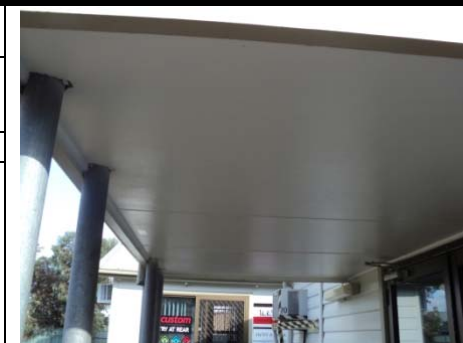
LOCATION - DESCRIPTION	EXTENT	ASBESTOS ASSESSMENT	CONDITION	SAMPLE NO VISUAL TEST	SIGNAGE STATUS
C. External, eastern admin building, east side, verandah linings – fibre cement sheet	Approx 6m <sup>2</sup> Limited access	Presume asbestos content	Good Sealed Non friable	Visual	Visible
<b>SURVEY FINDINGS and HAZARD MANAGEMENT RECOMMENDATIONS</b>					
<p><b>Low Risk P4</b> – Avoid physical and mechanical damage. When maintenance/upgrade is required, recommend removal and reinstate with non-asbestos product. Recommend sample (x1) to qualify material content, otherwise treat item as asbestos containing.</p>

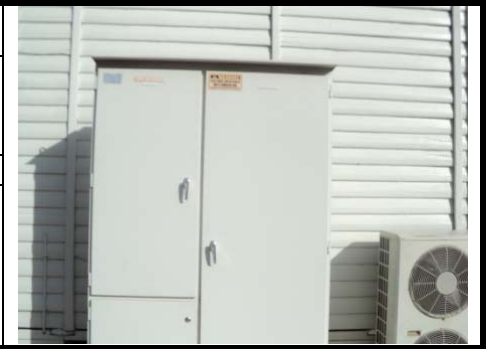
LOCATION - DESCRIPTION	EXTENT	ASBESTOS ASSESSMENT	CONDITION	SAMPLE NO VISUAL TEST	SIGNAGE STATUS
D. External, eastern admin building, north side, metal electrical cabinet (no access within) – possible asbestos containing materials within	Not quantified Limited access	Chrysotile asbestos (typical)	Not assessed	Not accessed	Visible
<b>SURVEY FINDINGS and HAZARD MANAGEMENT RECOMMENDATIONS</b>					
<p><b>Low Risk P4</b> – Avoid physical and mechanical damage. When maintenance/upgrade is required, recommend removal and reinstate with non-asbestos product.</p> <p>No access to this room / item. Treat as asbestos containing until qualified by inspection. Access with caution.</p>

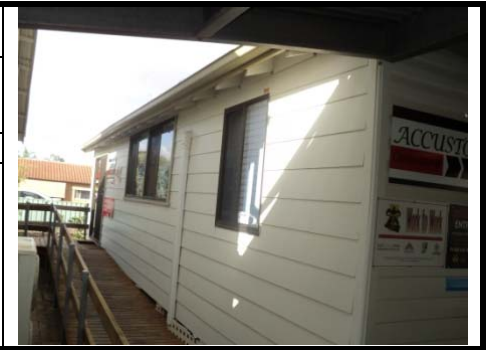
LOCATION - DESCRIPTION	EXTENT	ASBESTOS ASSESSMENT	CONDITION	SAMPLE NO VISUAL TEST	SIGNAGE STATUS
E. External, south eastern admin / classroom building, northern wall linings – fibre cement sheet.	Approx 24m <sup>2</sup> Accessible	Presume asbestos content	Good Sealed Non friable	Visual	Visible
<b>SURVEY FINDINGS and HAZARD MANAGEMENT RECOMMENDATIONS</b>					
<p><b>Low Risk P4</b> – Avoid physical and mechanical damage. When maintenance/upgrade is required, recommend removal and reinstate with non-asbestos product.</p> <p>Recommend sample (x1) to qualify material content, otherwise treat item as asbestos containing.</p>

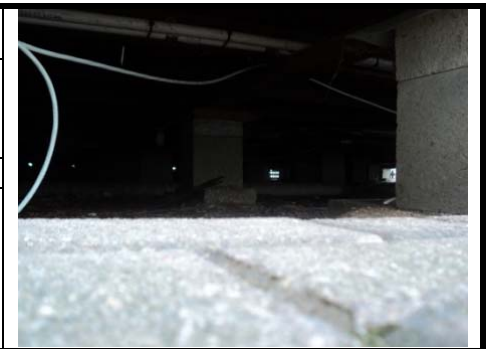
LOCATION - DESCRIPTION	EXTENT	ASBESTOS ASSESSMENT	CONDITION	SAMPLE NO VISUAL TEST	SIGNAGE STATUS
F. External, south eastern admin building, beneath building, packers – fibre cement fragments.	Not quantified Limited access	Presume asbestos content	Not assessed Unsealed Non friable	Not accessed	Not visible
<b>SURVEY FINDINGS and HAZARD MANAGEMENT RECOMMENDATIONS</b>					
<p><b>Low Risk P4</b> – Avoid physical and mechanical damage. When maintenance/upgrade is required, recommend removal and reinstate with non-asbestos product. Unable to affix specific warning sign to item, covered by General sign.</p>

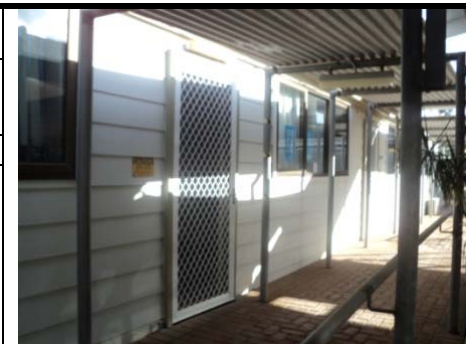
LOCATION - DESCRIPTION	EXTENT	ASBESTOS ASSESSMENT	CONDITION	SAMPLE NO VISUAL TEST	SIGNAGE STATUS
G. External, southern classroom building, northern wall linings – fibre cement sheet.	Approx 50m <sup>2</sup> Accessible	Presume asbestos content	Good Sealed Non friable	Visual	Visible
<b>SURVEY FINDINGS and HAZARD MANAGEMENT RECOMMENDATIONS</b>					
<p><b>Low Risk P4</b> – Avoid physical and mechanical damage. When maintenance/upgrade is required, recommend removal and reinstate with non-asbestos product.</p> <p>Recommend sample (x1) to qualify material content, otherwise treat item as asbestos containing.</p>

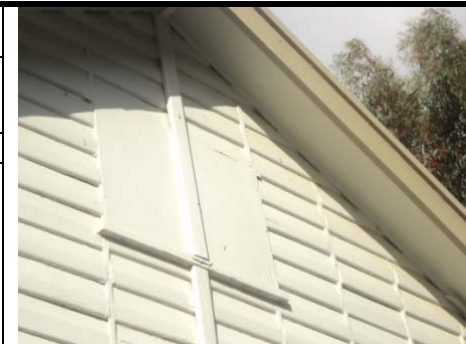
LOCATION - DESCRIPTION	EXTENT	ASBESTOS ASSESSMENT	CONDITION	SAMPLE NO VISUAL TEST	SIGNAGE STATUS
H. External, southern classroom building, west side wall infill at high level– fibre cement sheet.	Approx 1m <sup>2</sup> Limited access	Presume asbestos content	Good Sealed Non friable	Visual	Not visible
<b>SURVEY FINDINGS and HAZARD MANAGEMENT RECOMMENDATIONS</b>					
<p><b>Low Risk P4</b> – Avoid physical and mechanical damage. When maintenance/upgrade is required, recommend removal and reinstate with non-asbestos product.</p> <p>Recommend sample (x1) to qualify material content, otherwise treat item as asbestos containing. Unable to affix specific warning sign to item, covered by General sign.</p>

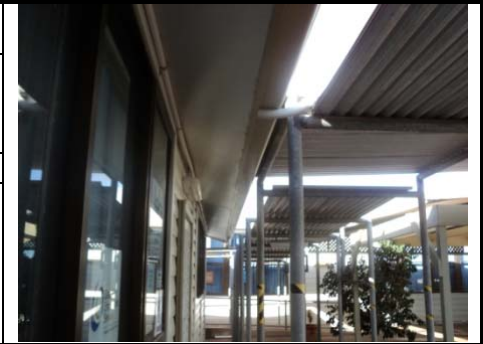
LOCATION - DESCRIPTION	EXTENT	ASBESTOS ASSESSMENT	CONDITION	SAMPLE NO VISUAL TEST	SIGNAGE STATUS
J. External, central classroom building, perimeter of building, eaves linings – fibre cement sheet.	Approx 50m <sup>2</sup> Limited access	Presume asbestos content	Good Sealed Non friable	Visual	Visible
<b>SURVEY FINDINGS and HAZARD MANAGEMENT RECOMMENDATIONS</b>					
<p><b>Low Risk P4</b> – Avoid physical and mechanical damage. When maintenance/upgrade is required, recommend removal and reinstate with non-asbestos product. Recommend sample (x2) to qualify material content, otherwise treat item as asbestos containing.</p>

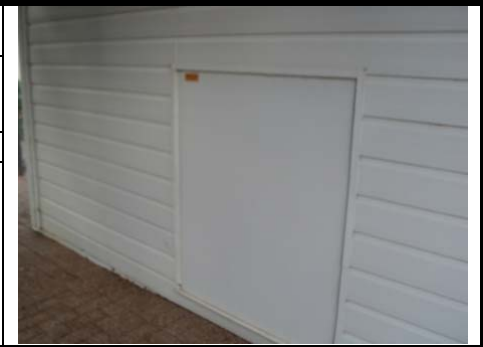
LOCATION - DESCRIPTION	EXTENT	ASBESTOS ASSESSMENT	CONDITION	SAMPLE NO VISUAL TEST	SIGNAGE STATUS
K. External, central classroom building, west side wall infill – fibre cement sheet.	Approx 1.5m <sup>2</sup> Accessible	Presume asbestos content	Good Sealed Non friable	Visual	Visible
<b>SURVEY FINDINGS and HAZARD MANAGEMENT RECOMMENDATIONS</b>					
<p><b>Low Risk P4</b> – Avoid physical and mechanical damage. When maintenance/upgrade is required, recommend removal and reinstate with non-asbestos product. Recommend sample (x1) to qualify material content, otherwise treat item as asbestos containing.</p>

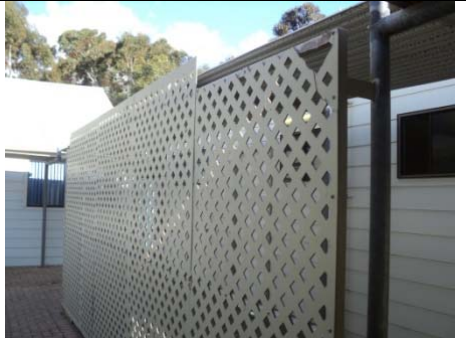
O. External, toilet block, west of block, lattice, – fibre cement sheet.	-	No asbestos detected (Organic fibre)	-	02/LJ/270712	-	
<b>SURVEY FINDINGS and HAZARD MANAGEMENT RECOMMENDATIONS</b> No asbestos detected upon laboratory analysis of sample.

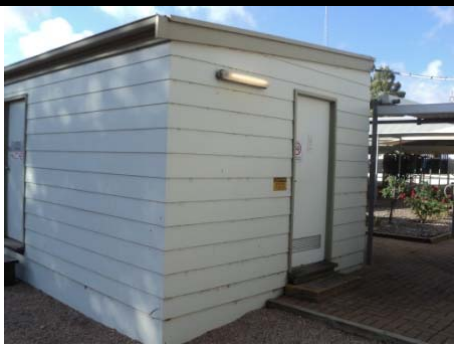
LOCATION - DESCRIPTION	EXTENT	ASBESTOS ASSESSMENT	CONDITION	SAMPLE NO VISUAL TEST	SIGNAGE STATUS
P. External, toilet block, wall linings – fibre cement sheet.	Approx 80m <sup>2</sup> Accessible	No asbestos detected (Organic fibre)	-	01/LJ/030812	-
<b>SURVEY FINDINGS and HAZARD MANAGEMENT RECOMMENDATIONS</b>					
No asbestos detected upon laboratory analysis of sample.

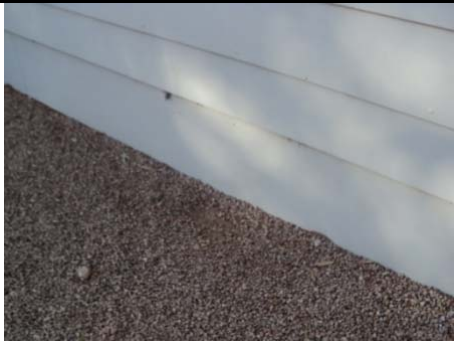
LOCATION - DESCRIPTION	EXTENT	ASBESTOS ASSESSMENT	CONDITION	SAMPLE NO VISUAL TEST	SIGNAGE STATUS
Q. External, toilet block, kick panels– fibre cement sheet.	Approx 30m <sup>2</sup> Accessible	Presume asbestos content	Good Sealed Non friable	Visual	Visible
<b>SURVEY FINDINGS and HAZARD MANAGEMENT RECOMMENDATIONS</b>					
<b>Low Risk P4</b> – Avoid physical and mechanical damage. When maintenance/upgrade is required, recommend removal and reinstate with non-asbestos product.

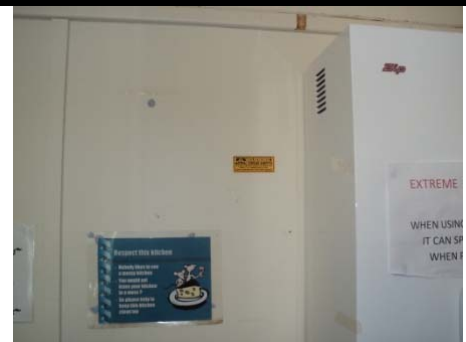
3. Internal, southern most classroom building, wet area, sink splashback lining – fibre cement sheet.	Approx 4m <sup>2</sup> Accessible	Presume asbestos content	Good Sealed Non friable	Visual	Visible	
<b>SURVEY FINDINGS and HAZARD MANAGEMENT RECOMMENDATIONS</b> <b>Low Risk P4</b> – Avoid physical and mechanical damage. When maintenance/upgrade is required, recommend removal and reinstate with non-asbestos product. Recommend sample (x1) to qualify material content, otherwise treat item as asbestos containing.

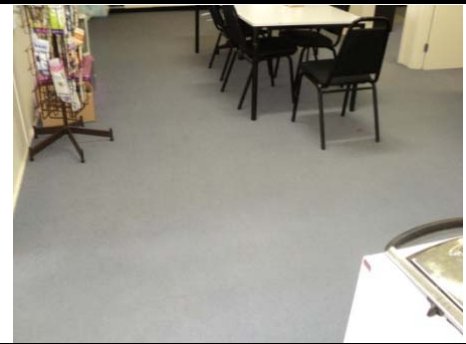
LOCATION - DESCRIPTION	EXTENT	ASBESTOS ASSESSMENT	CONDITION	SAMPLE NO VISUAL TEST	SIGNAGE STATUS
5. Internal, southern most classroom building, central room, floor covering beneath carpet – vinyl tiles (green colour).	Extent not able to be confirmed Limited access	Presume asbestos content	Not assessed Unsealed Non friable	Visual	Not visible
<b>SURVEY FINDINGS and HAZARD MANAGEMENT RECOMMENDATIONS</b>					
<p><b>Low Risk P4</b> – Avoid physical and mechanical damage. When maintenance/upgrade is required, recommend removal and reinstate with non-asbestos product. Tiles covered by carpet, full extent unknown.</p> <p>Recommend sample (x1) to qualify material content, otherwise treat item as asbestos containing.</p>

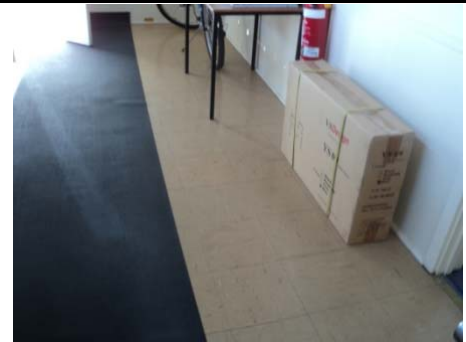
LOCATION - DESCRIPTION	EXTENT	ASBESTOS ASSESSMENT	CONDITION	SAMPLE NO VISUAL TEST	SIGNAGE STATUS
6. Internal, southern most classroom building, western office lobby, floor covering – vinyl tiles (orange/ beige colour).	Approx 20m <sup>2</sup> Accessible	Presume asbestos content	Good Unsealed Non friable	Visual	Visible
<b>SURVEY FINDINGS and HAZARD MANAGEMENT RECOMMENDATIONS</b>					
<p><b>Low Risk P4</b> – Avoid physical and mechanical damage. When maintenance/upgrade is required, recommend removal and reinstate with non-asbestos product.</p> <p>Recommend sample (x1) to qualify material content, otherwise treat item as asbestos containing.</p>

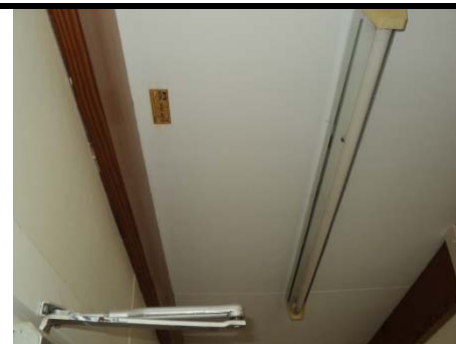
LOCATION - DESCRIPTION	EXTENT	ASBESTOS ASSESSMENT	CONDITION	SAMPLE NO VISUAL TEST	SIGNAGE STATUS
7. Internal, toilet block, ceiling linings throughout – fibre cement sheet.	Approx 36m <sup>2</sup> Limited access	Presume asbestos content	Good Sealed Non friable	Visual	Visible
<b>SURVEY FINDINGS and HAZARD MANAGEMENT RECOMMENDATIONS</b>					
<p><b>Low Risk P4</b> – Avoid physical and mechanical damage. When maintenance/upgrade is required, recommend removal and reinstate with non-asbestos product. Recommend sample (x1) to qualify material content, otherwise treat item as asbestos containing.</p>

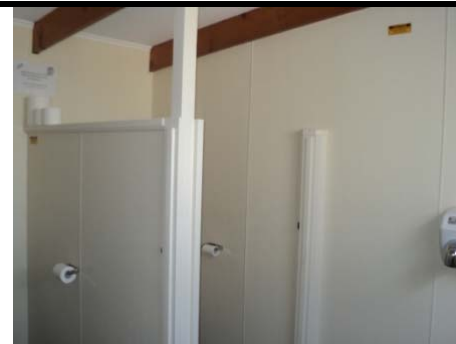
LOCATION - DESCRIPTION	EXTENT	ASBESTOS ASSESSMENT	CONDITION	SAMPLE NO VISUAL TEST	SIGNAGE STATUS
8. Internal, toilet block, wall linings throughout – fibre cement sheet.	Approx 85m <sup>2</sup> Accessible	Presume asbestos content	Good Sealed Non friable	Visual	Visible
<b>SURVEY FINDINGS and HAZARD MANAGEMENT RECOMMENDATIONS</b>					
<p><b>Low Risk P4</b> – Avoid physical and mechanical damage. When maintenance/upgrade is required, recommend removal and reinstate with non-asbestos product. Recommend sample (x2) to qualify material content, otherwise treat item as asbestos containing.</p>

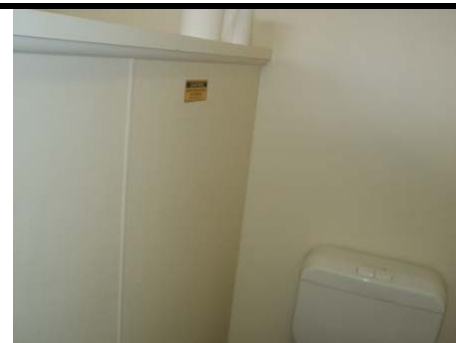
LOCATION - DESCRIPTION	EXTENT	ASBESTOS ASSESSMENT	CONDITION	SAMPLE NO VISUAL TEST	SIGNAGE STATUS
9. Internal, toilet block, male toilets, toilet partitions – fibre cement thick sheet.	Approx 12m <sup>2</sup> Accessible	Presume asbestos content	Good Sealed Non friable	Visual	Visible
<b>SURVEY FINDINGS and HAZARD MANAGEMENT RECOMMENDATIONS</b>					
<p><b>Low Risk P4</b> – Avoid physical and mechanical damage. When maintenance/upgrade is required, recommend removal and reinstate with non-asbestos product. Recommend sample (x1) to qualify material content, otherwise treat item as asbestos containing.</p>

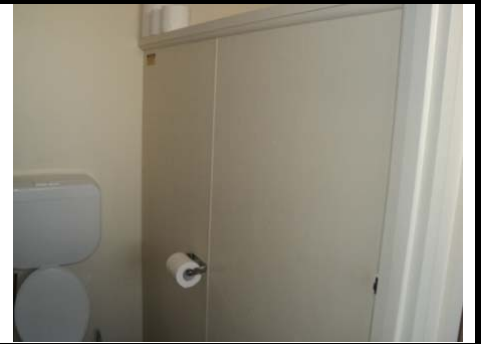
LOCATION - DESCRIPTION	EXTENT	ASBESTOS ASSESSMENT	CONDITION	SAMPLE NO VISUAL TEST	SIGNAGE STATUS
10. Internal, toilet block, female toilets, toilet partitions – fibre cement thick sheet.	Approx 12m <sup>2</sup> Accessible	Presume asbestos content	Good Sealed Non friable	Visual	Visible
<b>SURVEY FINDINGS and HAZARD MANAGEMENT RECOMMENDATIONS</b>					
<p><b>Low Risk P4</b> – Avoid physical and mechanical damage. When maintenance/upgrade is required, recommend removal and reinstate with non-asbestos product. Recommend sample (x1) to qualify material content, otherwise treat item as asbestos containing.</p>

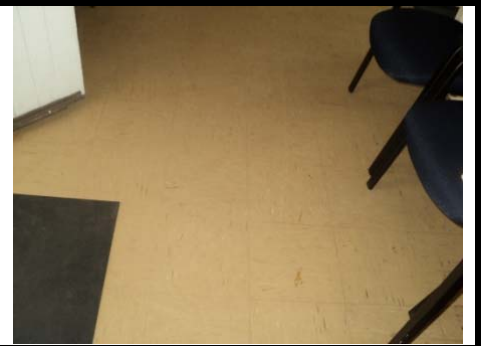
LOCATION - DESCRIPTION	EXTENT	ASBESTOS ASSESSMENT	CONDITION	SAMPLE NO VISUAL TEST	SIGNAGE STATUS
11. Internal, central classroom building, central lobby, floor covering – vinyl tiles (orange/ beige colour).	Approx 15m <sup>2</sup> Accessible	Presume asbestos content	Moderate Unsealed Non friable	Visual	Visible
<b>SURVEY FINDINGS and HAZARD MANAGEMENT RECOMMENDATIONS</b>					
<p><b>Low Risk P4</b> – Avoid physical and mechanical damage. When maintenance/upgrade is required, recommend removal and reinstate with non-asbestos product. Tiles are damaged at entrance by telecom entry point - monitor condition for further signs of damage, make safe if necessary in accordance with "Approved Code of Practice". <b>May 2013 note:</b> tiles to be presumed underneath modern vinyl as no removal information available.</p>
