ASBESTOS REGISTER

REGISTER NO.: AS2250-12

FOR THE PROPERTY AT: Council Park
Fifth Street & East Terrace
Kadina SA

DATE INSPECTED: 10/05/2013

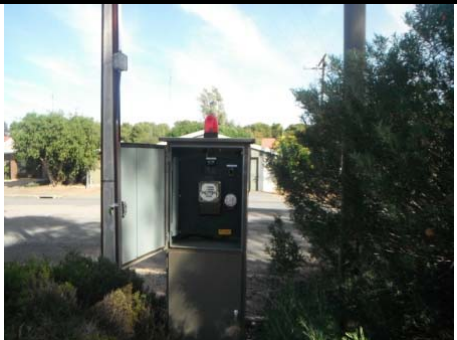
LOCATION – DESCRIPTION <u>EXTERNAL FREESTANDING ELECTRICAL CABINET</u>	EXTENT	ASBESTOS ASSESSMENT	CONDITION	SAMPLE NO VISUAL TEST	SIGNAGE STATUS

1. Upper electrical board – black resin board.	Approx 700x700mm Accessible	Chrysotile asbestos (typical)	Not assessed	Visual	Visible	
<i>SURVEY FINDINGS and HAZARD MANAGEMENT RECOMMENDATIONS</i> Low Risk P4 – Avoid physical and mechanical damage. When maintenance/upgrade is required, recommend removal and reinstate with non-asbestos product. October 2008 - Dust residue and debris in base of electrical cabinet cleaned up with approved asbestos vacuum system in accordance with "Approved Code of Practice". August 2010 Item made safe in accordance with "Approved code of practice".
