## ASBESTOS REGISTER

**REGISTER NO.:** AS2250-8

**FOR THE PROPERTY AT:** Town Hall and Council Chambers  
Taylor Street,  
Kadina SA

**CLIENT:** District Council of the Copper Coast

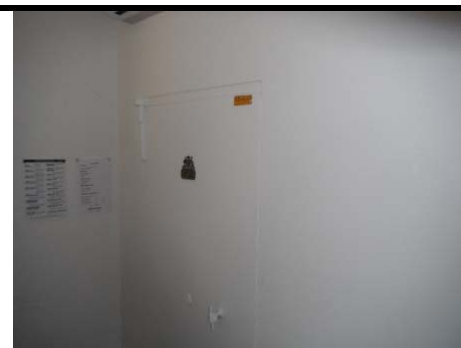
LOCATION - DESCRIPTION	EXTENT	ASBESTOS ASSESSMENT	CONDITION	SAMPLE NO VISUAL TEST	SIGNAGE STATUS
3. Internal, computer area, safe, fire door, internal core – compressed fibre insulation.	Not quantified Inaccessible	Presume asbestos content	Not assessed Unsealed Friable	Not accessed	Visible
<b>SURVEY FINDINGS and HAZARD MANAGEMENT RECOMMENDATIONS</b>					
<p><b>Low Risk P4</b> – Treat all fire doors as having an asbestos internal core unless confirmed otherwise by sample analysis. Avoid physical and mechanical damage. When maintenance/upgrade is required, recommend removal and reinstate with non-asbestos product.</p> <p><b>May 2013 note:</b> This door has been relocated to the internal passageway.</p>

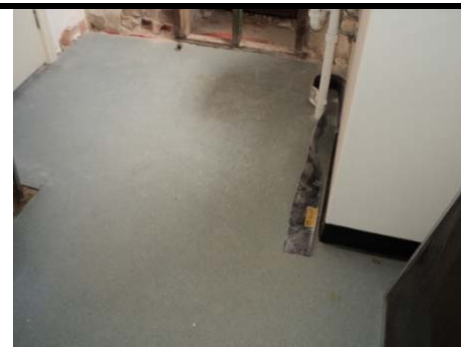
LOCATION - DESCRIPTION	EXTENT	ASBESTOS ASSESSMENT	CONDITION	SAMPLE NO VISUAL TEST	SIGNAGE STATUS
4. Internal, hall, kitchen, floor covering – blue sheet vinyl (lino) backing.	Approx 14m <sup>2</sup> Inaccessible	Presume asbestos content	Good Sealed Friable	Not accessed	Visible
<b>SURVEY FINDINGS and HAZARD MANAGEMENT RECOMMENDATIONS</b>					
<p><b>Low Risk P4</b> – Backing layer trapped under vinyl. Item regarded safe whilst vinyl remains in good condition to protect from and prevent disturbance of asbestos backing layer.</p> <p>Avoid physical and mechanical damage. When maintenance/upgrade is required, recommend removal and reinstate with non-asbestos product.</p> <p>Note - as required by the OHS&amp;W regulations, removal of this type of material is required to be performed by a licensed removalist.</p>

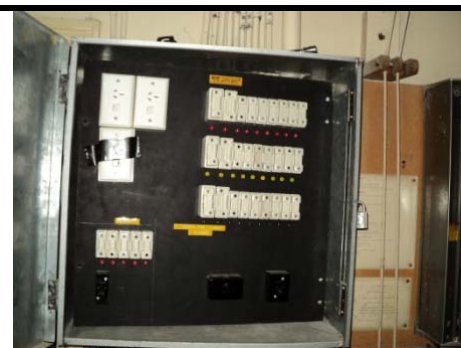
LOCATION - DESCRIPTION	EXTENT	ASBESTOS ASSESSMENT	CONDITION	SAMPLE NO VISUAL TEST	SIGNAGE STATUS
5. Internal, hall, stage area, within metal cabinet, electrical board – black resin board.	Approx 1m <sup>2</sup> Accessible	Chrysotile asbestos (typical)	-	Visual	-
<b>SURVEY FINDINGS and HAZARD MANAGEMENT RECOMMENDATIONS</b>					
<p><b>May 2013:</b> No Inspection - Item has been removed prior to audit. No record of removal available. Recommend gather any asbestos removal or maintenance information and include/document this into the work/access section of the register to gain compliance. Information to include air monitoring results and where applicable statutory government approvals.</p>

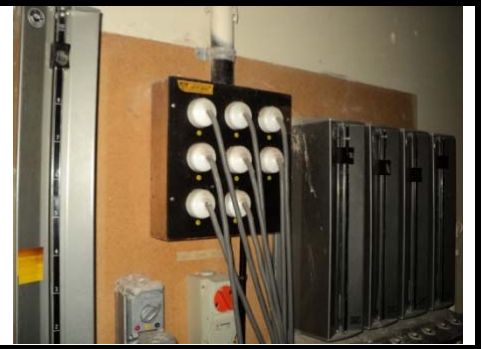
LOCATION - DESCRIPTION	EXTENT	ASBESTOS ASSESSMENT	CONDITION	SAMPLE NO VISUAL TEST	SIGNAGE STATUS
6. Internal, hall, stage area, wall mounted electrical board – black resin board	Approx 300x300mm Accessible	Chrysotile asbestos (typical)	-	Visual	-
<b>SURVEY FINDINGS and HAZARD MANAGEMENT RECOMMENDATIONS</b>					
<p><b>May 2013:</b> No Inspection - Item has been removed prior to audit. No record of removal available. Recommend gather any asbestos removal or maintenance information and include/document this into the work/access section of the register to gain compliance. Information to include air monitoring results and where applicable statutory government approvals.</p>

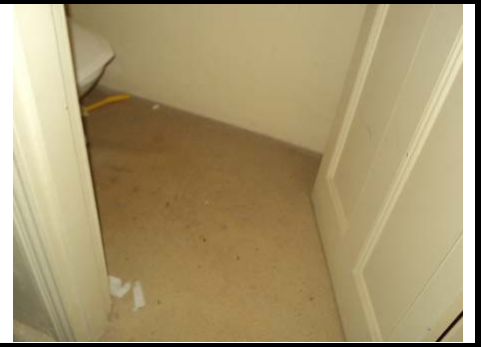
LOCATION - DESCRIPTION	EXTENT	ASBESTOS ASSESSMENT	CONDITION	SAMPLE NO VISUAL TEST	SIGNAGE STATUS
7. Internal, hall, dressing area toilet, floor covering – cream sheet vinyl (lino) backing.	Approx 2m <sup>2</sup> Inaccessible	Presume asbestos content	Good Sealed Friable	Not accessed	Visible
<b>SURVEY FINDINGS and HAZARD MANAGEMENT RECOMMENDATIONS</b>					
<p><b>Low Risk P4</b> – Backing layer trapped under vinyl. Item regarded safe whilst vinyl remains in good condition to protect from and prevent disturbance of asbestos backing layer. Avoid physical and mechanical damage. When maintenance/upgrade is required, recommend removal and reinstate with non-asbestos product. Note - as required by the OHS&amp;W regulations, removal of this type of material is required to be performed by a licensed removalist.</p>

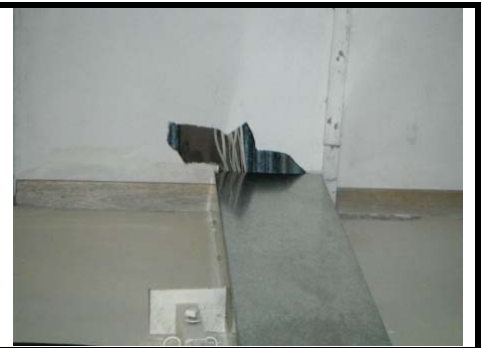
- Item '8' – Internal, hall, stage area, ceiling linings – fibre cement sheet broken at services. **Recommend make safe in accordance with the approved codes of practice.**

LOCATION - DESCRIPTION	EXTENT	ASBESTOS ASSESSMENT	CONDITION	SAMPLE NO VISUAL TEST	SIGNAGE STATUS
8. Internal, hall, stage area, ceiling linings – fibre cement sheet.	Not quantified Limited access	Presume asbestos content	Moderate Sealed Non friable	Visual	Not visible
<b>SURVEY FINDINGS and HAZARD MANAGEMENT RECOMMENDATIONS</b>					
<p><b>Medium Risk P3</b> – Avoid physical and mechanical damage. When maintenance/upgrade is required, recommend removal and reinstate with non-asbestos product. Unable to affix specific warning sign to item, covered by General sign.  <b>May 2013 note:</b> Item has been damaged at services. Recommend make safe in accordance with “Asbestos Approved Code of Practice”.</p>

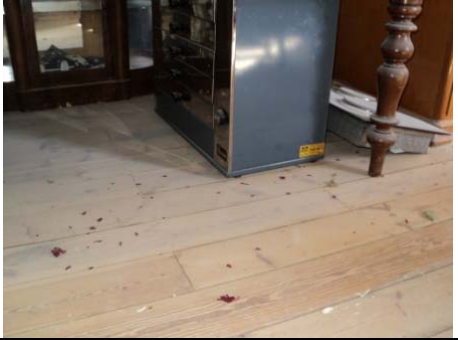
LOCATION - DESCRIPTION	EXTENT	ASBESTOS ASSESSMENT	CONDITION	SAMPLE NO VISUAL TEST	SIGNAGE STATUS
10. Internal, first floor council chambers, kitchen, 'Vauxhall' pie warmer, electrical component box – possible insulating heat shield and wire sheathing.	Not quantified Limited access	Presume asbestos content	Not assessed	Not accessed	-
<b><i>SURVEY FINDINGS and HAZARD MANAGEMENT RECOMMENDATIONS</i></b>					
Item not located upon inspection. Recommend client to qualify if item removed / relocated.
