## ASBESTOS REGISTER

**REGISTER NO.:** AS2250-25

**FOR THE PROPERTY AT:** Moonta Railway Station  
Blanche Terrace,  
Moonta SA

**DATE INSPECTED:** 10/05/2013

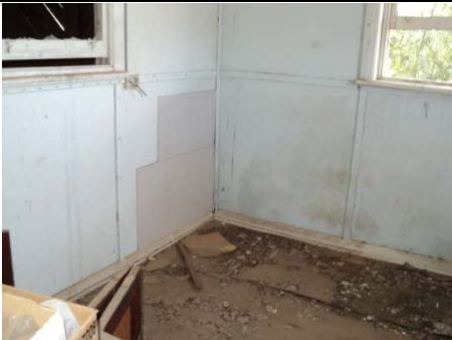
LOCATION – DESCRIPTION <u>BUILDINGS - INTERNAL</u>	EXTENT	ASBESTOS ASSESSMENT	CONDITION	SAMPLE NO VISUAL TEST	SIGNAGE STATUS
2. Internal, tram shed, south east corner, floor covering – green sheet vinyl (lino).	-	No asbestos detected	-	Sample no. 2 (Feb / 07)	-
<b><i>SURVEY FINDINGS and HAZARD MANAGEMENT RECOMMENDATIONS</i></b>					
No asbestos detected upon laboratory analysis of sample. Refer also notes below.

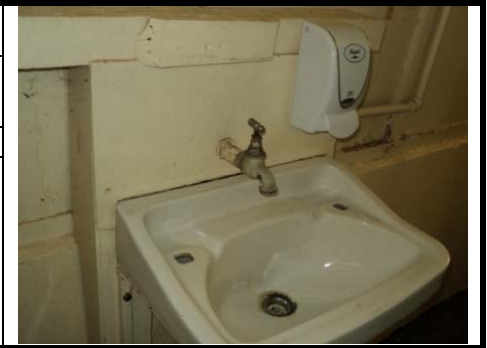
LOCATION – DESCRIPTION <u>BUILDINGS - INTERNAL</u>	EXTENT	ASBESTOS ASSESSMENT	CONDITION	SAMPLE NO VISUAL TEST	SIGNAGE STATUS
3. Internal, toilet block, male toilet, sink splashback & boxing around urinal – fibre cement sheet	Approx 3m <sup>2</sup> Accessible	Presume asbestos content	Good Sealed Non friable	Visual	Not visible
<b><i>SURVEY FINDINGS and HAZARD MANAGEMENT RECOMMENDATIONS</i></b>					
<p><b>Low Risk P4</b> – Avoid physical and mechanical damage. When maintenance/upgrade is required, recommend removal and reinstate with non-asbestos product.</p> <p>Covered by General sign affixed to (safety switch).</p> <p>Recommend sample (x1) to qualify material content, otherwise treat item as asbestos containing.</p>
