ASBESTOS REGISTER

REGISTER NO.: AS2250-22

FOR THE PROPERTY AT: Town Hall
71 George Street,
Moonta SA

CLIENT: District Council of the Copper Coast

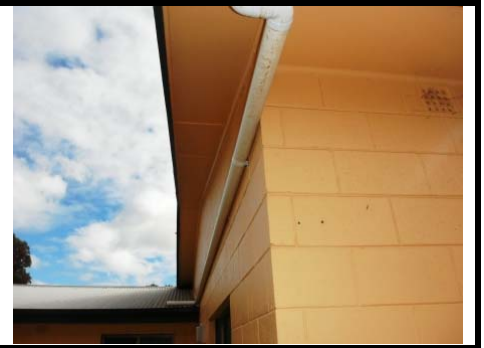
LOCATION - DESCRIPTION	EXTENT	ASBESTOS ASSESSMENT	CONDITION	SAMPLE NO VISUAL TEST	SIGNAGE STATUS
A. External, west section of hall, eaves linings – fibre cement sheet.	Approx 55m ² Limited access	Presume asbestos content	Good Sealed Non friable	Visual	Visible
SURVEY FINDINGS and HAZARD MANAGEMENT RECOMMENDATIONS					
<p>Low Risk P4 – Avoid physical and mechanical damage. When maintenance/upgrade is required, recommend removal and reinstate with non-asbestos product. Recommend sample (x1) to qualify material content, otherwise treat item as asbestos containing.</p>

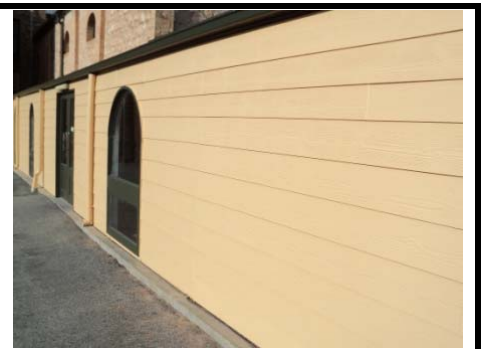
LOCATION - DESCRIPTION	EXTENT	ASBESTOS ASSESSMENT	CONDITION	SAMPLE NO VISUAL TEST	SIGNAGE STATUS
C. External, central northern section of hall, wall cladding – fibre cement planks.	Approx 50m ² Accessible	Presume asbestos content	Good Sealed Non friable	Visual	Visible
SURVEY FINDINGS and HAZARD MANAGEMENT RECOMMENDATIONS					
<p>Low Risk P4 – Avoid physical and mechanical damage. When maintenance/upgrade is required, recommend removal and reinstate with non-asbestos product. Recommend sample (x1) to qualify material content, otherwise treat item as asbestos containing.</p>

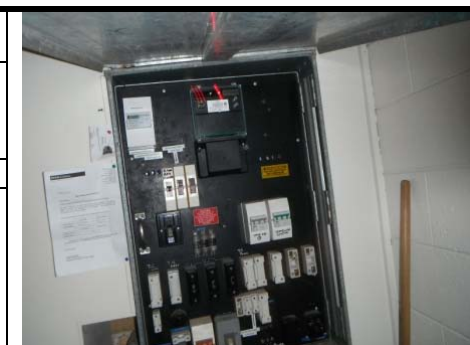
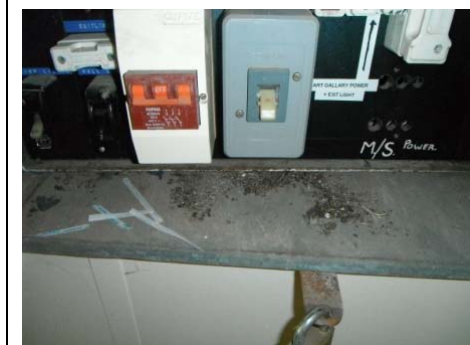
LOCATION - DESCRIPTION	EXTENT	ASBESTOS ASSESSMENT	CONDITION	SAMPLE NO VISUAL TEST	SIGNAGE STATUS
3. Internal, hall, rear corridor, within wall mounted metal cabinet, electrical board – black resin board.	Approx 1.5m ² Limited access	Chrysotile asbestos (typical)	Poor Unsealed Friable	Not accessed	Visible

May 2013 note: dust in the base of the cabinet. **Restrict access. Dust residue and debris visible in base of electrical cabinet. Recommend clean up immediately with approved asbestos vacuum system in accordance with "Asbestos Approved Code of Practice".**

High Risk P2 – Avoid physical and mechanical damage. When maintenance/upgrade is required, recommend removal and reinstate with non-asbestos product.

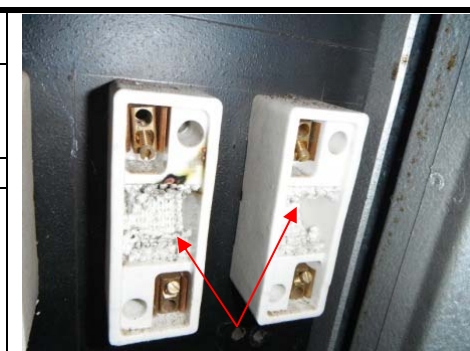
LOCATION - DESCRIPTION	EXTENT	ASBESTOS ASSESSMENT	CONDITION	SAMPLE NO VISUAL TEST	SIGNAGE STATUS
Additional Item 3a. Internal, ground floor, hall, rear corridor, within wall mounted metal cabinet, textile flash guards – fibrous material.	Approx 30mm dia. x 50mm	Presume asbestos content	Moderate Unsealed Friable	Visual	Not visible

High Risk P2 – Restrict access. Dust residue and debris visible in base of electrical cabinet. Recommend clean up immediately with approved asbestos vacuum system in accordance with "Asbestos Approved Code of Practice".

May 2013 note: recommend remove these flash guards at the same time as the vacuuming of the cabinet.

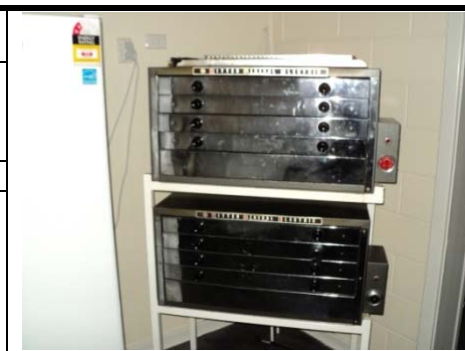
LOCATION - DESCRIPTION	EXTENT	ASBESTOS ASSESSMENT	CONDITION	SAMPLE NO VISUAL TEST	SIGNAGE STATUS
5. Internal, kitchen, store room, '2 x Ritter GE' pie warmers, electrical component box possible insulating heat shield and wire sheathing.	Not quantified Limited access	Presume asbestos content	Not assessed Unsealed Friable	Not accessed	Visible
<i>SURVEY FINDINGS and HAZARD MANAGEMENT RECOMMENDATIONS</i>					
Low Risk P4 – Avoid physical and mechanical damage. When maintenance/upgrade is required, recommend removal and reinstate with non-asbestos product. 2 x Pie Warmers not dismantled for inspection. Presume asbestos within the unit unless confirmed otherwise. Access with caution.

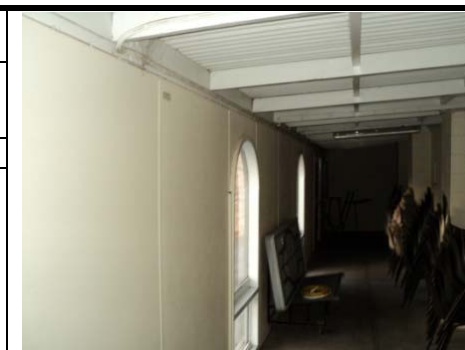
LOCATION - DESCRIPTION	EXTENT	ASBESTOS ASSESSMENT	CONDITION	SAMPLE NO VISUAL TEST	SIGNAGE STATUS
6. Internal, hall, rear corridor, wall linings – fibre cement sheet.	Approx 55m ² Accessible	Presume asbestos content	Good Sealed Non friable	Visual	Visible
<i>SURVEY FINDINGS and HAZARD MANAGEMENT RECOMMENDATIONS</i>					
Low Risk P4 – Avoid physical and mechanical damage. When maintenance/upgrade is required, recommend removal and reinstate with non-asbestos product. Recommend sample (x1) to qualify material content, otherwise treat item as asbestos containing.

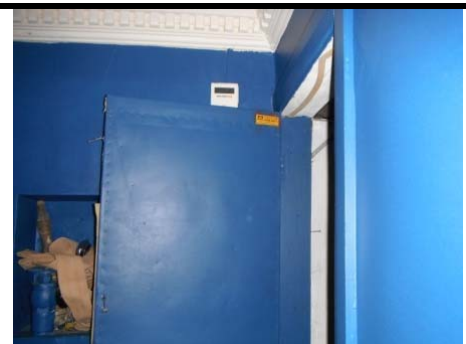
LOCATION - DESCRIPTION	EXTENT	ASBESTOS ASSESSMENT	CONDITION	SAMPLE NO VISUAL TEST	SIGNAGE STATUS
7. Internal, hall, upper floor, projector room, fire door, internal core – compressed fibre insulation.	Not quantified Inaccessible	Presume asbestos content	Not assessed Unsealed Friable	Not accessed	Visible
SURVEY FINDINGS and HAZARD MANAGEMENT RECOMMENDATIONS					
<p>Low Risk P4 – Treat all fire doors as having an asbestos internal core unless confirmed otherwise by sample analysis. Avoid physical and mechanical damage. When maintenance/upgrade is required, recommend removal and reinstate with non-asbestos product. 2011 inspection no internal access.</p> <p>April 2012 note: no access. No key available at time of inspection.</p>
