ASBESTOS REGISTER

REGISTER NO.: AS2250-19

FOR THE PROPERTY AT: Amenity Block (not clubs)
Moonta Oval, Milne Terrace,
Moonta SA

DATE INSPECTED: 09/05/2013

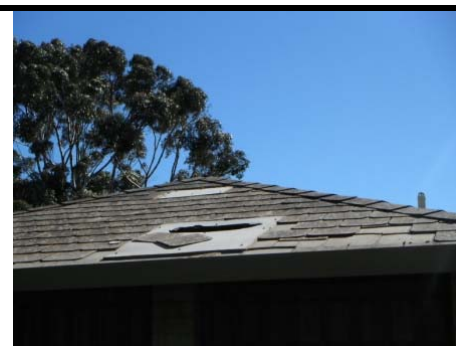
- **Item 'A/1' – Roof, fibre cement shingles fixed to fibre cement backing board, large hole visible.**

LOCATION – DESCRIPTION <u>AMENITY BUILDING – EXTERNAL</u>	EXTENT	ASBESTOS ASSESSMENT	CONDITION	SAMPLE NO VISUAL TEST	SIGNAGE STATUS
A. Roof, fibre cement shingles fixed to fibre cement backing board, cladding – fibre cement.	Approx 50m ² Limited access	Presume asbestos content	Moderate Unsealed Non friable	Visual	Visible
<i>SURVEY FINDINGS and HAZARD MANAGEMENT RECOMMENDATIONS</i>					
<p>Medium Risk P3 – Total access to the roof area was not gained, as safe access was not available. This asbestos product is inherently hard and brittle. Treat all asbestos roof areas as fragile. Access with caution. Use safe access systems.</p> <p>October 2008 – Made safe / collected loose tiles for transport & disposal, in accordance with “Approved Code of Practice”.</p> <p>April 2010 A few missing tiles noted.</p> <p>May 2013 note: large hole visible. Recommend make safe in accordance with “Asbestos Approved Code of Practice”.</p>

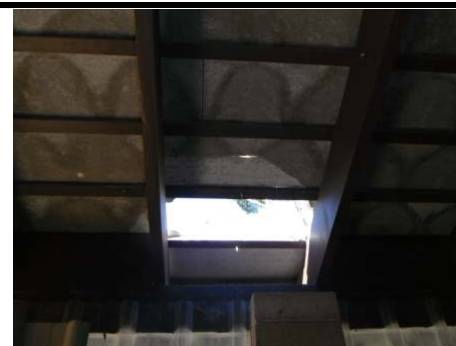
LOCATION – DESCRIPTION <u>AMENITY BUILDING – INTERNAL</u>	EXTENT	ASBESTOS ASSESSMENT	CONDITION	SAMPLE NO VISUAL TEST	SIGNAGE STATUS
1. Roof/Ceiling, underside of shingle roof, fibre cement backing board, cladding – fibre cement.	Approx 50m ² Limited access	Presume asbestos content	Moderate Unsealed Non friable	Visual	Visible
<i>SURVEY FINDINGS and HAZARD MANAGEMENT RECOMMENDATIONS</i>					
<p>Medium Risk P3 – Avoid physical and mechanical damage. When maintenance/upgrade is required, recommend removal and reinstate with non-asbestos product.</p> <p>May 2013 note: large hole visible. Recommend make safe in accordance with “Asbestos Approved Code of Practice”.</p>
