ASBESTOS REGISTER

REGISTER NO.: AS2250-26

FOR THE PROPERTY AT: Moonta Bay, Foreshore Carpark,
Amenities Block
Bay Road,
Moonta SA

DATE INSPECTED: 09/05/2013

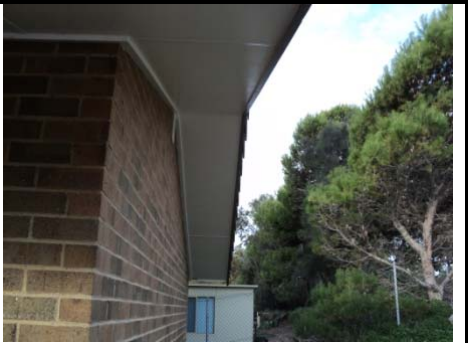
LOCATION – DESCRIPTION <u>BUILDING – EXTERNAL</u>	EXTENT	ASBESTOS ASSESSMENT	CONDITION	SAMPLE NO VISUAL TEST	SIGNAGE STATUS
A. North and south elevations, eaves, lining – fibre cement sheet.	Approx 8m ² Limited access	Chrysotile asbestos detected	Good Sealed Non friable	04RTA050810	Visible
SURVEY FINDINGS and HAZARD MANAGEMENT RECOMMENDATIONS					
Low Risk P4 – Avoid physical and mechanical damage. When maintenance/upgrade is required, recommend removal and reinstate with non-asbestos product.

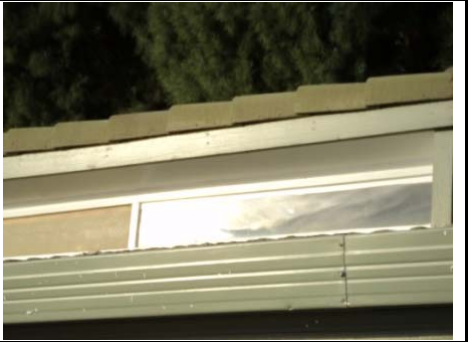
LOCATION – DESCRIPTION <u>BUILDING – EXTERNAL</u>	EXTENT	ASBESTOS ASSESSMENT	CONDITION	SAMPLE NO VISUAL TEST	SIGNAGE STATUS
B. Roof light feature, western elevation, eave, lining – fibre cement sheet.	Approx 5m ² Limited access	Chrysotile asbestos detected	Good Sealed Non friable	05RTA050810	Visible
SURVEY FINDINGS and HAZARD MANAGEMENT RECOMMENDATIONS					
Low Risk P4 – Avoid physical and mechanical damage. When maintenance/upgrade is required, recommend removal and reinstate with non-asbestos product.

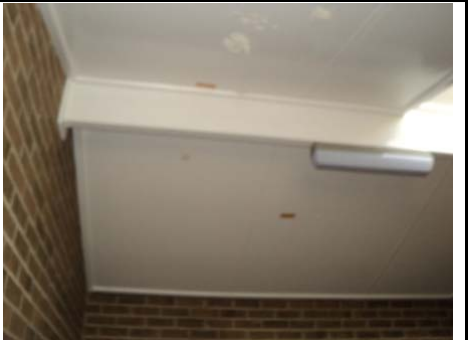
LOCATION – DESCRIPTION <u>BUILDING - INTERNAL</u>	EXTENT	ASBESTOS ASSESSMENT	CONDITION	SAMPLE NO VISUAL TEST	SIGNAGE STATUS
1. All areas, ceilings, lining – fibre cement sheet.	Approx 65m ² Limited access	Chrysotile asbestos detected	Good Sealed Non friable	06RTA050810	Visible
SURVEY FINDINGS and HAZARD MANAGEMENT RECOMMENDATIONS					
Low Risk P4 – Avoid physical and mechanical damage. When maintenance/upgrade is required, recommend removal and reinstate with non-asbestos product.
