ASBESTOS REGISTER

REGISTER NO.: AS2250-55

FOR THE PROPERTY AT: Old Steam Train, Kadina Playground Reserve
Cnr Taylor and Digby Streets,
Kadina, SA

DATE INSPECTED: 10/05/2013

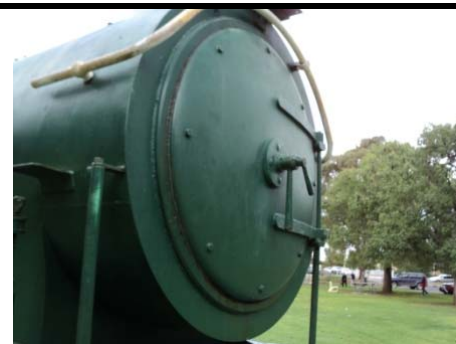
LOCATION - DESCRIPTION	EXTENT	ASBESTOS ASSESSMENT	CONDITION	SAMPLE NO VISUAL TEST	SIGNAGE STATUS
A. Front of train, steam boiler gasket to front round cover plate – fibrous rope material.	Approx 1m diameter x 10mm Accessible.	Presume asbestos content	Good Sealed Friable	Visual	Not visible
<i>SURVEY FINDINGS and HAZARD MANAGEMENT RECOMMENDATIONS</i>					
<p>Medium Risk P3 – Avoid physical and mechanical damage. When maintenance/upgrade is required, recommend removal and reinstate with non-asbestos product.</p> <p>Although item is sealed with paint, recommend planned removal in accordance with “Approved Code of Practice”.</p> <p>Recommend install a general awareness sign.</p>
