## ASBESTOS REGISTER

**REGISTER NO.:** AS2250-44

**FOR THE PROPERTY AT:** Council Depot, Old Fertiliser Works,  
Industrial Shedding  
Chatfield Terrace,  
Wallaroo, SA

**DATE INSPECTED:** 09/05/2013

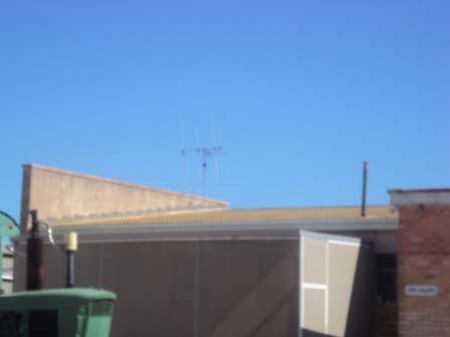
LOCATION - DESCRIPTION	EXTENT	ASBESTOS ASSESSMENT	CONDITION	SAMPLE NO VISUAL TEST	SIGNAGE STATUS
B. External, mussel business building, roof cladding – corrugated fibre cement sheet and associated flashings.	Approx 450m <sup>2</sup> Limited access	Presume asbestos content	Moderate Unsealed Non friable	Visual	Visible
<b>SURVEY FINDINGS and HAZARD MANAGEMENT RECOMMENDATIONS</b>					
<b>Low Risk P4</b> – Avoid physical and mechanical damage. When maintenance/upgrade is required, recommend removal and reinstate with non-asbestos product. Recommend sample (x2) to qualify material content, otherwise treat item as asbestos containing. Total access to the roof area was not gained, as safe access was not available. This asbestos product is inherently hard and brittle. Treat all asbestos roof areas as fragile. Access with caution. Use safe access systems.

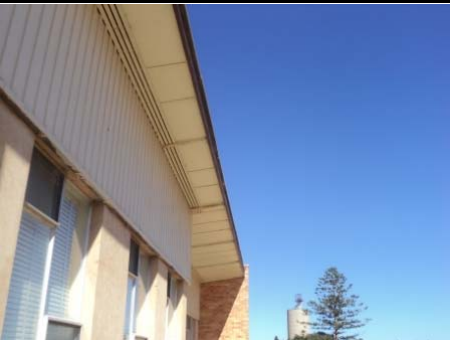
LOCATION - DESCRIPTION	EXTENT	ASBESTOS ASSESSMENT	CONDITION	SAMPLE NO VISUAL TEST	SIGNAGE STATUS
C. External, mussel business building, north elevation, eaves lining – fibre cement sheet.	Approx 26m <sup>2</sup> Limited access	Presume asbestos content	Good Sealed Non friable	Visual	Visible
<b>SURVEY FINDINGS and HAZARD MANAGEMENT RECOMMENDATIONS</b>					
<b>Low Risk P4</b> – Avoid physical and mechanical damage. When maintenance/upgrade is required, recommend removal and reinstate with non-asbestos product. Recommend sample (x1) to qualify material content, otherwise treat item as asbestos containing.

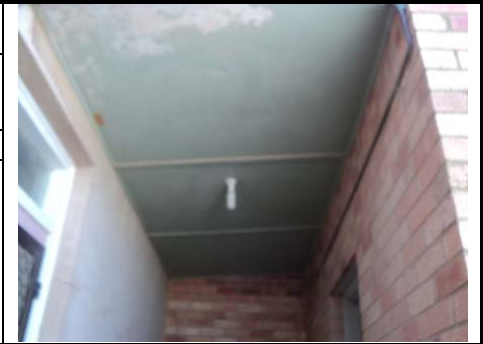
LOCATION - DESCRIPTION	EXTENT	ASBESTOS ASSESSMENT	CONDITION	SAMPLE NO VISUAL TEST	SIGNAGE STATUS
D. External, mussel business building, south rear entry, porch lining – fibre cement sheet.	Approx 3m <sup>2</sup> Limited access	Presume asbestos content	Good Unsealed Non friable	Visual	Visible
<b>SURVEY FINDINGS and HAZARD MANAGEMENT RECOMMENDATIONS</b>					
<p><b>Low Risk P4</b> – Avoid physical and mechanical damage. When maintenance/upgrade is required, recommend removal and reinstate with non-asbestos product.</p> <p>Recommend sample (x1) to qualify material content, otherwise treat item as asbestos containing.</p>

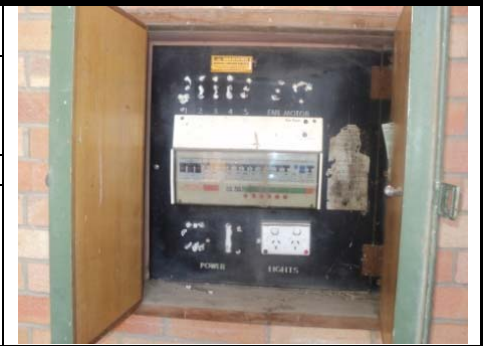
LOCATION - DESCRIPTION	EXTENT	ASBESTOS ASSESSMENT	CONDITION	SAMPLE NO VISUAL TEST	SIGNAGE STATUS
E. External, mussel business building, south rear entry, porch lobby, within timber cabinet, electrical board – black resin board.	Approx 0.5m <sup>2</sup> visible Accessible	Presume asbestos content	Good Unsealed Non friable	Visual	Visible
<b>SURVEY FINDINGS and HAZARD MANAGEMENT RECOMMENDATIONS</b>					
<p><b>Low Risk P4</b> – Avoid physical and mechanical damage. When maintenance/upgrade is required, recommend removal and reinstate with non-asbestos product.</p> <p><b>October 2008</b> - Dust residue and debris in base of electrical cabinet cleaned up with approved asbestos vacuum system in accordance with "Approved Code of Practice".</p>

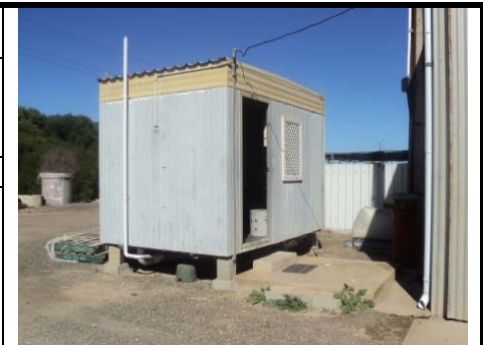
LOCATION - DESCRIPTION	EXTENT	ASBESTOS ASSESSMENT	CONDITION	SAMPLE NO VISUAL TEST	SIGNAGE STATUS
F. External, toilet transportable building, beneath building, possible packers – fibre cement fragments.	Not quantified Limited access	Presume asbestos content	Moderate Unsealed Non friable	Visual	Not visible
<b>SURVEY FINDINGS and HAZARD MANAGEMENT RECOMMENDATIONS</b>					
<p><b>Low Risk P4</b> – Avoid physical and mechanical damage. When maintenance/upgrade is required, recommend removal and reinstate with non-asbestos product. Unable to affix specific warning sign to item, covered by General sign.</p>

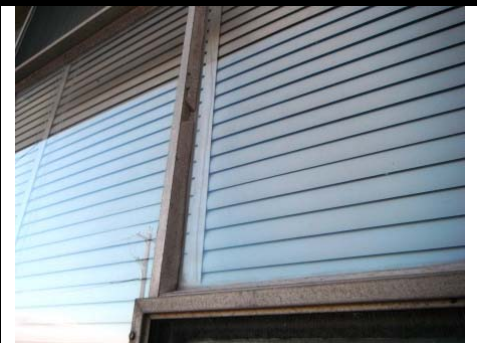
G. External, ground floor, mussel business building, windows, expansion / control joint – mastic / caulking.	-	No asbestos detected	-	01/LJ/090513	-	
<b>SURVEY FINDINGS and HAZARD MANAGEMENT RECOMMENDATIONS</b> No asbestos detected upon laboratory analysis of sample.

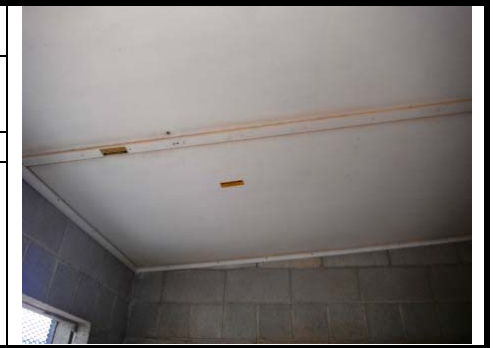
LOCATION - DESCRIPTION	EXTENT	ASBESTOS ASSESSMENT	CONDITION	SAMPLE NO VISUAL TEST	SIGNAGE STATUS
3. Internal, Works Depot fuel storage room, ground floor, ceiling, lining – fibre cement sheet.	Approx 5m <sup>2</sup> Limited access	Presume asbestos content	Good Sealed Non friable	Visual	Visible
<b><i>SURVEY FINDINGS and HAZARD MANAGEMENT RECOMMENDATIONS</i></b>					
<p><b>Low Risk P4</b> – Avoid physical and mechanical damage. When maintenance/upgrade is required, recommend removal and reinstate with non-asbestos product. Recommend sample (x1) to qualify material content, otherwise treat item as asbestos containing.</p>
